SHEET INDEX

REPAIR BRIDGES, VARIOUS LOCATIONS MCB, CLNC

PROJECT AREA DESCRIPTIONS
 BRIDGE NO. 750 (PROP. REC. NO. 200480)
 SETH WILLIAMS BLVD. OVER WALLACE CREEK

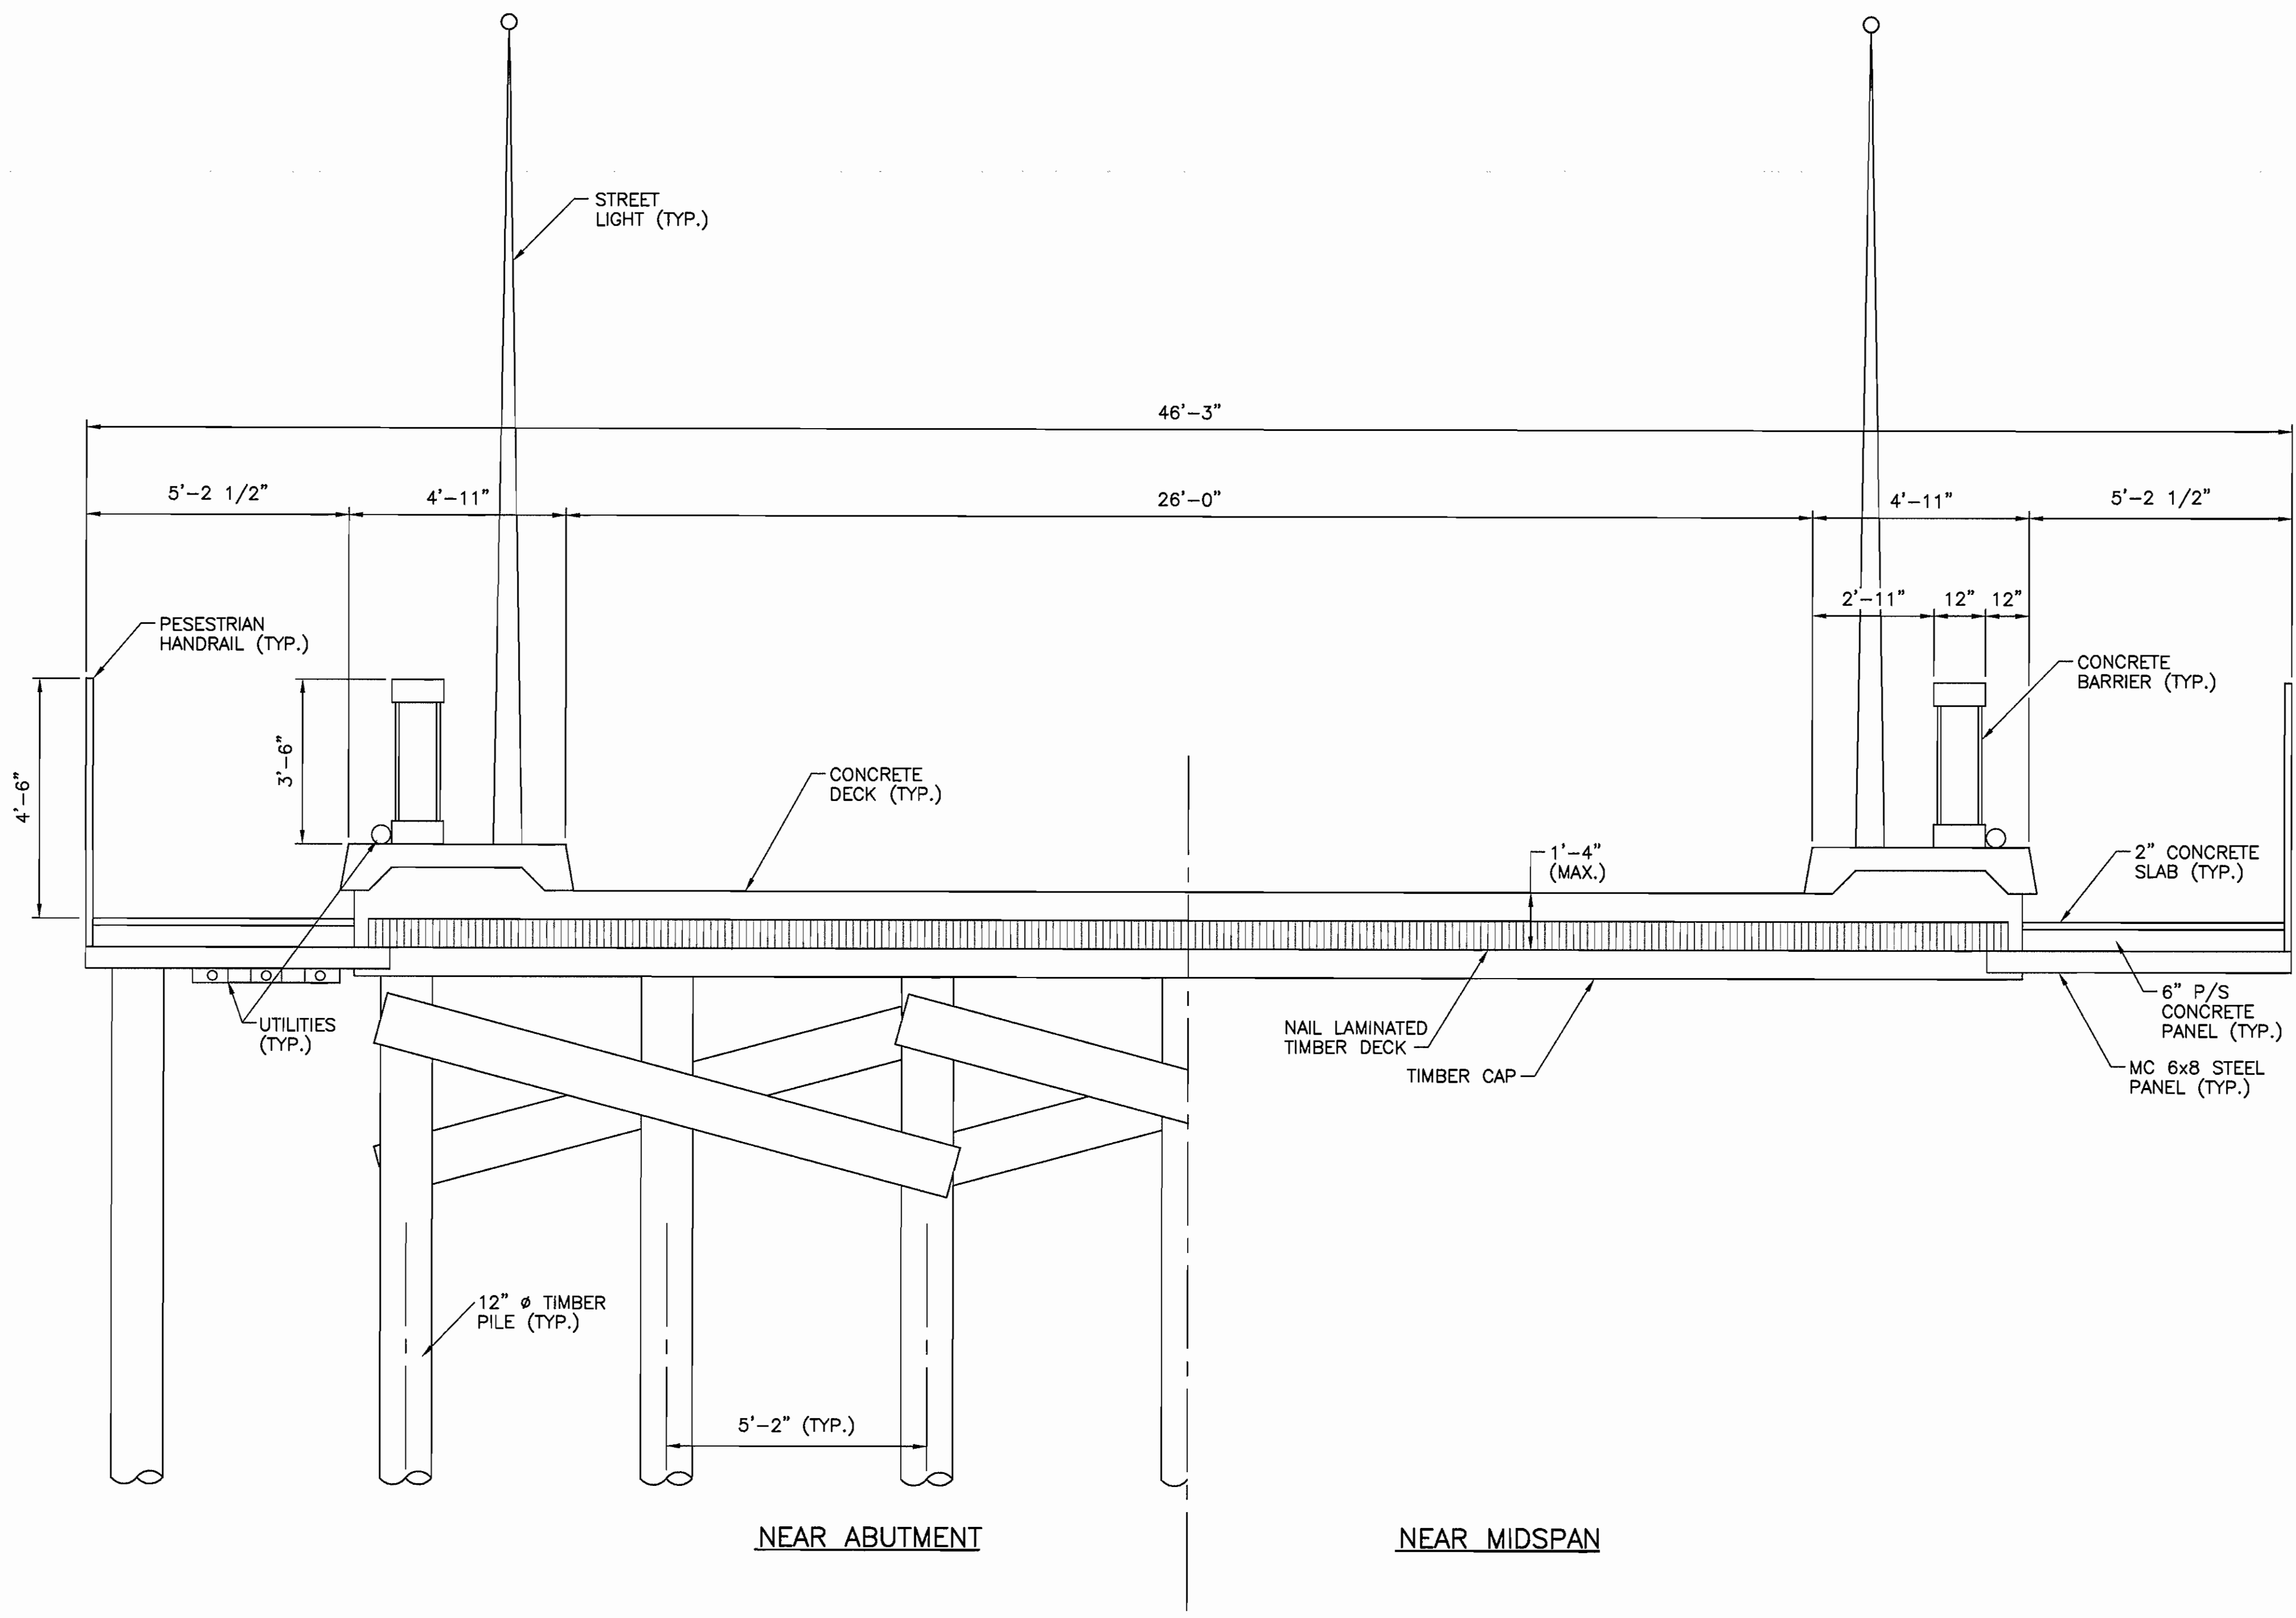
TYPICAL BRIDGE SECTION
 NOT TO SCALE

CONTRACTOR RESPONSIBILITY AND REQUIREMENTS	
DESCRIPTION OF RESPONSIBILITY AND REQUIREMENTS:	ACTION TO BE TAKEN:
1. THERE IS A GOUGE IN THE NORTHBOUND LANE OF THE NORTH APPROACH, A 1/2" WIDE LONGITUDINAL CRACK ALONG THE CENTERLINE OF THE NORTH APPROACH, RANDOM GOUGES IN THE NORTHBOUND LANE OF THE SOUTH APPROACH UP TO 1/2", AND MINOR MAPCRACKING IN THE SOUTH APPROACH PAVEMENT.	CLEAN AND SEAL PAVEMENT CRACKS AND GOUGES.

2. THERE IS A POTHOLE IN THE NORTHBOUND LANE OF THE NORTH APPROACH, 1'x6"Wx3'DP.	REPAIR POTHOLE PER DETAIL.
3. THE FOLLOWING PILES HAVE GREATER THAN 20% SECTION LOSS: BENT 5 PILE 2, BENT 22 PILE 2, AND BENT 37 PILE 8.	REPAIR THE SECTIONS PER DETAIL.

4. THERE IS SEVERE DECAY OR SPLITTING OF CROSS BRACING.	REPLACE THE CROSS BRACING AND USE NEW HARDWARE FOR THE CONNECTION.
5. PAVEMENT MARKINGS ON THE DECK AND APPROACHES IS FADED.	RESTRIPES THE DECK AND APPROACH WITH THERMOPLASTIC MATERIAL IN ACCORDANCE WITH NCDOT GUIDELINES.

6. THE CABLES ON THE GUARDRAIL END TREATMENTS WE FOUND TO BE LOOSE.	TIGHTEN CABLES ON GUARDRAIL END TREATMENTS.
7. ELIMINATE VEHICLE SNAG POINTS (ERODED SOILS) AT THE NORTHWEST AND SOUTHEAST CORNERS.	REPLACE THE CROSS BRACING AND USE NEW HARDWARE FOR THE CONNECTION.

8. THE HANDRAIL AT THE NORTHEAST CORNER IS OVERGROWN WITH VEGETATION.	REMOVE VEGETATION AND SPRAY WITH HERBICIDE.
9. THE CONDUIT FOR LIGHTING IS SEPARATED AT THE CENTER OF THE BRIDGE.	REPAIR THE SEPARATED CONDUIT.

10. ISOLATED AREAS OF DECAY WITH UP TO 100% LOSS OF SECTION ARE PRESENT ON THE TIMBER BULKHEAD OF END BENT 1.	REPLACE THE DECAYING TIMBERS.
11. PERIODICALLY CLEAN THE BRIDGE JOINTS, GUTTERS, AND DRAINS.	CLEAN AS NEEDED DURING CONTRACT TIMEFRAME.

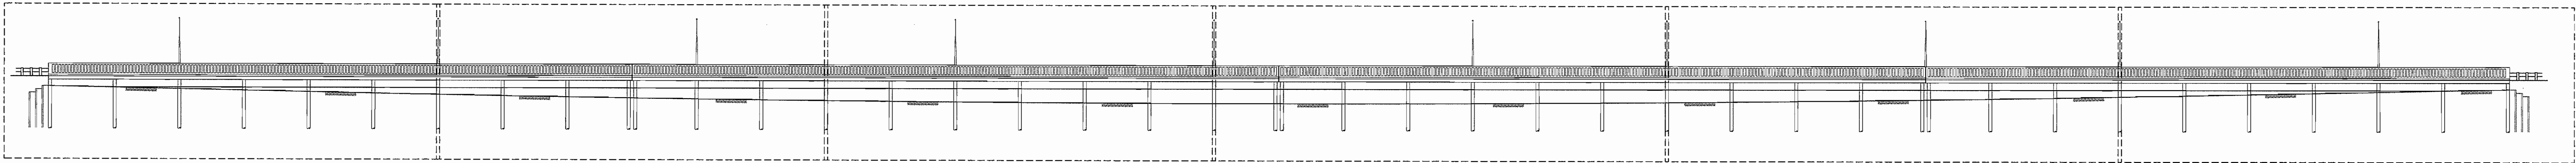
BRIDGE ELEVATION KEY MAP
 NOT TO SCALE

BENT 1 - 7 SHEET C-2 BENT 7 - 14 SHEET C-2 BENT 14 - 20 SHEET C-3 BENT 20 - 28 SHEET C-3 BENT 28 - 36 SHEET C-4 BENT 36 - 42 SHEET C-4

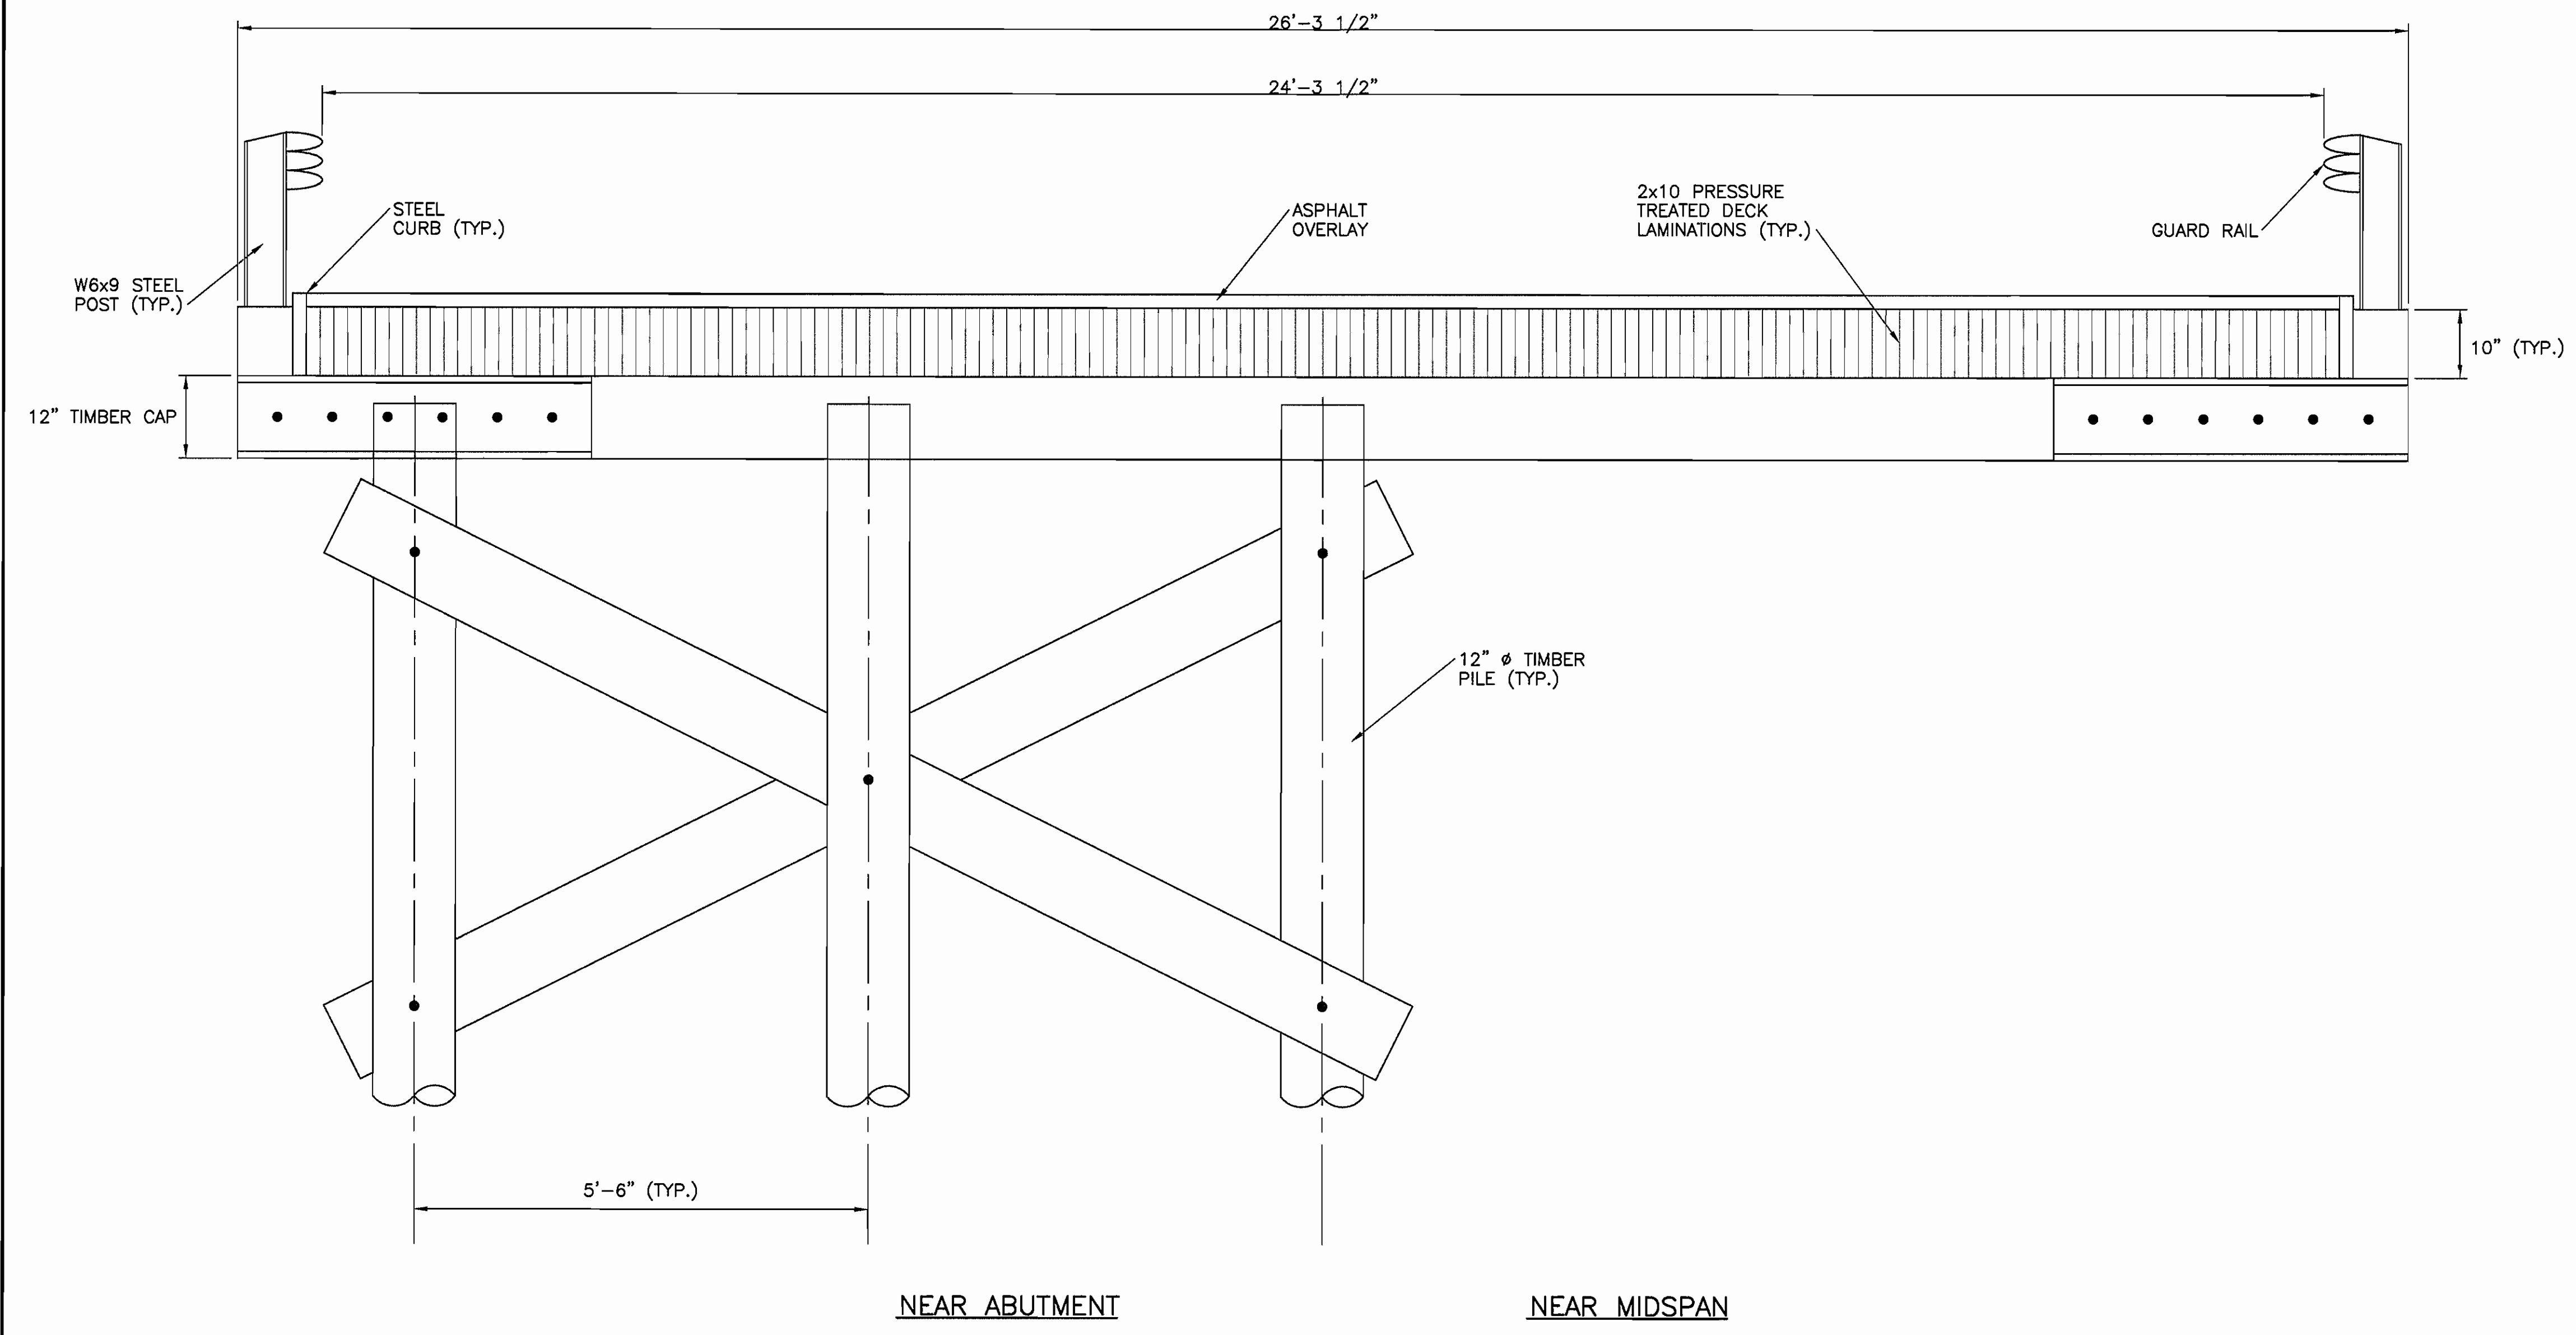
TYPICAL BRIDGE SECTION
 NOT TO SCALE

CONTRACTOR RESPONSIBILITY AND REQUIREMENTS	
DESCRIPTION OF RESPONSIBILITY AND REQUIREMENTS:	ACTION TO BE TAKEN:
1. PILE 1 AT BENT 14 HAS EXTERNAL AND INTERNAL DECAY WITH APPROXIMATELY 60% SECTION LOSS.	REPLACE DECAYED PILE.

2. REPAIR DECAYED SECTIONS OF THE FOLLOWING PILES: PILE 4 AT BENT 2, PILE 5 AT BENT 7, PILE 5 AT BENT 9, PILE 1 AT BENT 10, PILE 3 AT BENT 11, PILE 5 AT BENT 15 (2 AREAS), PILE 1 AT BENT 16, PILE 5 AT BENT 17, AND PILE 5 AT BENT 18.	REPAIR DECAYED PILE SECTIONS PER "DECAYED PILE REPAIR DETAIL".

3. CROSS-BRACING MEMBERS HARDWARE IS HEAVILY CORRODED OR MISSING FOR THE CROSS-BRACING TIMBERS.	REPLACE OR ADD HARDWARE FOR ADEQUATE REPAIR OF THE TIMBER CROSS-BRACING.

4. SOME OF THE CROSS-BRACING MEMBERS ARE DISCONNECTED DUE TO 100% SECTION LOSS.	REPLACE CROSS-BRACING MEMBERS AND SECURE WITH NEW HARDWARE.
5. REPAIR THE UNDERMINED AREAS AT THE SOUTH BULKHEAD AT END BENT1 AND AT THE SOUTHEAST WING WALL WITH GROUT BAGS.	CONTRACTOR SHALL CLEAN OUT UNDERMINED AREAS OF UNSUITABLE SOILS AND BACKFILL WITH GROUT BAGS.

6. REPLACE THE TWO FAILED OR SEVERELY DECAYED TIMBER GUARDRAIL POSTS AT THE SOUTHEAST APPROACH AND THE ONE DECAYED TIMBER GUARDRAIL POST AT THE NORTHWEST APPROACH.	REPLACE TIMBER GUARDRAIL POSTS PER NCDOT STANDARD DETAILS.

7. REINSTALL THE INCORRECTLY LAPPED GUARDRAIL SECTION AT THE NORTHEAST BRIDGE CORNER.	REINSTALL GUARDRAIL PER NCDOT STANDARD DETAILS.
8. SEAL THE CRACKS IN THE ASPHALT DECK OVERLAY AT THE SOUTH APPROACH.	CLEAN AND SEAL ALL JOINTS IN ACCORDANCE WITH NCDOT STANDARD DETAILS.

10. REALIGN ALL OF THE MISALIGNED GUARDRAIL TIMBER OFFSET BLOCKS AND TIGHTEN ALL OF THE GUARDRAIL ATTACHMENT BOLTS.	REALIGN OFFSET BLOCKS USING NCDOT STANDARD DETAILS AND TIGHTEN ATTACHMENT BOLTS ON THE GUARDRAILS.
