FACILITIES ENGINEERING DEPARTMENT  
FACILITIES DIRECTORATE  
Marine Corps Air Station  
Cherry Point, North Carolina 28533-0006

PHOTO #1, Building 4310

**Sketch No. B4310-01**

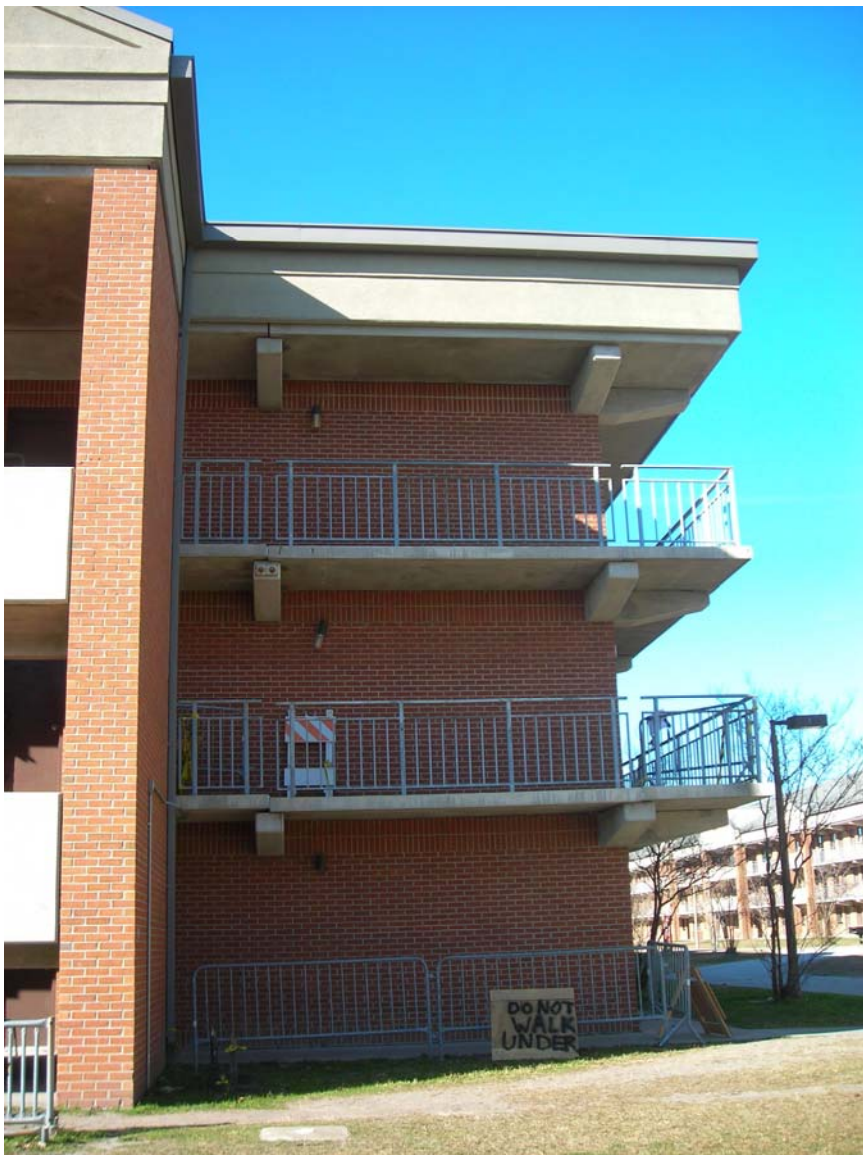
Southeast end of building showing 1<sup>st</sup>, 2<sup>nd</sup> & 3<sup>rd</sup> floor walkways. The left side of the photo shows the right edge of the stairs. The 2<sup>nd</sup> floor walkway has dropped due to movement of the support beam.

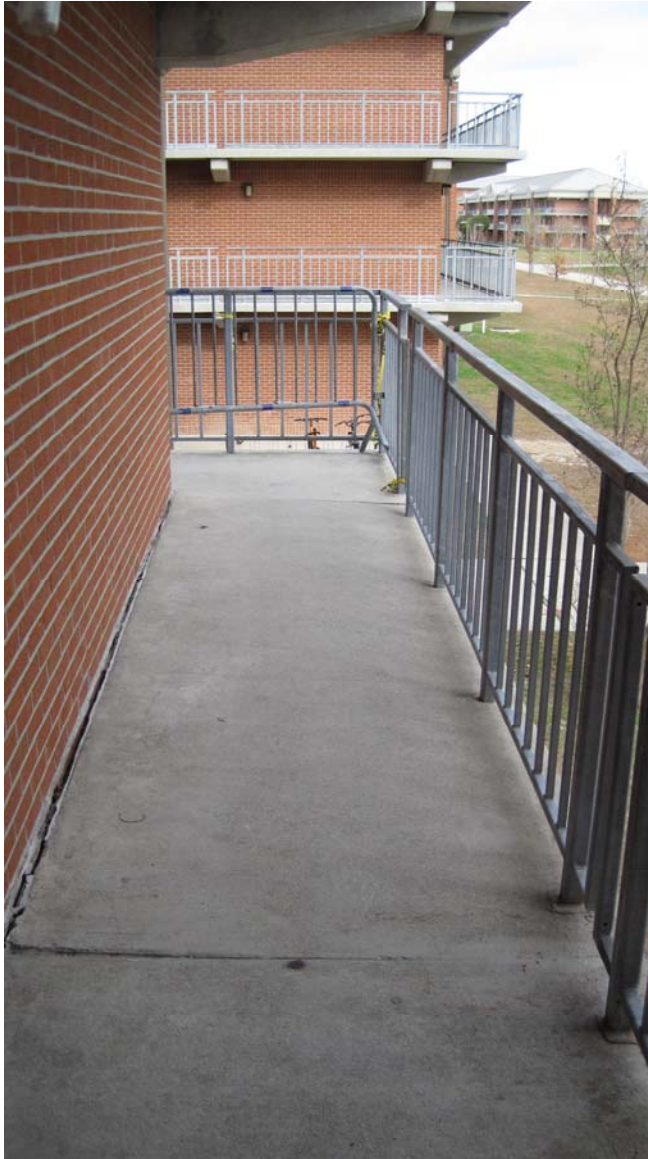
PHOTO #2, Building 4310

2<sup>nd</sup> floor walkway that has been affected by failure of its cantilevered beam support.

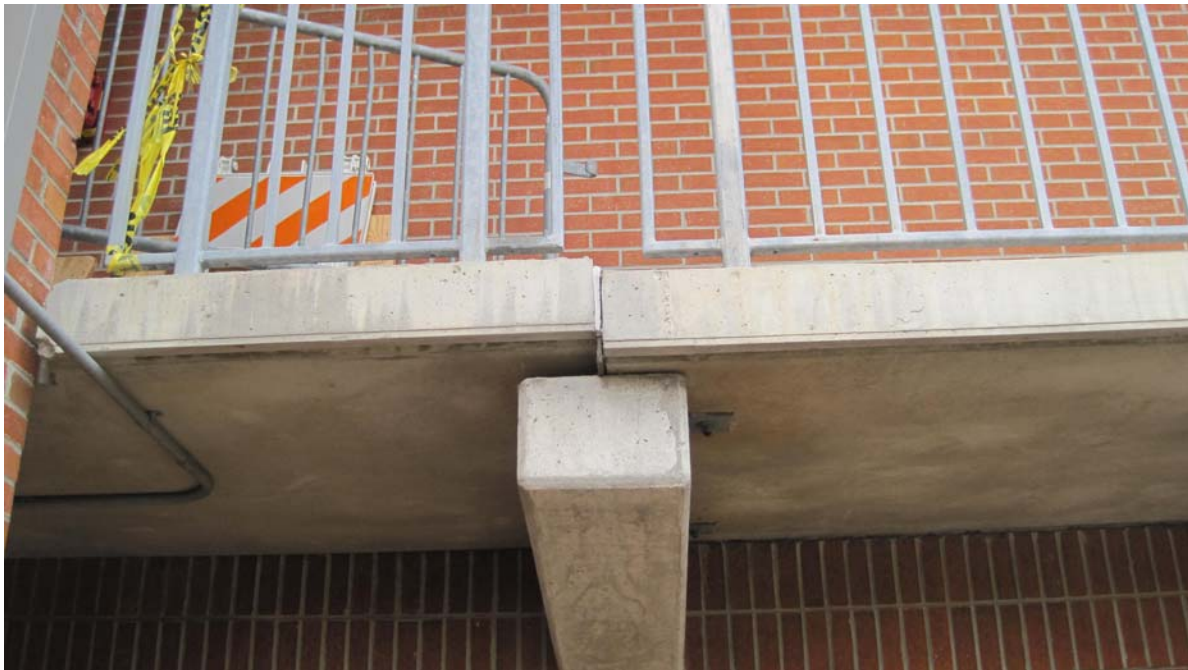
PHOTO #3, Building 4310

This photo is zoomed in on the cantilevered beam that has failed and the 2nd floor walkway. Note the walkway slab on the right side is resting on the beam, and the walkway slab on the left side isn't resting on the beam but is being held higher because it rests on the stair structure.

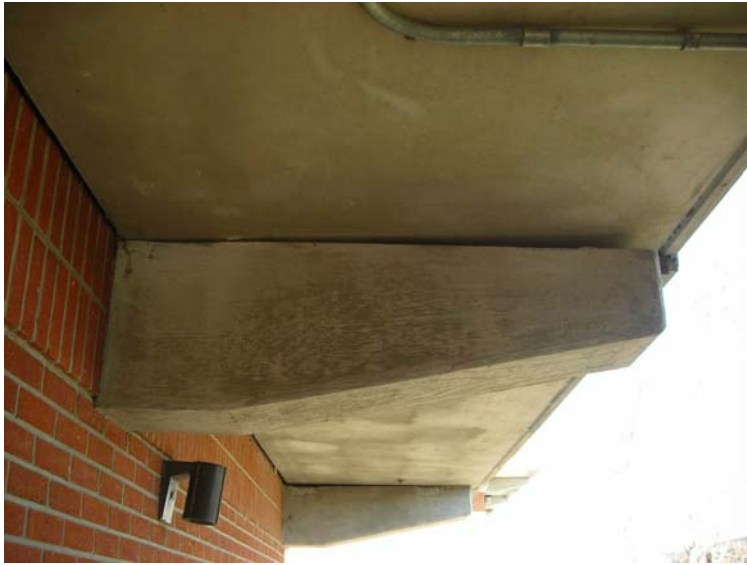
PHOTO #4, Building 4310  
Failed beam, left side.

REPLACE BEAM # FB9

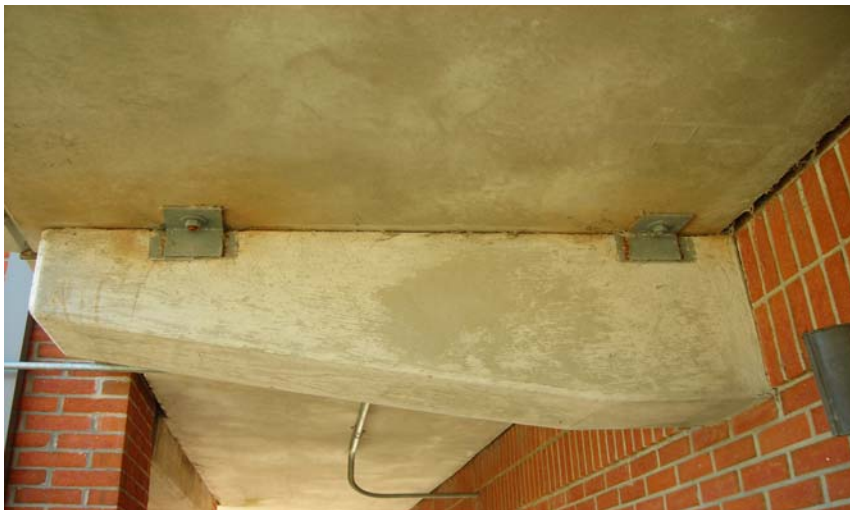
PHOTO #5, Building 4310  
Failed beam, right side.

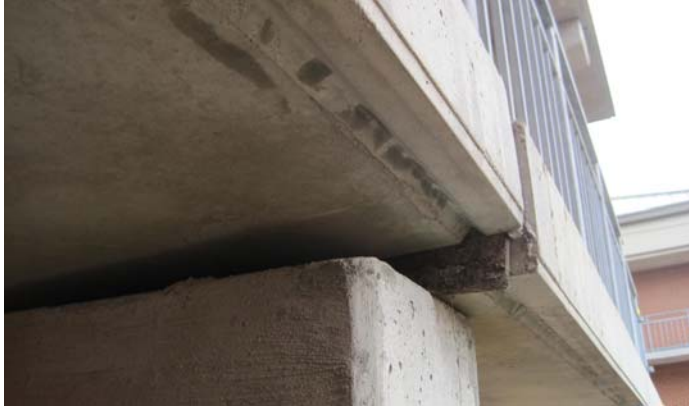
PHOTO #6, Building 4310

Side angle view, zoomed in on the joint where walkway slabs meet, left side.

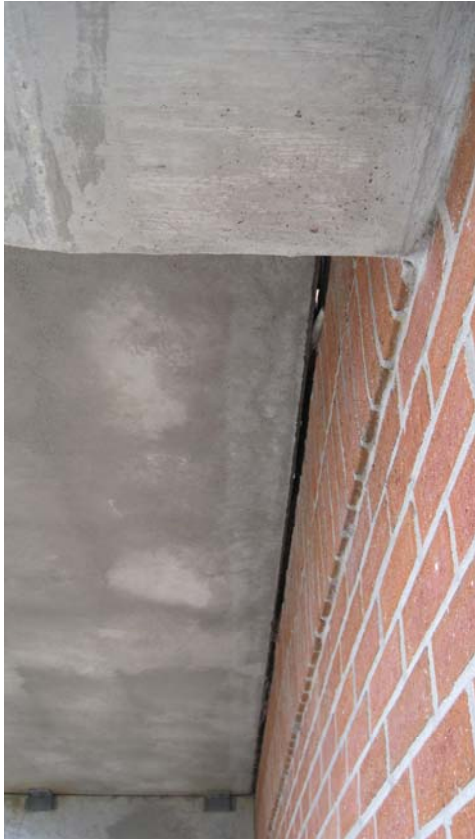
PHOTO #7, Building 4310

Underneath looking up at 2<sup>nd</sup> floor slab.

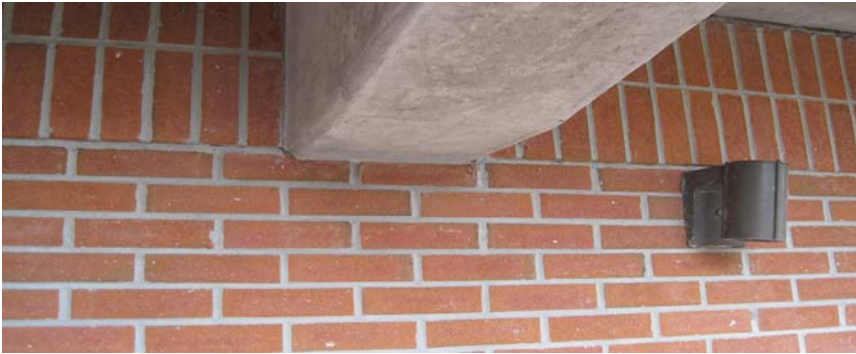
PHOTO #8, Building 4310

Failed beam at face of building, bottom left side

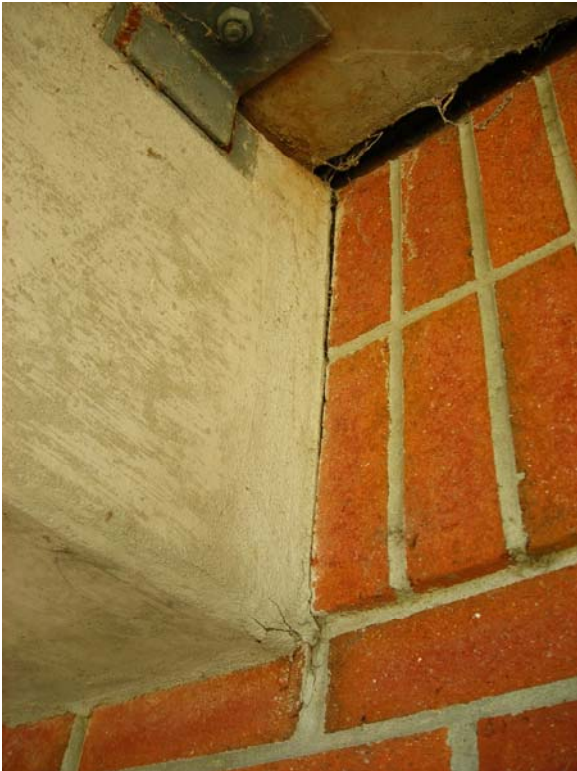
PHOTO #9, Building 4310

Failed beam at face of building, right side
