SHEET INDEX

REPAIR BRIDGES, VARIOUS LOCATIONS MCB, CLNC

PROJECT AREA DESCRIPTIONS
 BRIDGE NO. 750 (PROP. REC. NO. 200480)
 SETH WILLIAMS BLVD. OVER WALLACE CREEK

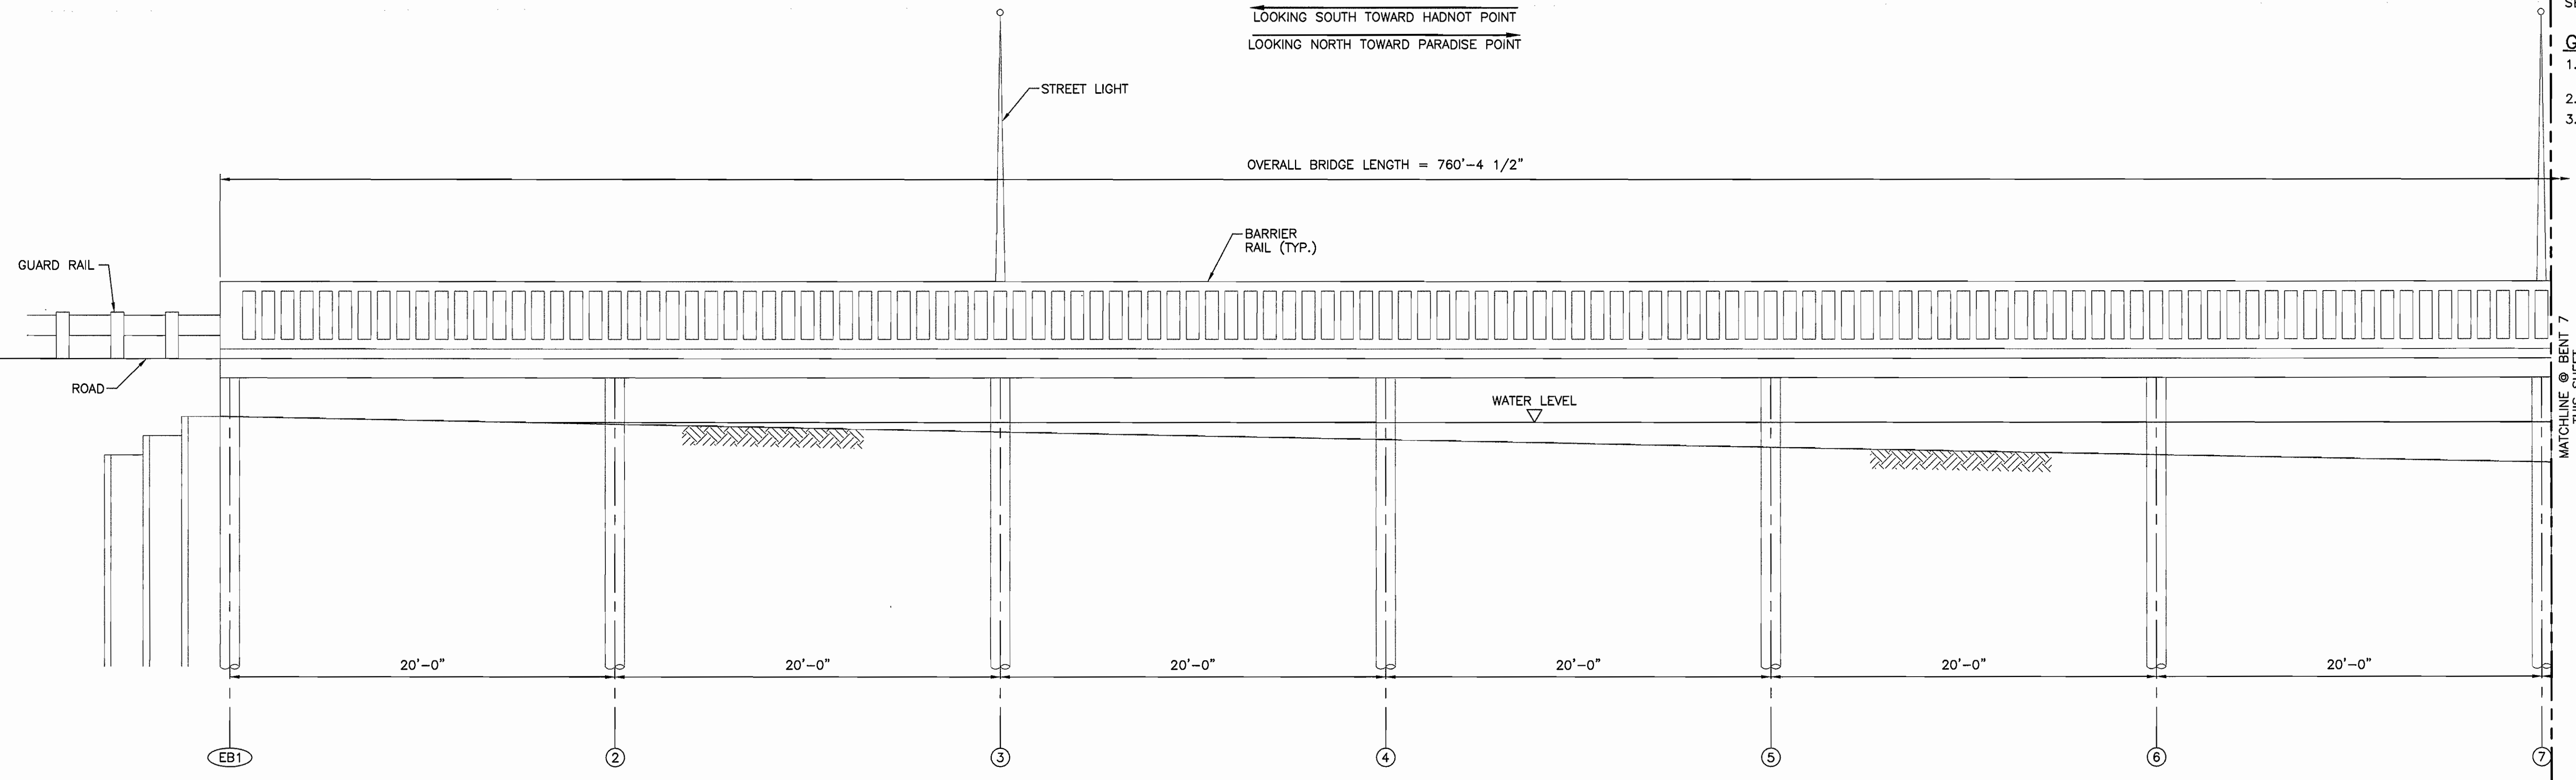
BRIDGE S750

DESCRIPTION OF RESPONSIBILITY AND REQUIREMENTS:	ACTION TO BE TAKEN:
1. THERE IS A GOUGE IN THE NORTHBOUND LANE OF THE NORTH APPROACH, A 1/2" WIDE LONGITUDINAL CRACK ALONG THE CENTERLINE OF THE NORTH APPROACH, RANDOM GOUGES IN THE NORTHBOUND LANE OF THE SOUTH APPROACH UP TO 1/2", AND MINOR MAPCRACKING IN THE SOUTH APPROACH PAVEMENT.	CLEAN AND SEAL PAVEMENT CRACKS AND GOUGES.

2. THERE IS A POTHOLE IN THE NORTHBOUND LANE OF THE NORTH APPROACH, 1'x6"Wx3"DP.	REPAIR POTHOLES PER DETAIL.
3. THE FOLLOWING PILES HAVE GREATER THAN 20% SECTION LOSS: BENT 5 PILE 2, BENT 22 PILE 2, AND BENT 37 PILE 8.	REPAIR THE SECTIONS PER DETAIL.

4. THERE IS SEVERE DECAY OR SPLITTING OF CROSS BRACING.	REPLACE THE CROSS BRACING AND USE NEW HARDWARE FOR THE CONNECTION.
5. PAVEMENT MARKINGS ON THE DECK AND APPROACHES IS FADED.	RESTRIPE THE DECK AND APPROACH WITH THERMOPLASTIC MATERIAL IN ACCORDANCE WITH NCDOT GUIDELINES.

6. THE CABLES ON THE GUARDRAIL END TREATMENTS WE FOUND TO BE LOOSE.	TIGHTEN CABLES ON GUARDRAIL END TREATMENTS.
7. ELIMINATE VEHICLE SNAG POINTS (ERODED SOILS) AT THE NORTHWEST AND SOUTHEAST CORNERS.	REPLACE THE CROSS BRACING AND USE NEW HARDWARE FOR THE CONNECTION.

8. THE HANDRAIL AT THE NORTHEAST CORNER IS OVERGROWN WITH VEGETATION.	REMOVE VEGETATION AND SPRAY WITH HERBICIDE.
9. THE CONDUIT FOR LIGHTING IS SEPARATED AT THE CENTER OF THE BRIDGE.	REPAIR THE SEPARATED CONDUIT.

10. ISOLATED AREAS OF DECAY WITH UP TO 100% LOSS OF SECTION ARE PRESENT ON THE TIMBER BULKHEAD OF END BENT 1.	REPLACE THE DECAYING TIMBERS.
11. PERIODICALLY CLEAN THE BRIDGE JOINTS, GUTTERS, AND DRAINS.	CLEAN AS NEEDED DURING CONTRACT TIMEFRAME.

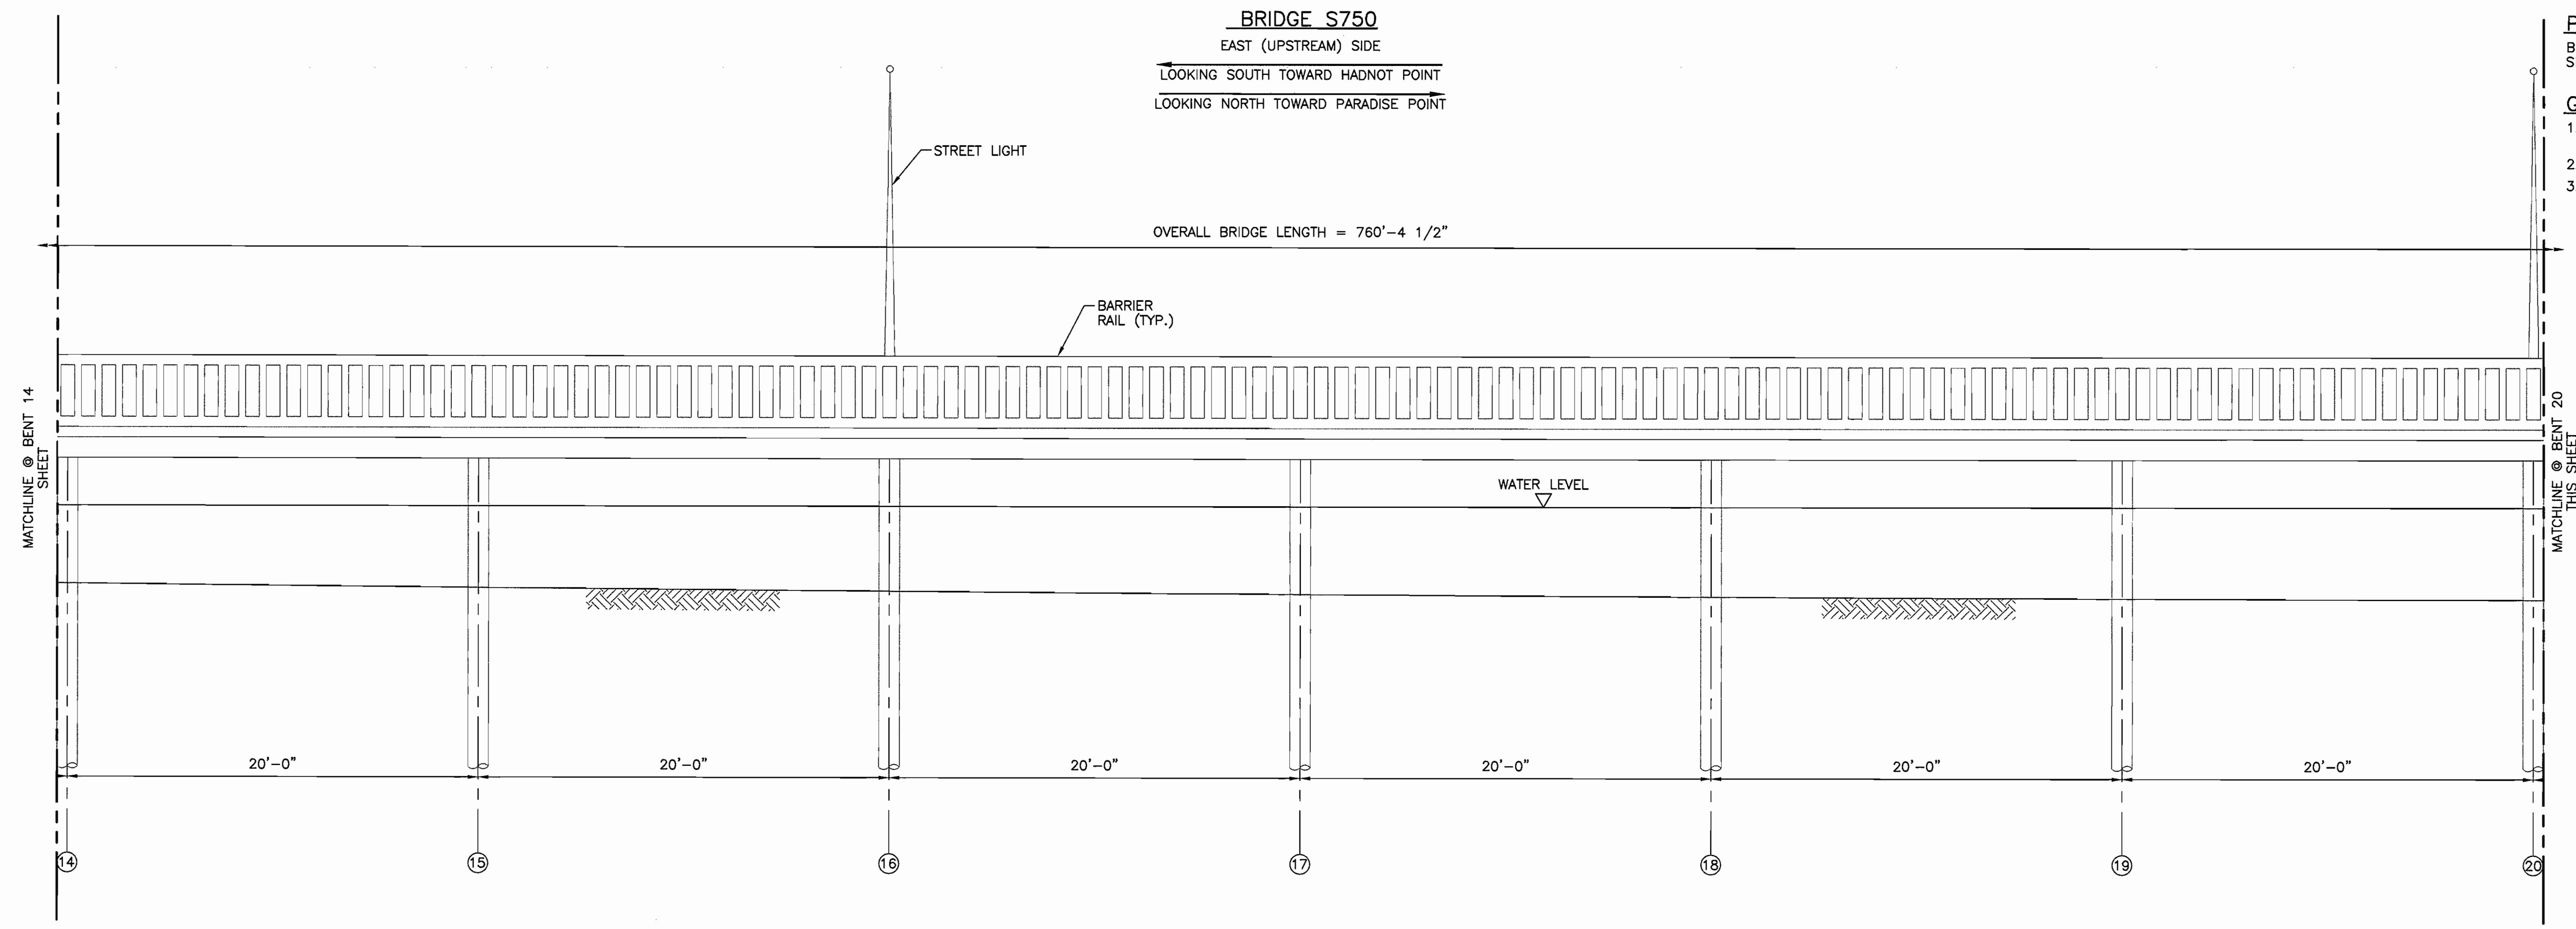
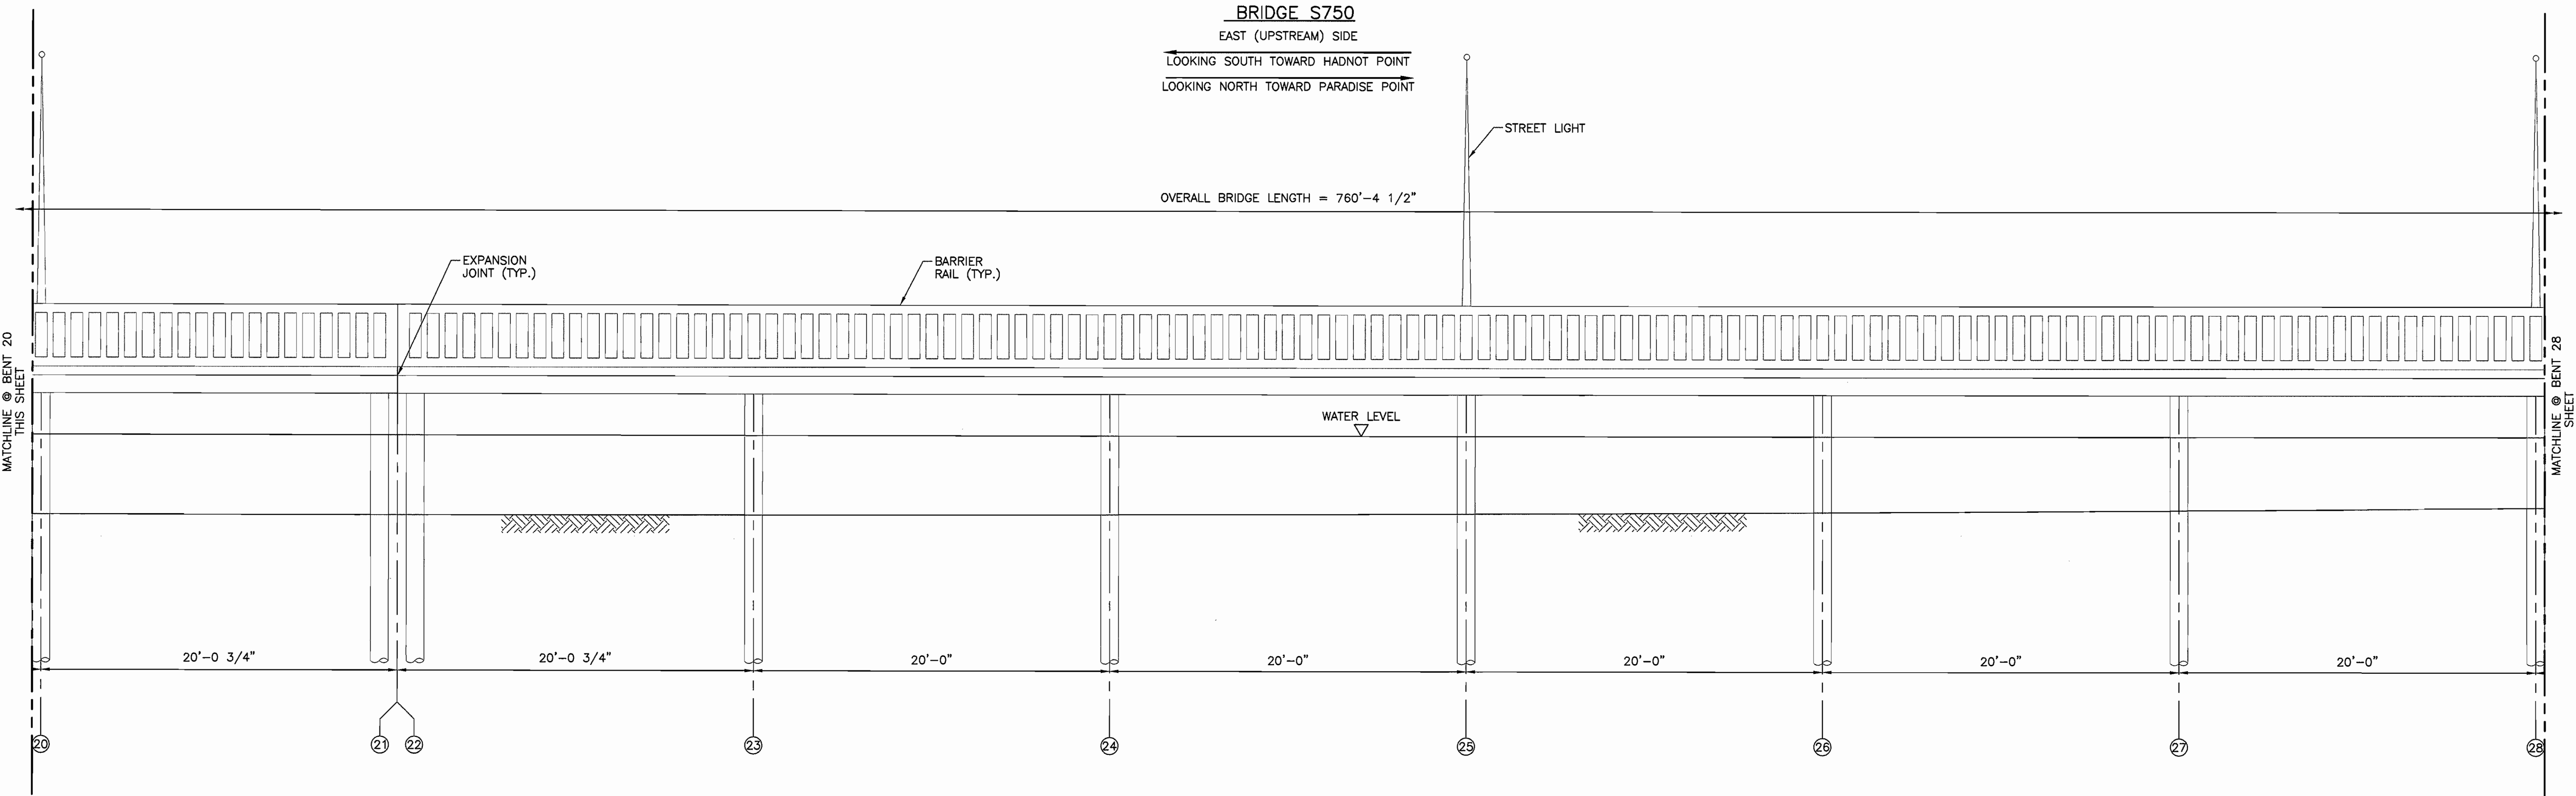
CONTRACTOR RESPONSIBILITY AND REQUIREMENTS	
DESCRIPTION OF RESPONSIBILITY AND REQUIREMENTS:	ACTION TO BE TAKEN:
1. THERE IS A GOUGE IN THE NORTHBOUND LANE OF THE NORTH APPROACH, A 1/2" WIDE LONGITUDINAL CRACK ALONG THE CENTERLINE OF THE NORTH APPROACH, RANDOM GOUGES IN THE NORTHBOUND LANE OF THE SOUTH APPROACH UP TO 1/2", AND MINOR MAPCRACKING IN THE SOUTH APPROACH PAVEMENT.	CLEAN AND SEAL PAVEMENT CRACKS AND GOUGES.

2. THERE IS A POTHOLE IN THE NORTHBOUND LANE OF THE NORTH APPROACH, 1'x6"wx3"DP.	REPAIR POTHOLES PER DETAIL.
3. THE FOLLOWING PILES HAVE GREATER THAN 20% SECTION LOSS: BENT 5 PILE 2, BENT 22 PILE 2, AND BENT 37 PILE 8.	REPAIR THE SECTIONS PER DETAIL.

4. THERE IS SEVERE DECAY OR SPLITTING OF CROSS BRACING.	REPLACE THE CROSS BRACING AND USE NEW HARDWARE FOR THE CONNECTION.
5. PAVEMENT MARKINGS ON THE DECK AND APPROACHES IS FADED.	RESTRIPE THE DECK AND APPROACH WITH THERMOPLASTIC MATERIAL IN ACCORDANCE WITH NCDOT GUIDELINES.

6. THE CABLES ON THE GUARDRAIL END TREATMENTS WE FOUND TO BE LOOSE.	TIGHTEN CABLES ON GUARDRAIL END TREATMENTS.
7. ELIMINATE VEHICLE SNAG POINTS (ERODED SOILS) AT THE NORTHWEST AND SOUTHEAST CORNERS.	REPLACE THE CROSS BRACING AND USE NEW HARDWARE FOR THE CONNECTION.

8. THE HANDRAIL AT THE NORTHEAST CORNER IS OVERGROWN WITH VEGETATION.	REMOVE VEGETATION AND SPRAY WITH HERBICIDE.
9. THE CONDUIT FOR LIGHTING IS SEPARATED AT THE CENTER OF THE BRIDGE.	REPAIR THE SEPARATED CONDUIT.

10. ISOLATED AREAS OF DECAY WITH UP TO 100% LOSS OF SECTION ARE PRESENT ON THE TIMBER BULKHEAD OF END BENT 1.	REPLACE THE DECAYING TIMBERS.
11. PERIODICALLY CLEAN THE BRIDGE JOINTS, GUTTERS, AND DRAINS.	CLEAN AS NEEDED DURING CONTRACT TIMEFRAME.

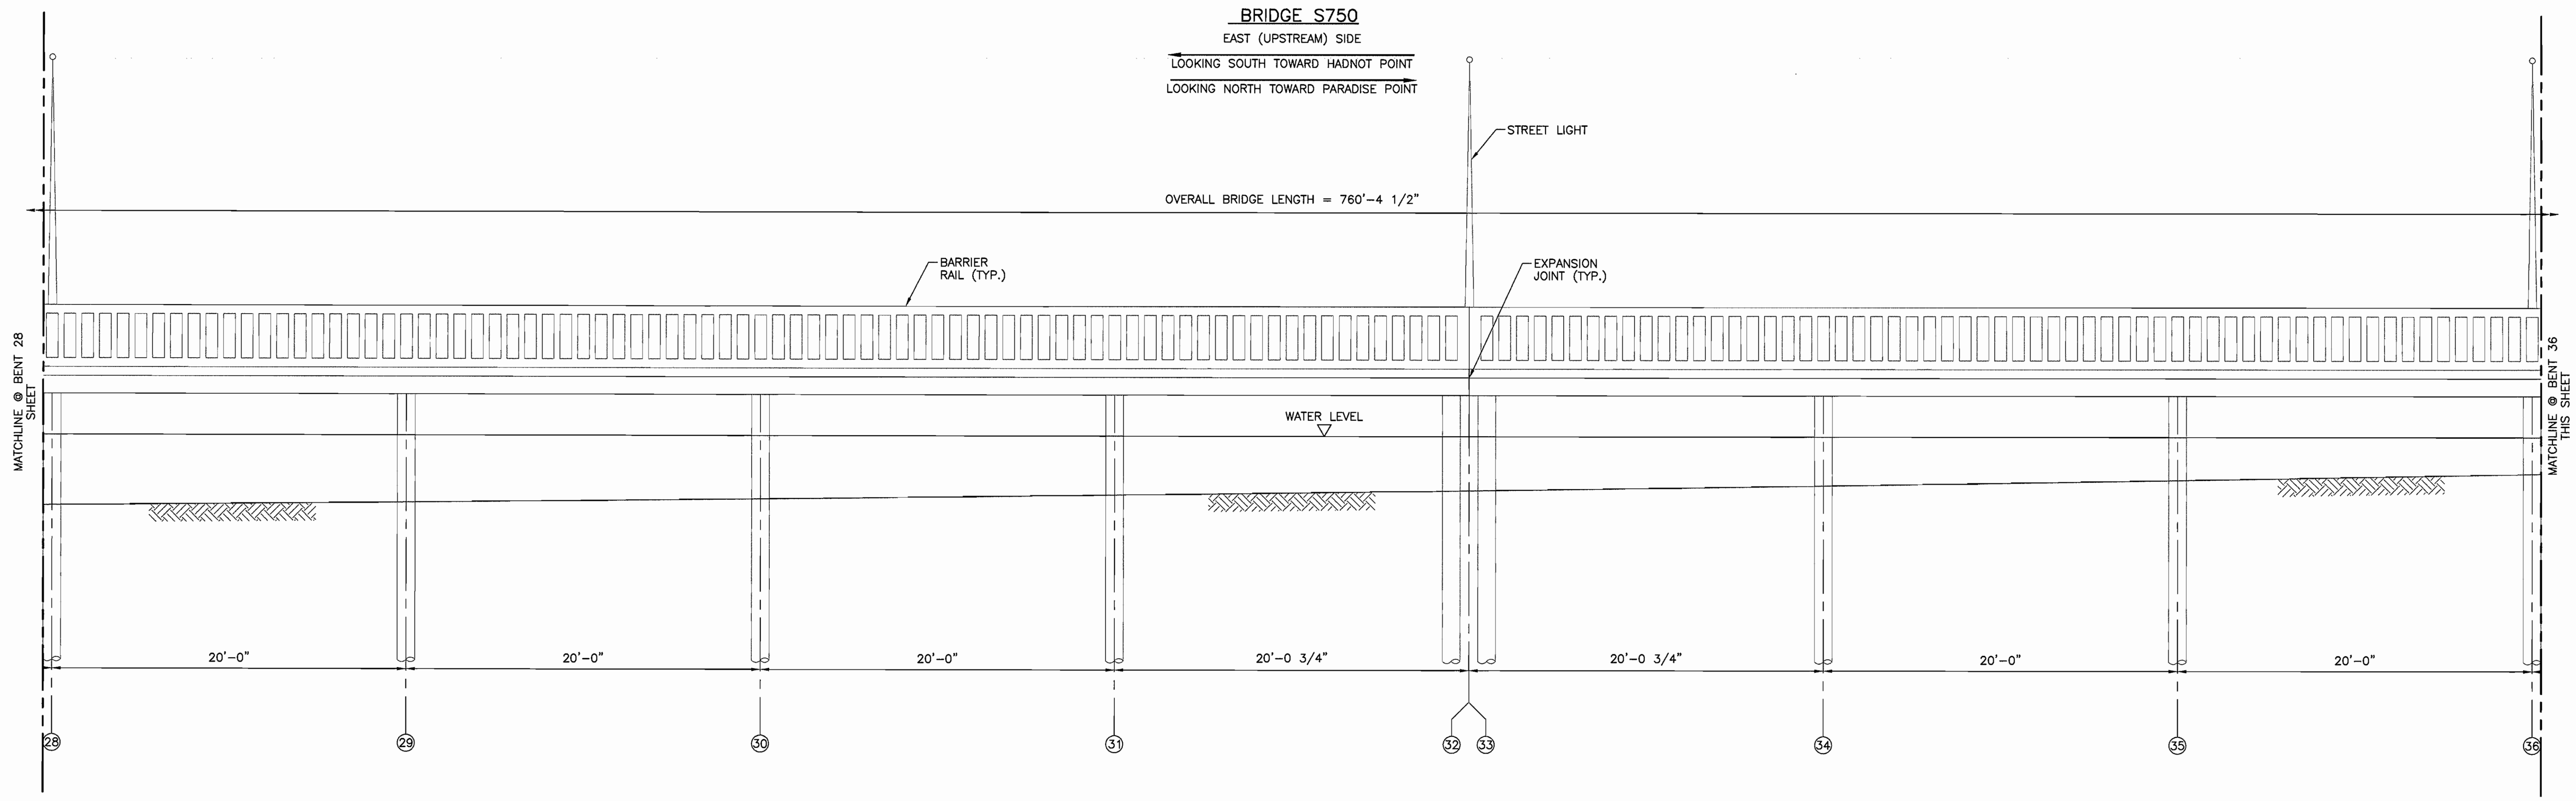
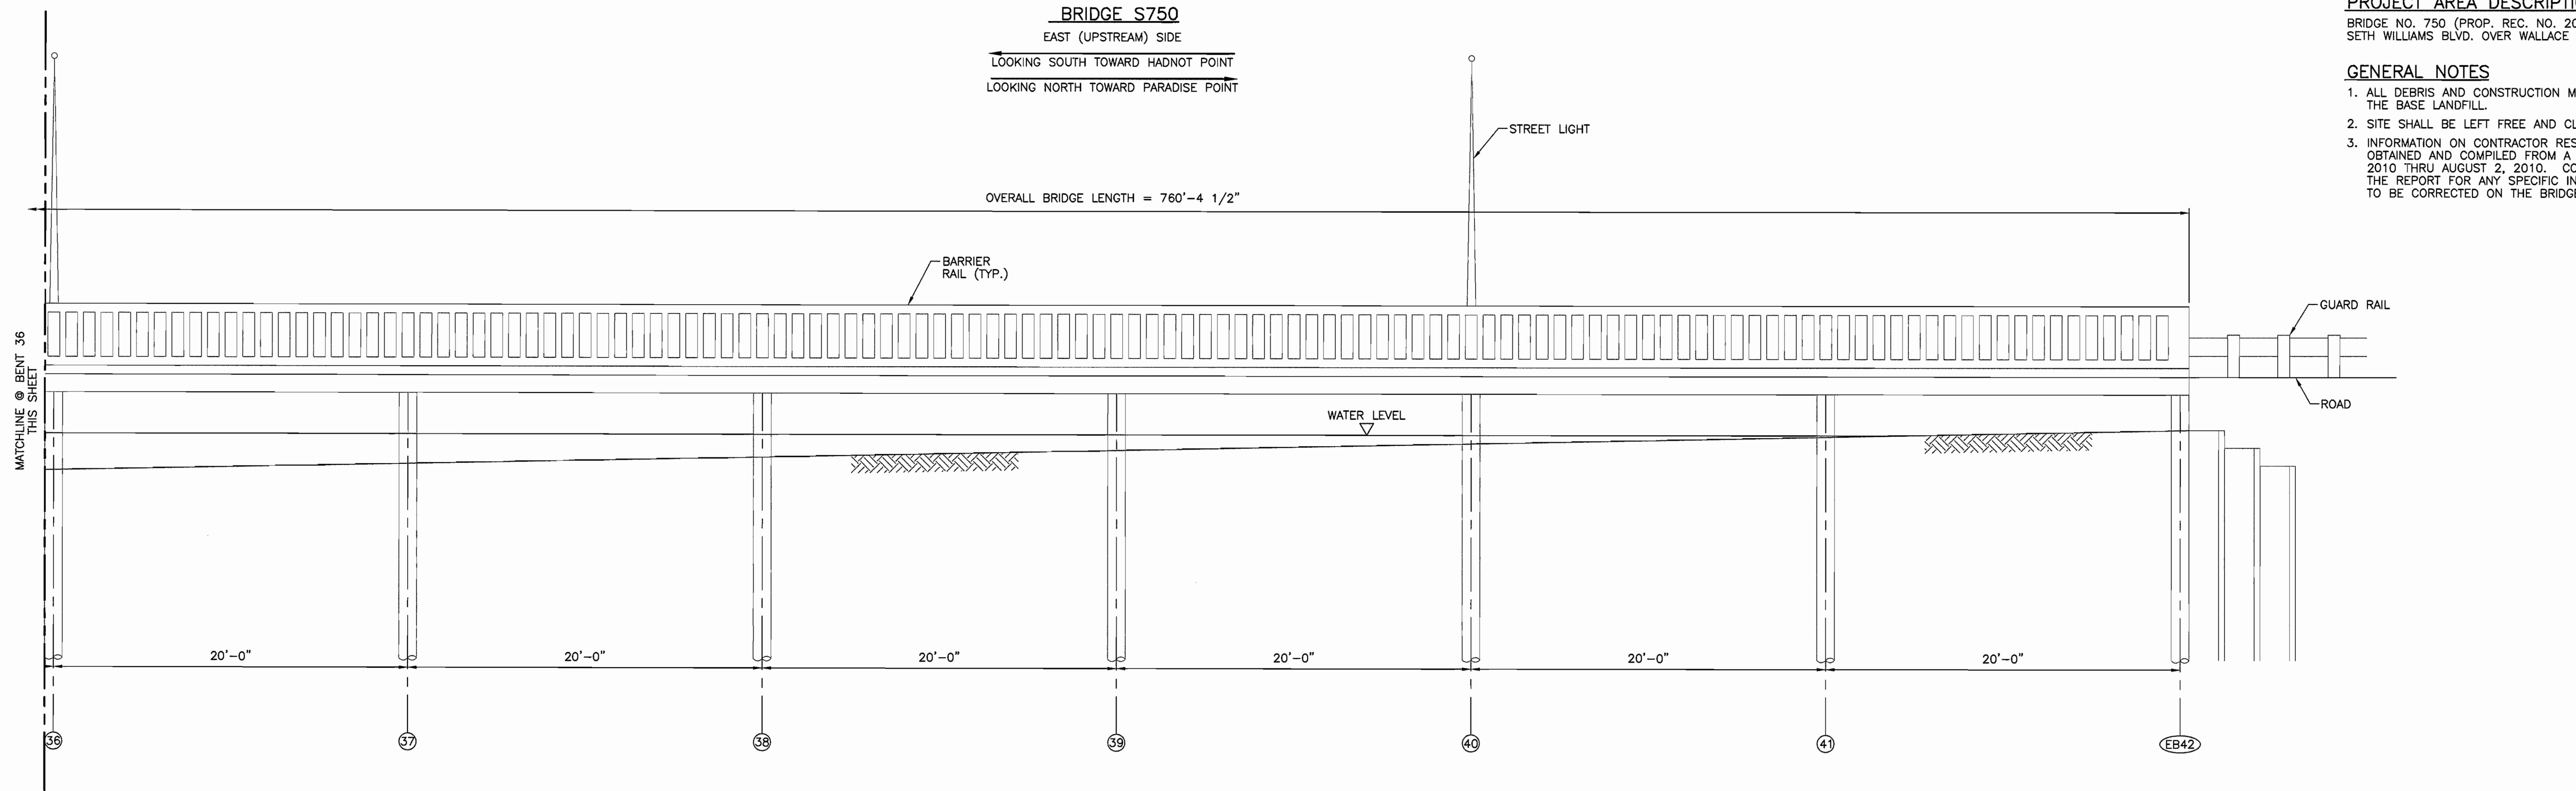
CONTRACTOR RESPONSIBILITY AND REQUIREMENTS	
DESCRIPTION OF RESPONSIBILITY AND REQUIREMENTS:	ACTION TO BE TAKEN:
1. THERE IS A GOUGE IN THE NORTHBOUND LANE OF THE NORTH APPROACH, A 1/2" WIDE LONGITUDINAL CRACK ALONG THE CENTERLINE OF THE NORTH APPROACH, RANDOM GOUGES IN THE NORTHBOUND LANE OF THE SOUTH APPROACH UP TO 1/2", AND MINOR MAPCRACKING IN THE SOUTH APPROACH PAVEMENT.	CLEAN AND SEAL PAVEMENT CRACKS AND GOUGES.

2. THERE IS A POTHOLE IN THE NORTHBOUND LANE OF THE NORTH APPROACH, 1'x6" Wx3" DP.	REPAIR POTHOLES PER DETAIL.
3. THE FOLLOWING PILES HAVE GREATER THAN 20% SECTION LOSS: BENT 5 PILE 2, BENT 22 PILE 2, AND BENT 37 PILE 8.	REPAIR THE SECTIONS PER DETAIL.

4. THERE IS SEVERE DECAY OR SPLITTING OF CROSS BRACING.	REPLACE THE CROSS BRACING AND USE NEW HARDWARE FOR THE CONNECTION.
5. PAVEMENT MARKINGS ON THE DECK AND APPROACHES IS FADED.	RESTRIPE THE DECK AND APPROACH WITH THERMOPLASTIC MATERIAL IN ACCORDANCE WITH NCDOT GUIDELINES.

6. THE CABLES ON THE GUARDRAIL END TREATMENTS WE FOUND TO BE LOOSE.	TIGHTEN CABLES ON GUARDRAIL END TREATMENTS.
7. ELIMINATE VEHICLE SNAG POINTS (ERODED SOILS) AT THE NORTHWEST AND SOUTHEAST CORNERS.	REPLACE THE CROSS BRACING AND USE NEW HARDWARE FOR THE CONNECTION.

8. THE HANDRAIL AT THE NORTHEAST CORNER IS OVERGROWN WITH VEGETATION.	REMOVE VEGETATION AND SPRAY WITH HERBICIDE.
9. THE CONDUIT FOR LIGHTING IS SEPARATED AT THE CENTER OF THE BRIDGE.	REPAIR THE SEPARATED CONDUIT.

10. ISOLATED AREAS OF DECAY WITH UP TO 100% LOSS OF SECTION ARE PRESENT ON THE TIMBER BULKHEAD OF END BENT 1.	REPLACE THE DECAYING TIMBERS.
11. PERIODICALLY CLEAN THE BRIDGE JOINTS, GUTTERS, AND DRAINS.	CLEAN AS NEEDED DURING CONTRACT TIMEFRAME.

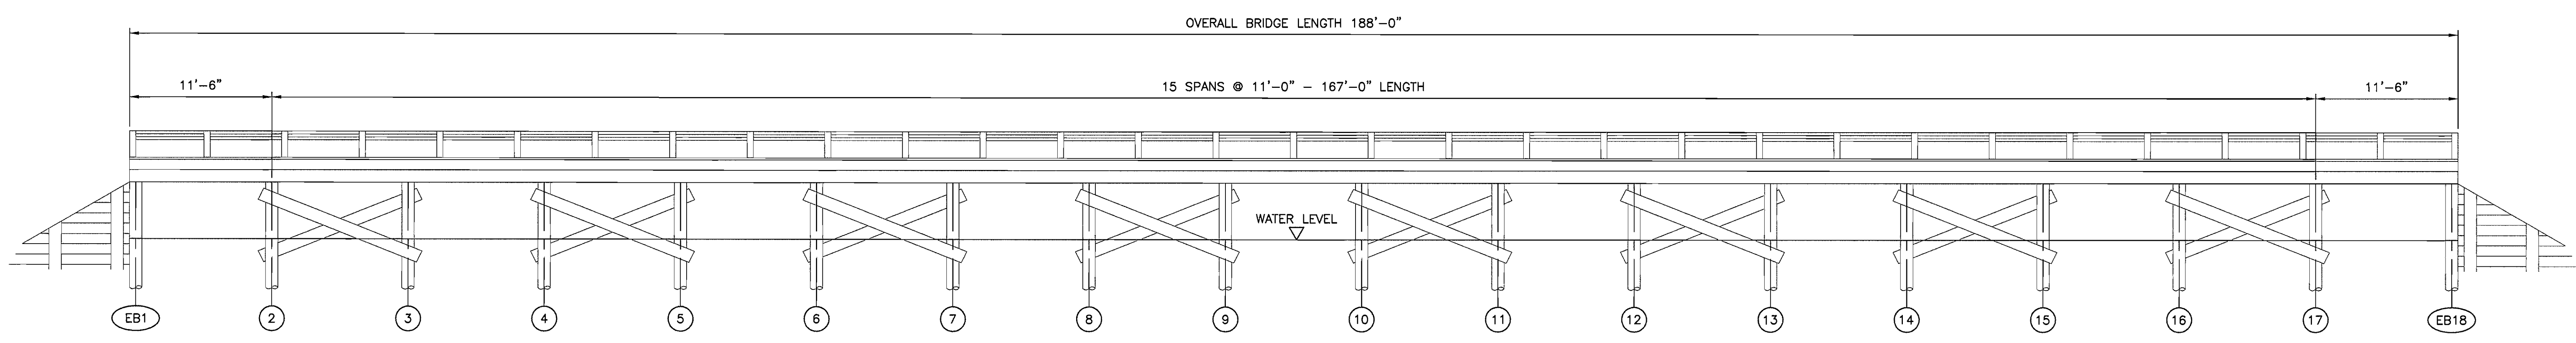
BRIDGE SM328
 EAST (UPSTREAM) SIDE
 ← SOUTH TOWARD PARADISE POINT
 ← NORTH TOWARD CAMP JOHNSON →

CONTRACTOR RESPONSIBILITY AND REQUIREMENTS	
DESCRIPTION OF RESPONSIBILITY AND REQUIREMENTS:	ACTION TO BE TAKEN:
1. PILE 1 AT BENT 14 HAS EXTERNAL AND INTERNAL DECAY WITH APPROXIMATELY 60% SECTION LOSS.	REPLACE DECAYED PILE.

2. REPAIR DECAYED SECTIONS OF THE FOLLOWING PILES: PILE 4 AT BENT 2, PILE 5 AT BENT 7, PILE 5 AT BENT 9, PILE 1 AT BENT 10, PILE 3 AT BENT 11, PILE 5 AT BENT 15 (2 AREAS), PILE 1 AT BENT 16, PILE 5 AT BENT 17, AND PILE 5 AT BENT 18.	REPAIR DECAYED PILE SECTIONS PER "DECAYED PILE REPAIR DETAIL".

3. CROSS-BRACING MEMBERS HARDWARE IS HEAVILY CORRODED OR MISSING FOR THE CROSS-BRACING TIMBERS.	REPLACE OR ADD HARDWARE FOR ADEQUATE REPAIR OF THE TIMER CROSS-BRACING.

4. SOME OF THE CROSS-BRACING MEMBERS ARE DISCONNECTED DUE TO 100% SECTION LOSS.	REPLACE CROSS-BRACING MEMBERS AND SECURE WITH NEW HARDWARE.
5. REPAIR THE UNDERMINED AREAS AT THE SOUTH BULKHEAD AT END BENT1 AND AT THE SOUTHEAST WING WALL WITH GROUT BAGS.	CONTRACTOR SHALL CLEAN OUT UNDERMINED AREAS OF UNSUITABLE SOILS AND BACKFILL WITH GROUT BAGS.

6. REPLACE THE TWO FAILED OR SEVERELY DECAYED TIMBER GUARDRAIL POSTS AT THE SOUTHEAST APPROACH AND THE ONE DECAYED TIMBER GUARDRAIL POST AT THE NORTHWEST APPROACH.	REPLACE TIMBER GUARDRAIL POSTS PER NCDOT STANDARD DETAILS.

7. REINSTALL THE INCORRECTLY LAPPED GUARDRAIL SECTION AT THE NORTHEAST BRIDGE CORNER.	REINSTALL GUARDRAIL PER NCDOT STANDARD DETAILS.
8. SEAL THE CRACKS IN THE ASPHALT DECK OVERLAY AT THE SOUTH APPROACH.	CLEAN AND SEAL ALL JOINTS IN ACCORDANCE WITH NCDOT STANDARD DETAILS

10. REALIGN ALL OF THE MISALIGNED GUARDRAIL TIMBER OFFSET BLOCKS AND TIGHTEN ALL OF THE GUARDRAIL ATTACHMENT BOLTS.	REALIGN OFFSET BLOCKS USING NCDOT STANDARD DETAILS AND TIGHTEN ATTACHMENT BOLTS ON THE GUARDRAILS.

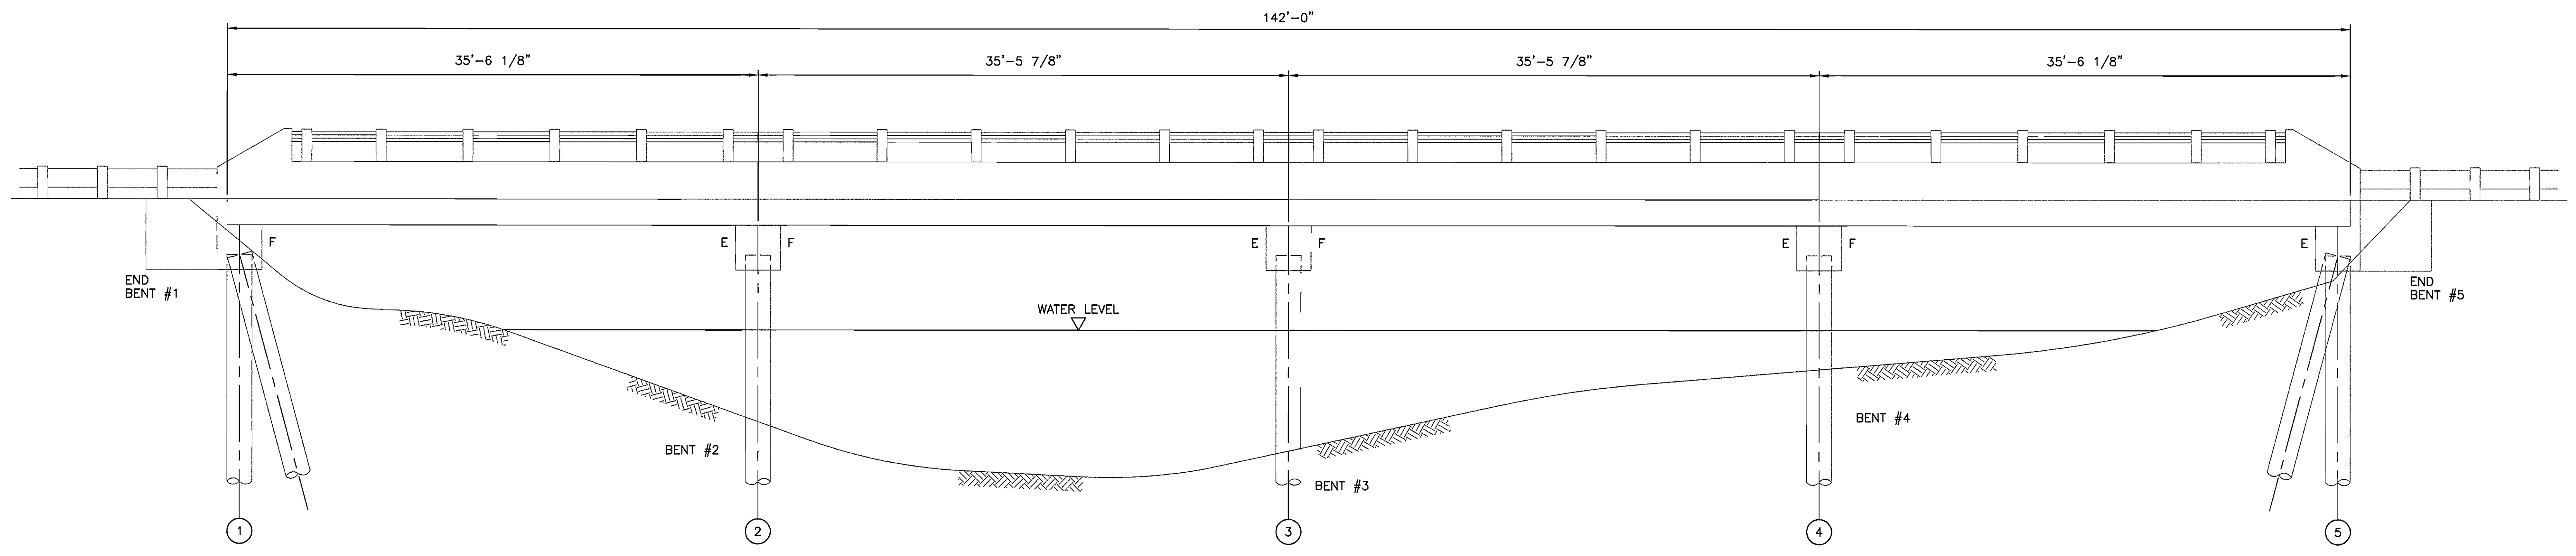
BRIDGE S788
 EAST (UPSTREAM) SIDE
 ← SOUTH TOWARD HADNOT POINT
 ← NORTH TOWARD MAIN GATE →

6. PERIODICALLY CLEAN THE BRIDGE GUTTERS AND DRAINS.	CLEAN AS NEEDED DURING CONTRACT TIMEFRAME.
7. RELOCATE THE OBJECT MARKERS ON THE WEST SIDE OF THE BRIDGE TO THE ENDS OF THE BRIDGE RAILS AND INSTALL NEW OBJECT MARKERS ON THE EAST SIDE OF THE BRIDGE.	RELOCATE AND ADD MARKERS ENSURING PROPER INSTALLATION IN ACCORDANCE WITH ANY NCDOT STANDARDS AND BASE GUIDELINES.

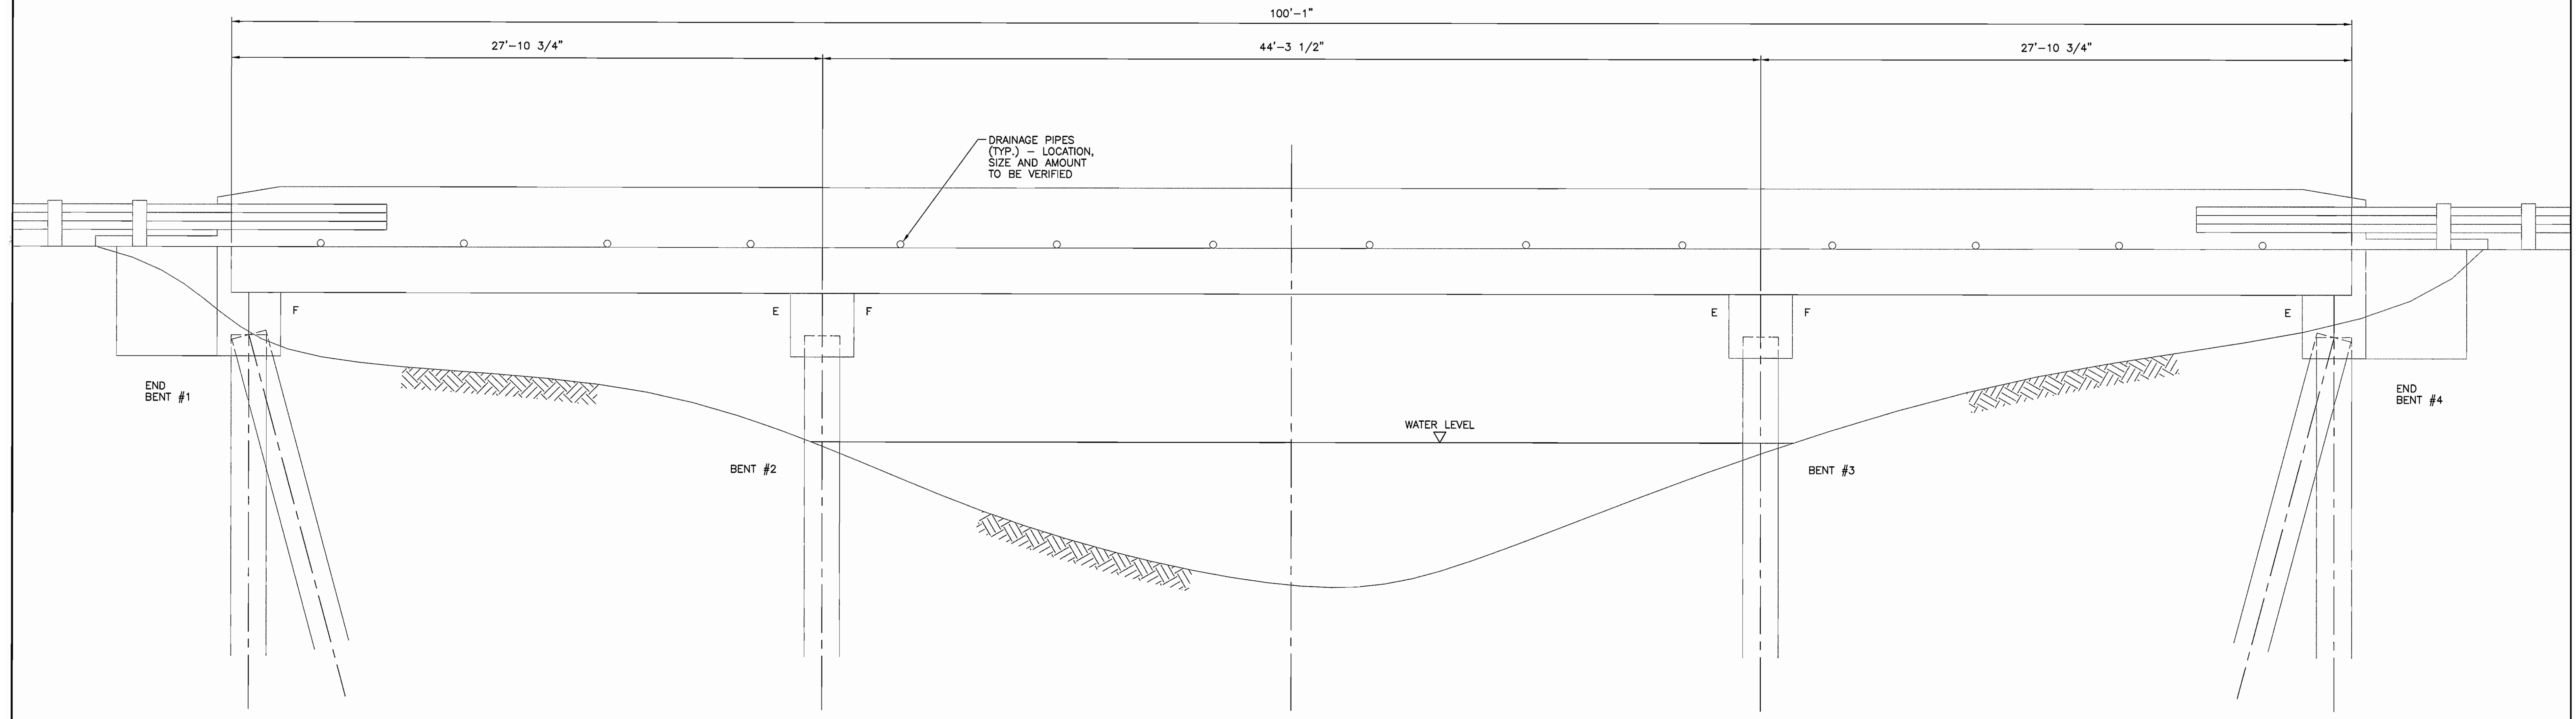
BRIDGE SSR20
 EAST (UPSTREAM) SIDE
 SOUTH TOWARD HOLLY RIDGE
 NORTH TOWARD SKY MANOR AIRPORT

CONTRACTOR RESPONSIBILITY AND REQUIREMENTS	
DESCRIPTION OF RESPONSIBILITY AND REQUIREMENTS:	ACTION TO BE TAKEN:
1. REMOVE THE GROUT BUILD-UP ON THE SEAT OF BENT 3 AT THE NORTH END	REMOVE THE BUILD-UP.
2. GRADUALLY STIFFEN THE GUARDRAIL TRANSITIONS.	STIFFEN GUARDRAIL TRANSITIONS TO MEET BASE REQUIREMENTS.
3. TIGHTEN THE BOLT AT THE SOUTHWEST GUARDRAIL TRANSITION.	TIGHTEN THE BOLT.
4. PATCH THE POTHOLE AND THE SETTLED AREA IN THE SOUTH APPROACH ROADWAY.	REGRADE AREA OF STONE APPROACH REPAIRING ANY DEPRESSED AREAS.
5. REMOVE THE VEGETATION FROM BENT 4 AND ALONG THE WEST FACIA OF SPAN 2.	CLEAR VEGETATION AS STATED.

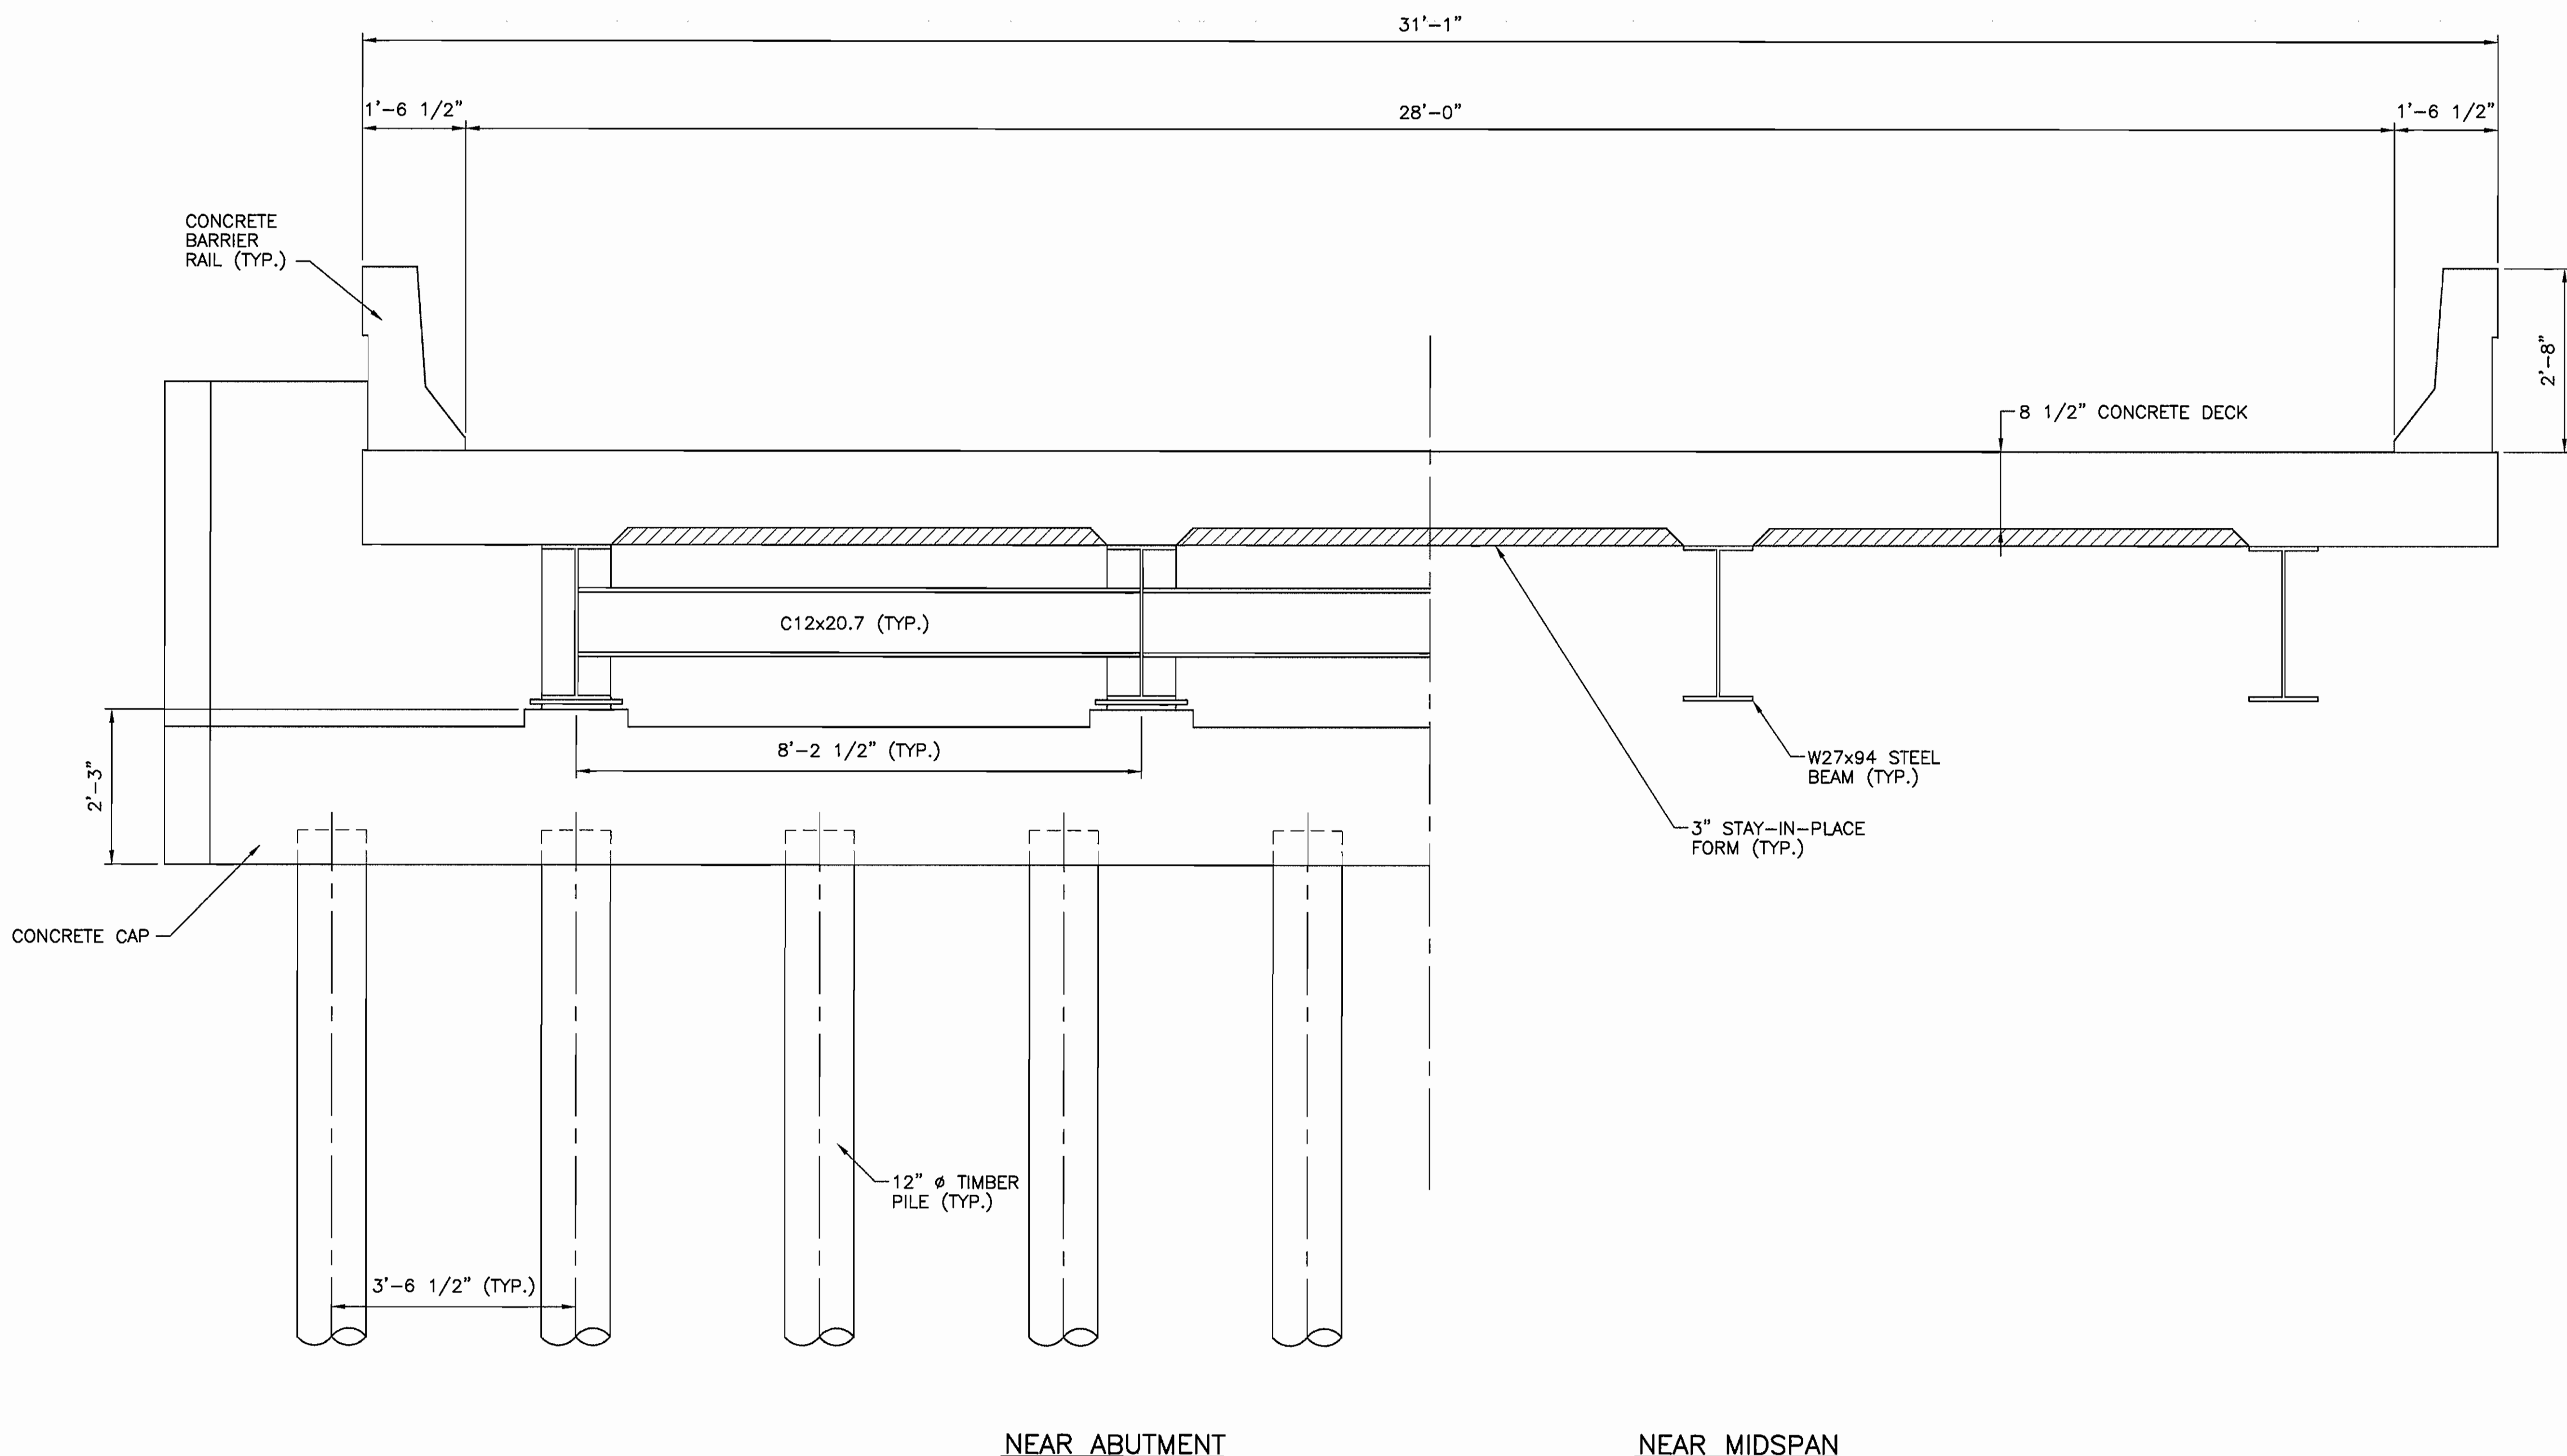
PROJECT AREA DESCRIPTIONS
 BRIDGE NO. SSR21 (PROP. REC. NO. 210931)
 CC ROAD OVER SHELTER SWAMP CREEK

CONTRACTOR RESPONSIBILITY AND REQUIREMENTS	
DESCRIPTION OF RESPONSIBILITY AND REQUIREMENTS:	ACTION TO BE TAKEN:
1. ADD POSTS TO GRADUALLY STIFFEN THE GUARDRAIL TRANSITIONS.	ADD POSTS IN ACCORDANCE WITH NCDOT STANDARD DETAILS.
2. THE ATTACHMENT BOLTS FOR THE BEAM DIAPHRAGMS TYPICALLY HAVE MINOR TO MODERATE SURFACE CORROSION DUE TO PAINT FAILURE.	THE BOLTS ARE TO BE CLEANED TO BARE METAL, PRIMED AND PAINTED WITH WATERPROOF MATERIALS.
3. ATTACH THE GUARDRAILS TO THE TIMBER POSTS AT EACH END TREATMENT.	REATTACH THE GUARDRAILS TO THE POST WITH THE PROPER HARDWARE IN ACCORDANCE WITH NCDOT STANDARD DETAILS.
4. FILL THE POTHoles IN THE APPROACH ROADWAY.	REGRADE AREA OF STONE APPROACH REPAIRING ANY DEPRESSED AREAS.
5. TIGHTEN THE LOOSE CABLES AT THE GUARDRAIL END TREATMENTS.	TIGHTEN THE CABLES AT THE GUARDRAIL END TREATMENTS TO THE PROPER TENSION.
