SHEET INDEX

REPAIR BRIDGES, VARIOUS LOCATIONS MCB, CLNC

PROJECT AREA DESCRIPTIONS
 BRIDGE NO. 750 (PROP. REC. NO. 200480)
 SETH WILLIAMS BLVD. OVER WALLACE CREEK

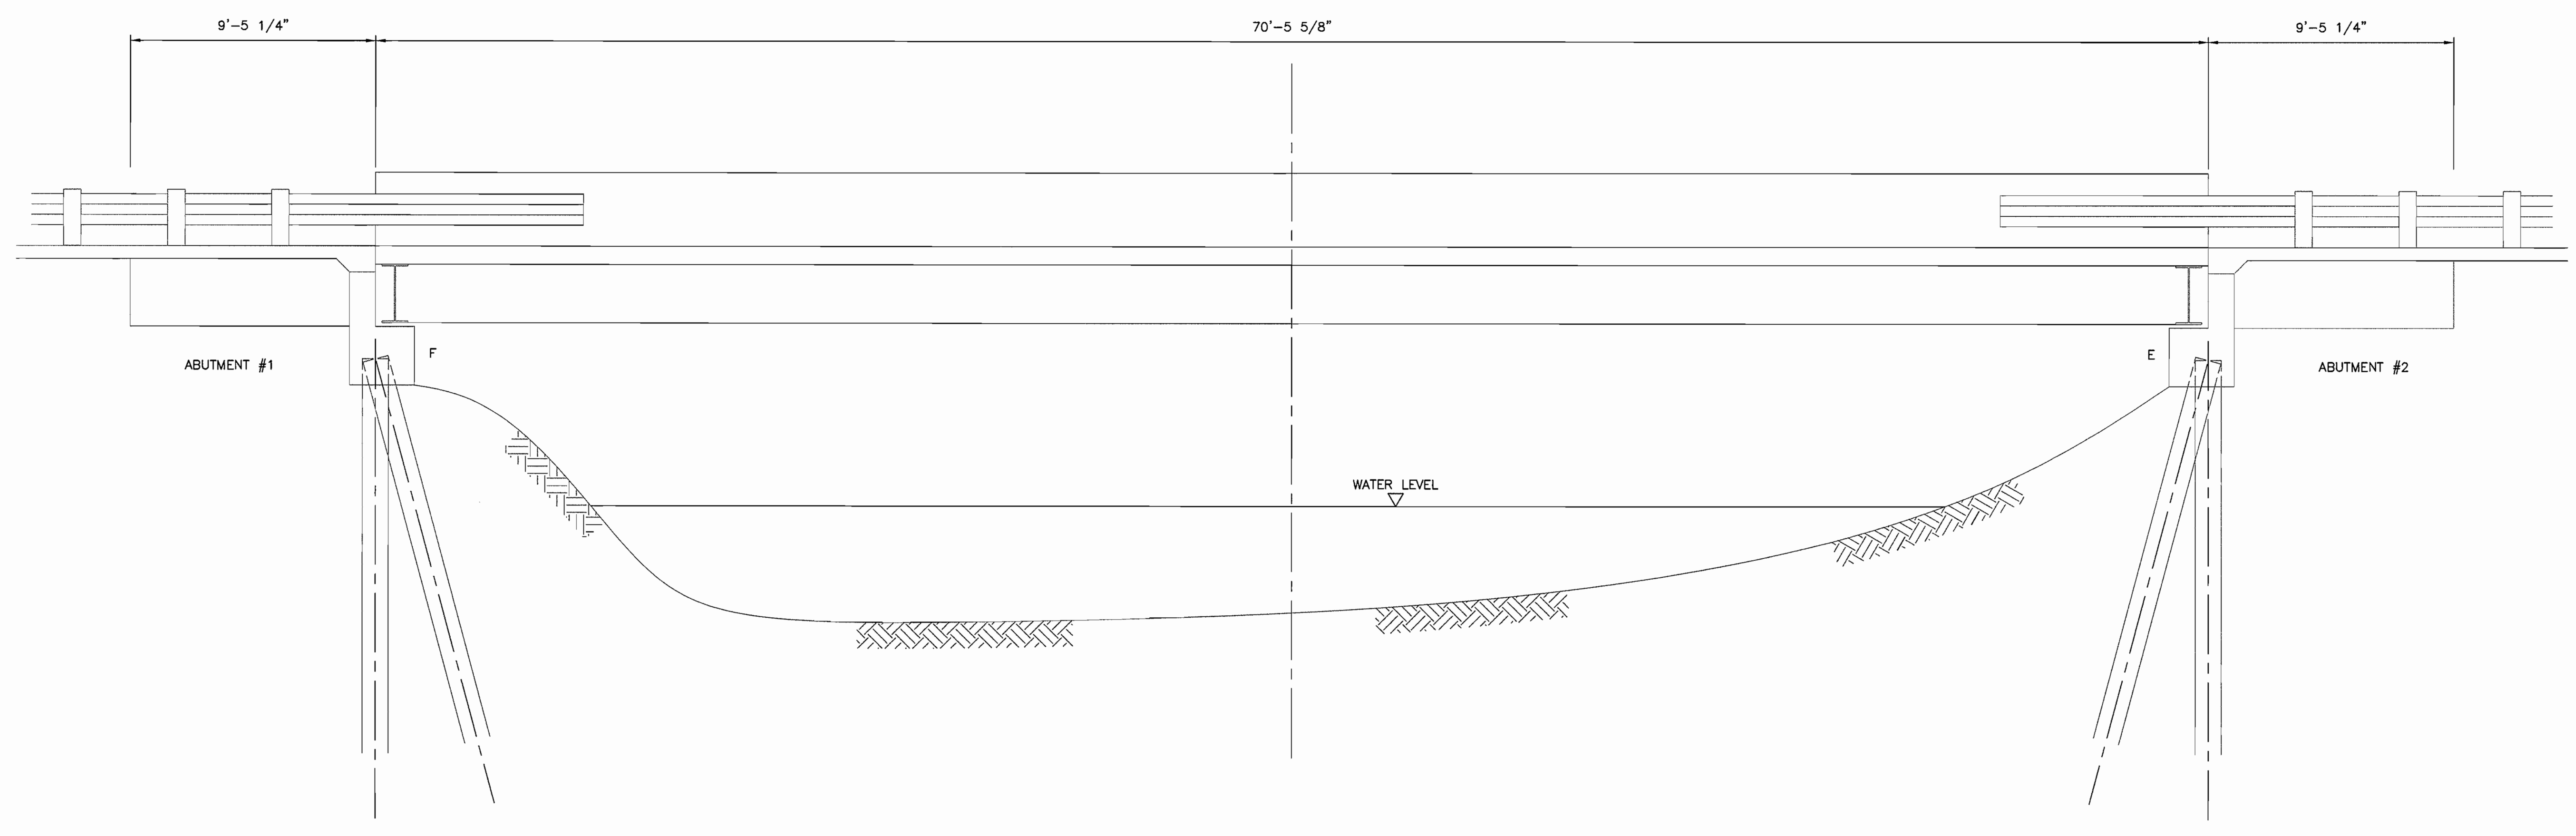
BRIDGE SSR21
NORTH (UPSTREAM) SIDE
← WEST TOWARD NC HWY 50
→ EAST TOWARD DIXON

CONTRACTOR RESPONSIBILITY AND REQUIREMENTS	
DESCRIPTION OF RESPONSIBILITY AND REQUIREMENTS:	ACTION TO BE TAKEN:
1. ADD POSTS TO GRADUALLY STIFFEN THE GUARDRAIL TRANSITIONS.	ADD POSTS IN ACCORDANCE WITH NCDOT STANDARD DETAILS.
2. THE ATTACHMENT BOLTS FOR THE BEAM DIAPHRAGMS TYPICALLY HAVE MINOR TO MODERATE SURFACE CORROSION DUE TO PAINT FAILURE.	THE BOLTS ARE TO BE CLEANED TO BARE METAL, PRIMED AND PAINTED WITH WATERPROOF MATERIALS.
3. ATTACH THE GUARDRAILS TO THE TIMBER POSTS AT EACH END TREATMENT.	REATTACH THE GUARDRAILS TO THE POST WITH THE PROPER HARDWARE IN ACCORDANCE WITH NCDOT STANDARD DETAILS.
4. FILL THE POTHOLES IN THE APPROACH ROADWAY.	REGRADE AREA OF STONE APPROACH REPAIRING ANY DEPRESSED AREAS.
5. TIGHTEN THE LOOSE CABLES AT THE GUARDRAIL END TREATMENTS.	TIGHTEN THE CABLES AT THE GUARDRAIL END TREATMENTS TO THE PROPER TENSION.

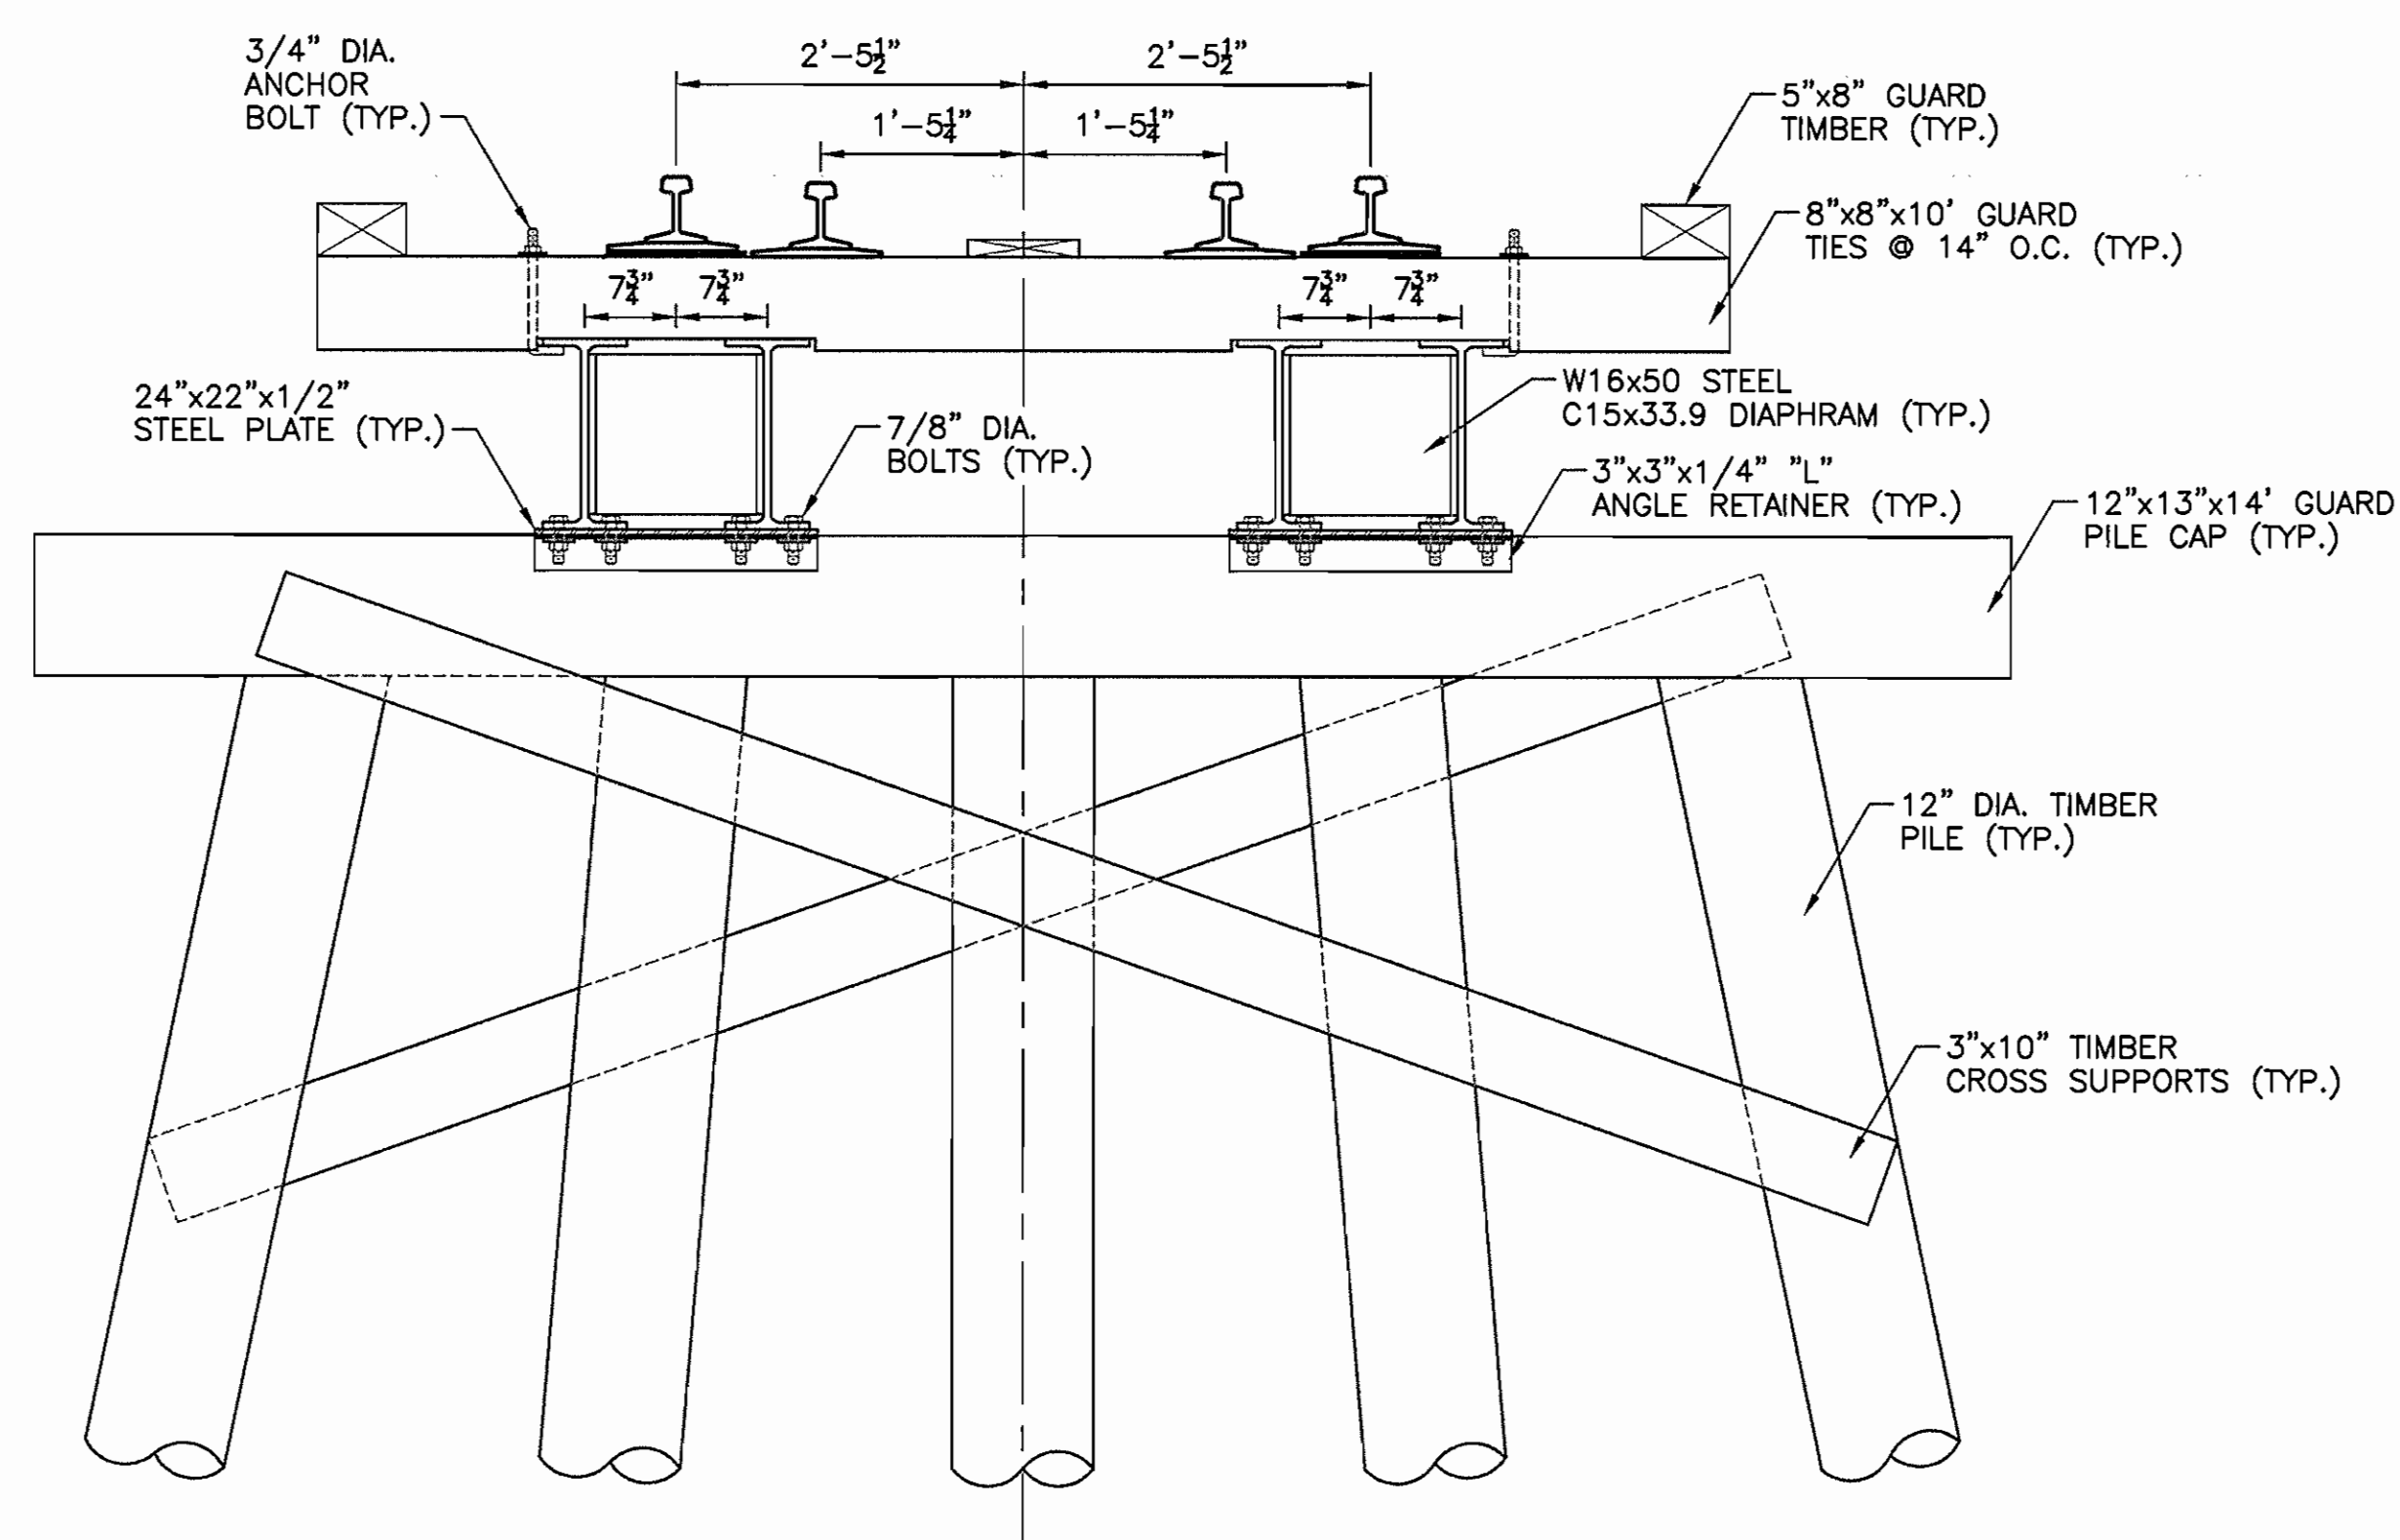
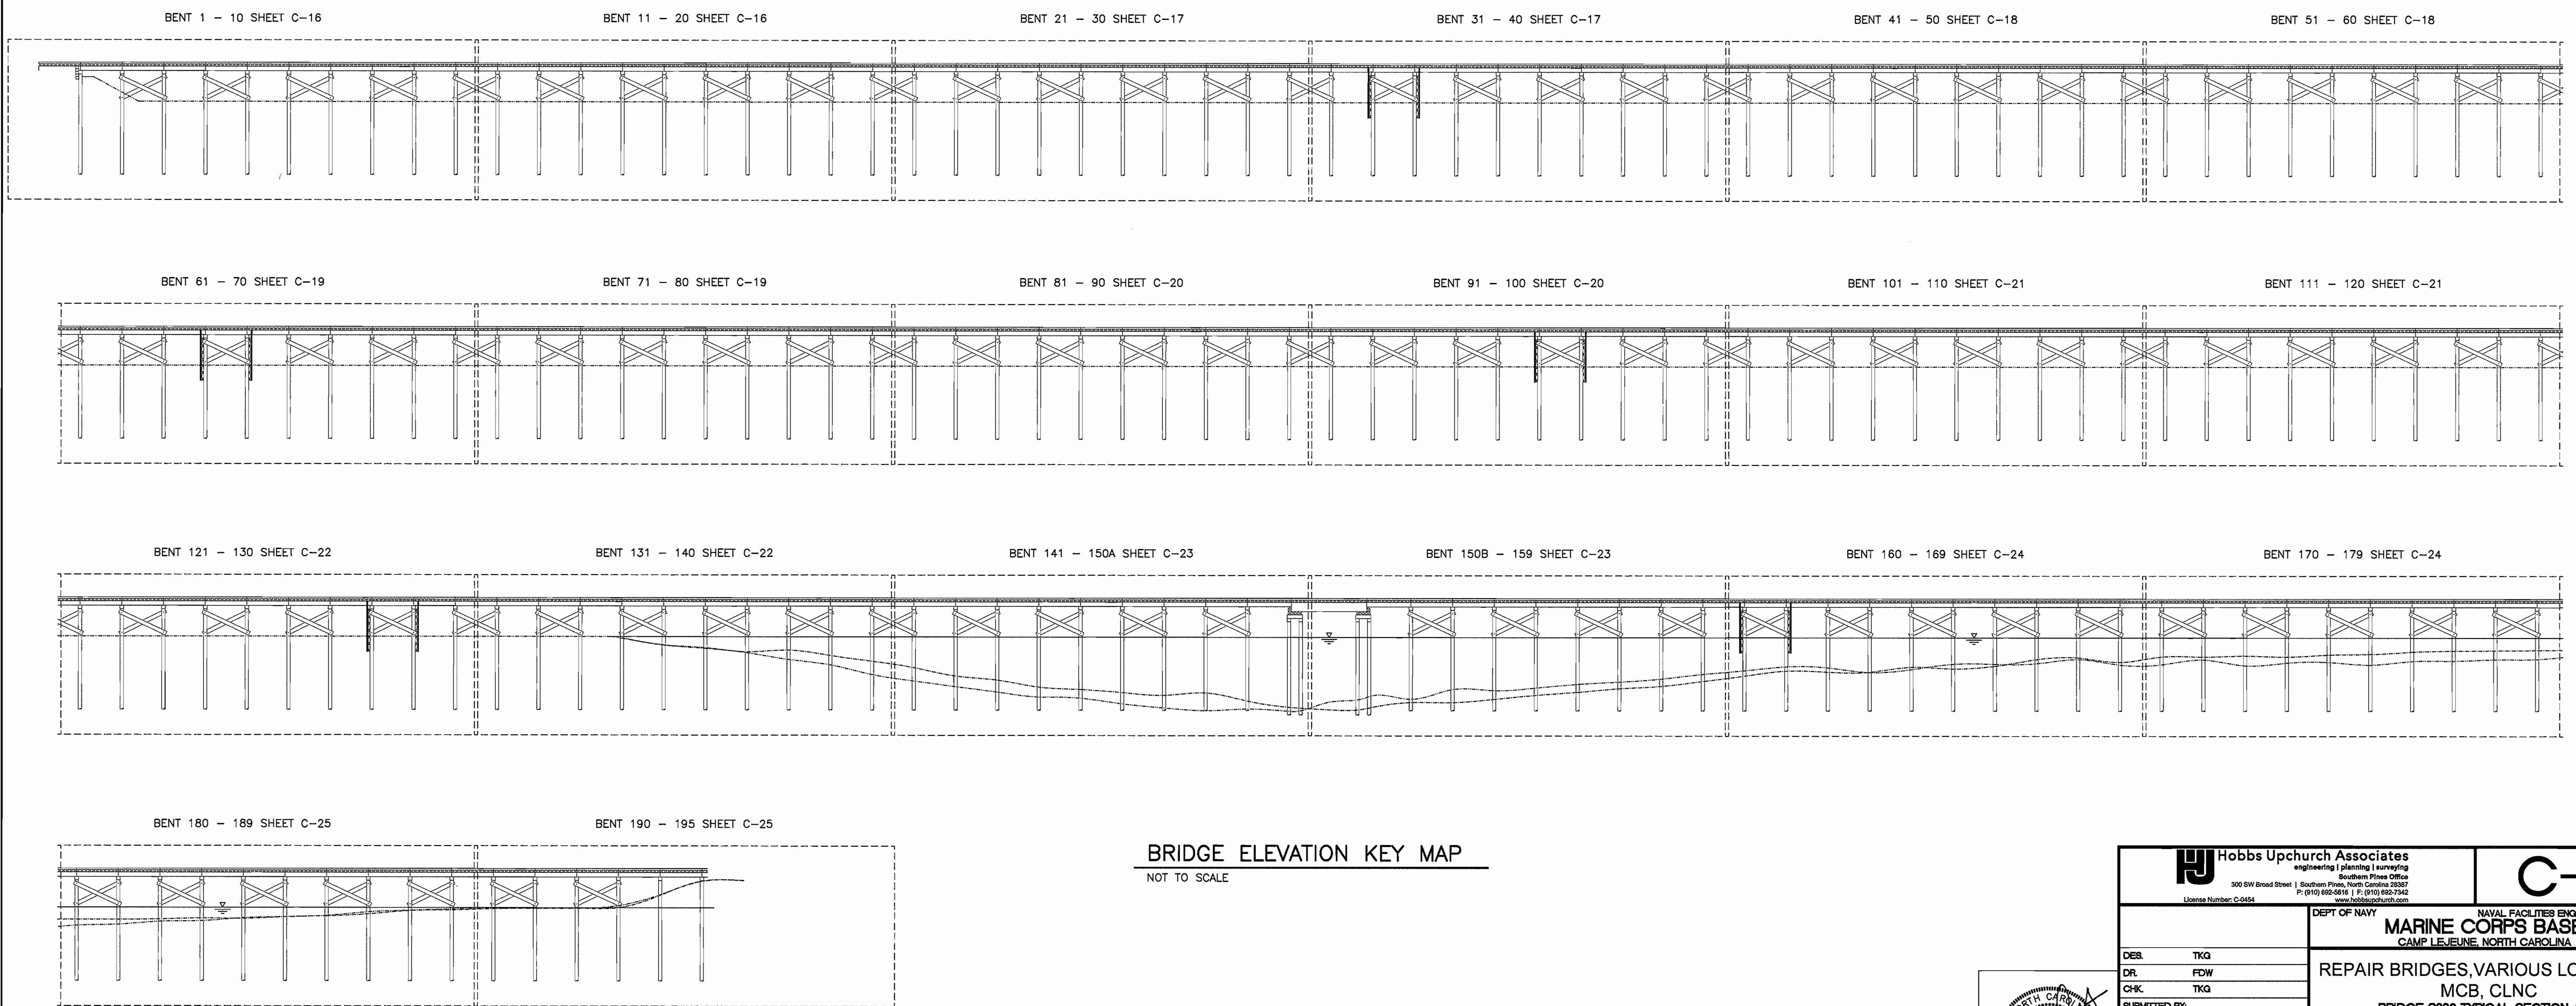
PROJECT AREA DESCRIPTIONS
 BRIDGE NO. S882
 RAILROAD BRIDGE OVER WHITE OAK RIVER

CONTRACTOR RESPONSIBILITY AND REQUIREMENTS	
DESCRIPTION OF RESPONSIBILITY AND REQUIREMENTS:	ACTION TO BE TAKEN:
1. REPAIR BENT 5 PILE CAP	REPAIR PILE CAP AS NEEDED.

2. REPAIR PILE D, BENT 154	REPAIR PILE PER "DECAYED PILE REPAIR DETAIL".
3. CLEAN AND INSTALL FULL HEIGHT PILE WRAPS ON ALL TIMBER PILES IDENTIFIED WITH MODERATE CHECKS, SPLINTERING, MARINE BORER ACTIVITY, FRACTURED AND/OR HEAVILY DECAYED TIMBER PILES WITH 10% OR MORE SECTION LOSS TO PREVENT FURTHER DETERIORATION AND LOSS OF SECTION.	REPAIR PILE PER "DECAYED PILE REPAIR DETAIL" TO FULL HEIGHT OF IDENTIFIED PILES AT 44 LOCATIONS IDENTIFIED IN THE REPORT.

4. REPLACE MISSING, FRACTURED, AND/OR HEAVILY DECAYED TIMBER CROSSBRACING MEMBERS, TIMBER CURBS, AND TIMBER RAIL TIES, INCLUDING REPLACEMENT OF THE MISSING, CORRODED OR BROKEN HARDWARE.	REPLACE MISSING, FRACTURED, AND/OR HEAVILY DECAYED TIMBER CROSSBRACING, CURBS, RAIL TIES, AND ANY MISSING OR CORRODED HARDWARE.

5. REPLACE THE LOWER PANELS WITH HEAVY CORROSION AND SECTION LOSS AT THE FIREBREAKS BETWEEN BENTS 1 AND 134.	REPLACE THE LOWER PANELS IN ACCORDANCE WITH THE DETAILS.

6. REPLACE THE MISSING AND BROKEN RAIL BEARING PLATES, AND RAIL SPIKES AS NEEDED.	IDENTIFY AND REPLACE THE MISSING AND BROKEN RAIL BEARING PLATES AND RAIL SPIKES AS NEEDED.

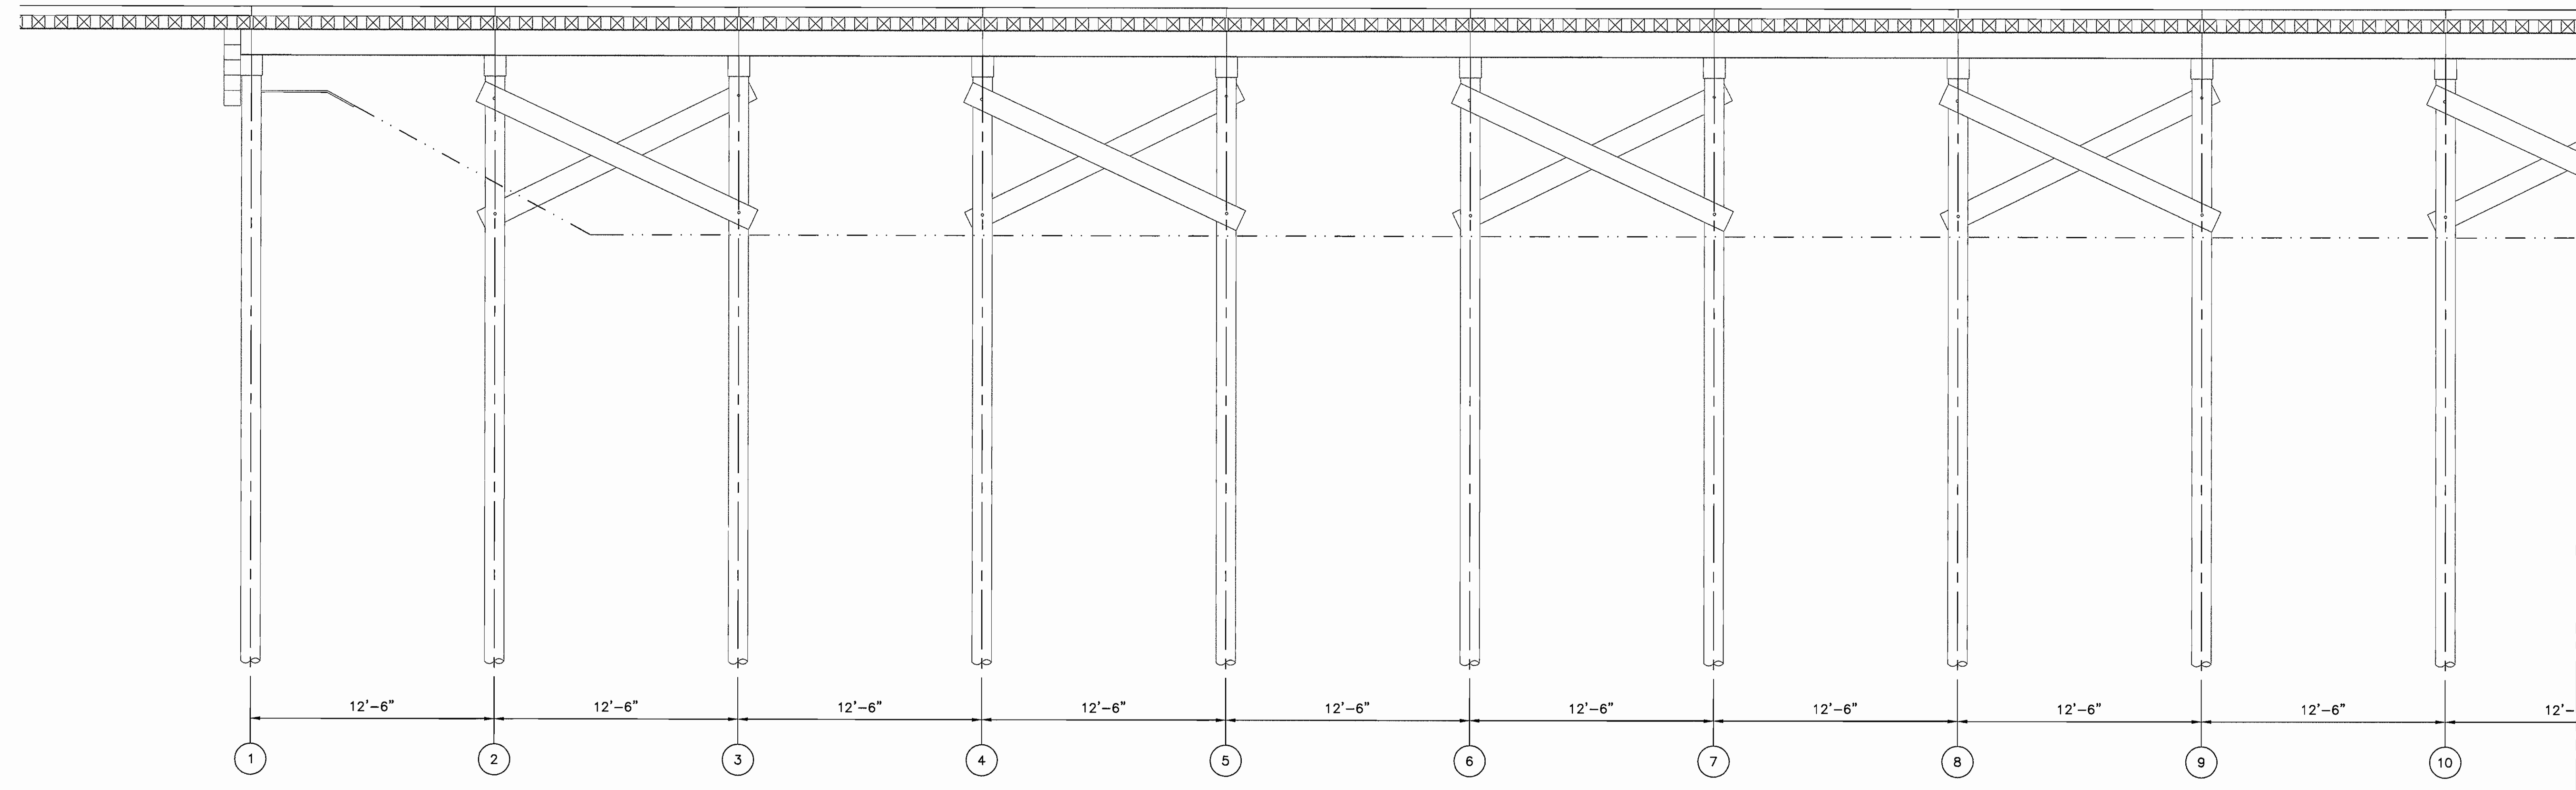
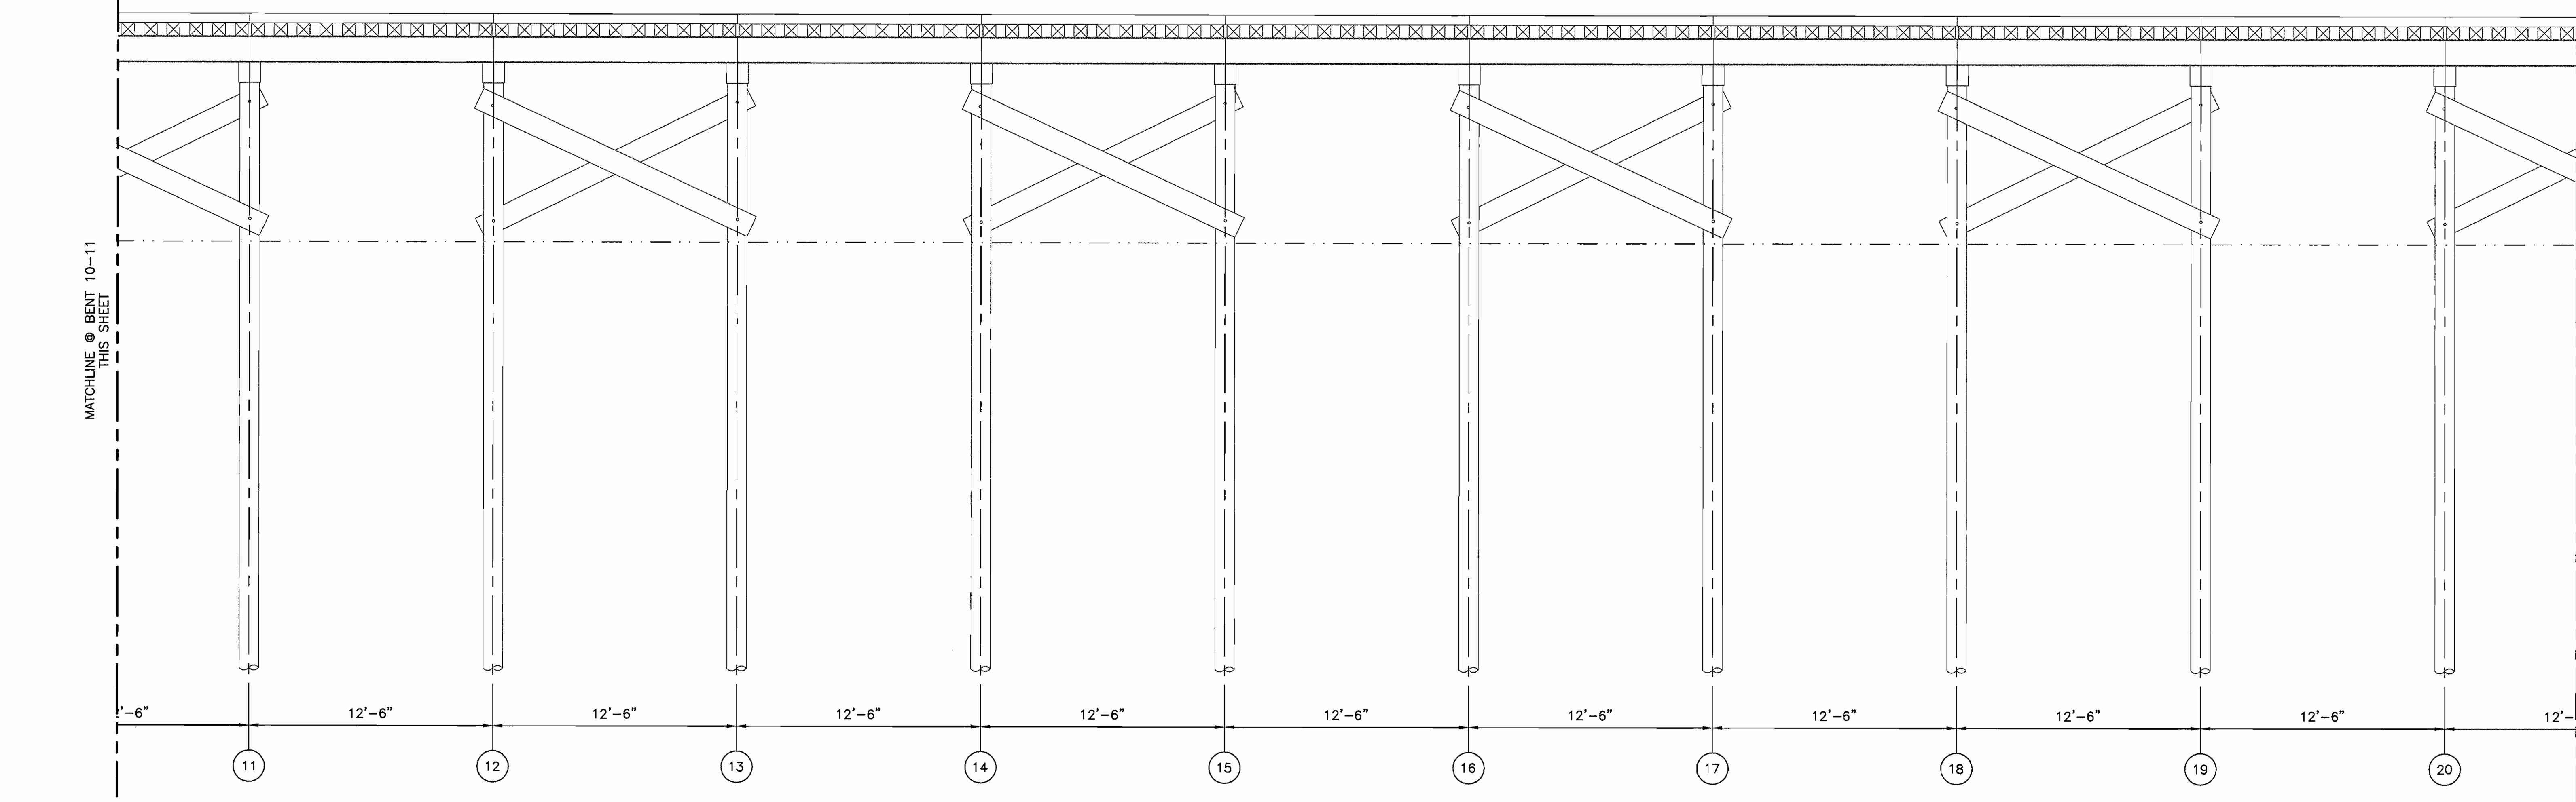
BRIDGE S882

DESCRIPTION OF RESPONSIBILITY AND REQUIREMENTS:	ACTION TO BE TAKEN:
1. REPAIR BENT 5 PILE CAP	REPAIR PILE CAP AS NEEDED.
2. REPAIR PILE D, BENT 154	REPAIR PILE PER "DECAYED PILE REPAIR DETAIL".

3. CLEAN AND INSTALL FULL HEIGHT PILE WRAPS ON ALL TIMBER PILES IDENTIFIED WITH MODERATE CHECKS, SPLINTERING, MARINE BORER ACTIVITY, FRACTURED AND/OR HEAVILY DECAYED TIMBER PILES WITH 10% OR MORE SECTION LOSS TO PREVENT FURTHER DETERIORATION AND LOSS OF SECTION.	REPAIR PILE PER "DECAYED PILE REPAIR DETAIL" TO FULL HEIGHT OF IDENTIFIED PILES AT 44 LOCATIONS IDENTIFIED IN THE REPORT.

4. REPLACE MISSING, FRACTURED, AND/OR HEAVILY DECAYED TIMBER CROSSBRACING MEMBERS, TIMBER CURBS, AND TIMBER RAIL TIES, INCLUDING REPLACEMENT OF THE MISSING, CORRODED OR BROKEN HARDWARE.	REPLACE MISSING, FRACTURED, AND/OR HEAVILY DECAYED TIMBER CROSSBRACING, CURBS, RAIL TIES, AND ANY MISSING OR CORRODED HARDWARE.

5. REPLACE THE LOWER PANELS WITH HEAVY CORROSION AND SECTION LOSS AT THE FIREBREAKS BETWEEN BENTS 1 AND 134.	REPLACE THE LOWER PANELS IN ACCORDANCE WITH THE DETAILS.

6. REPLACE THE MISSING AND BROKEN RAIL BEARING PLATES, AND RAIL SPIKES AS NEEDED.	IDENTIFY AND REPLACE THE MISSING AND BROKEN RAIL BEARING PLATES AND RAIL SPIKES AS NEEDED.

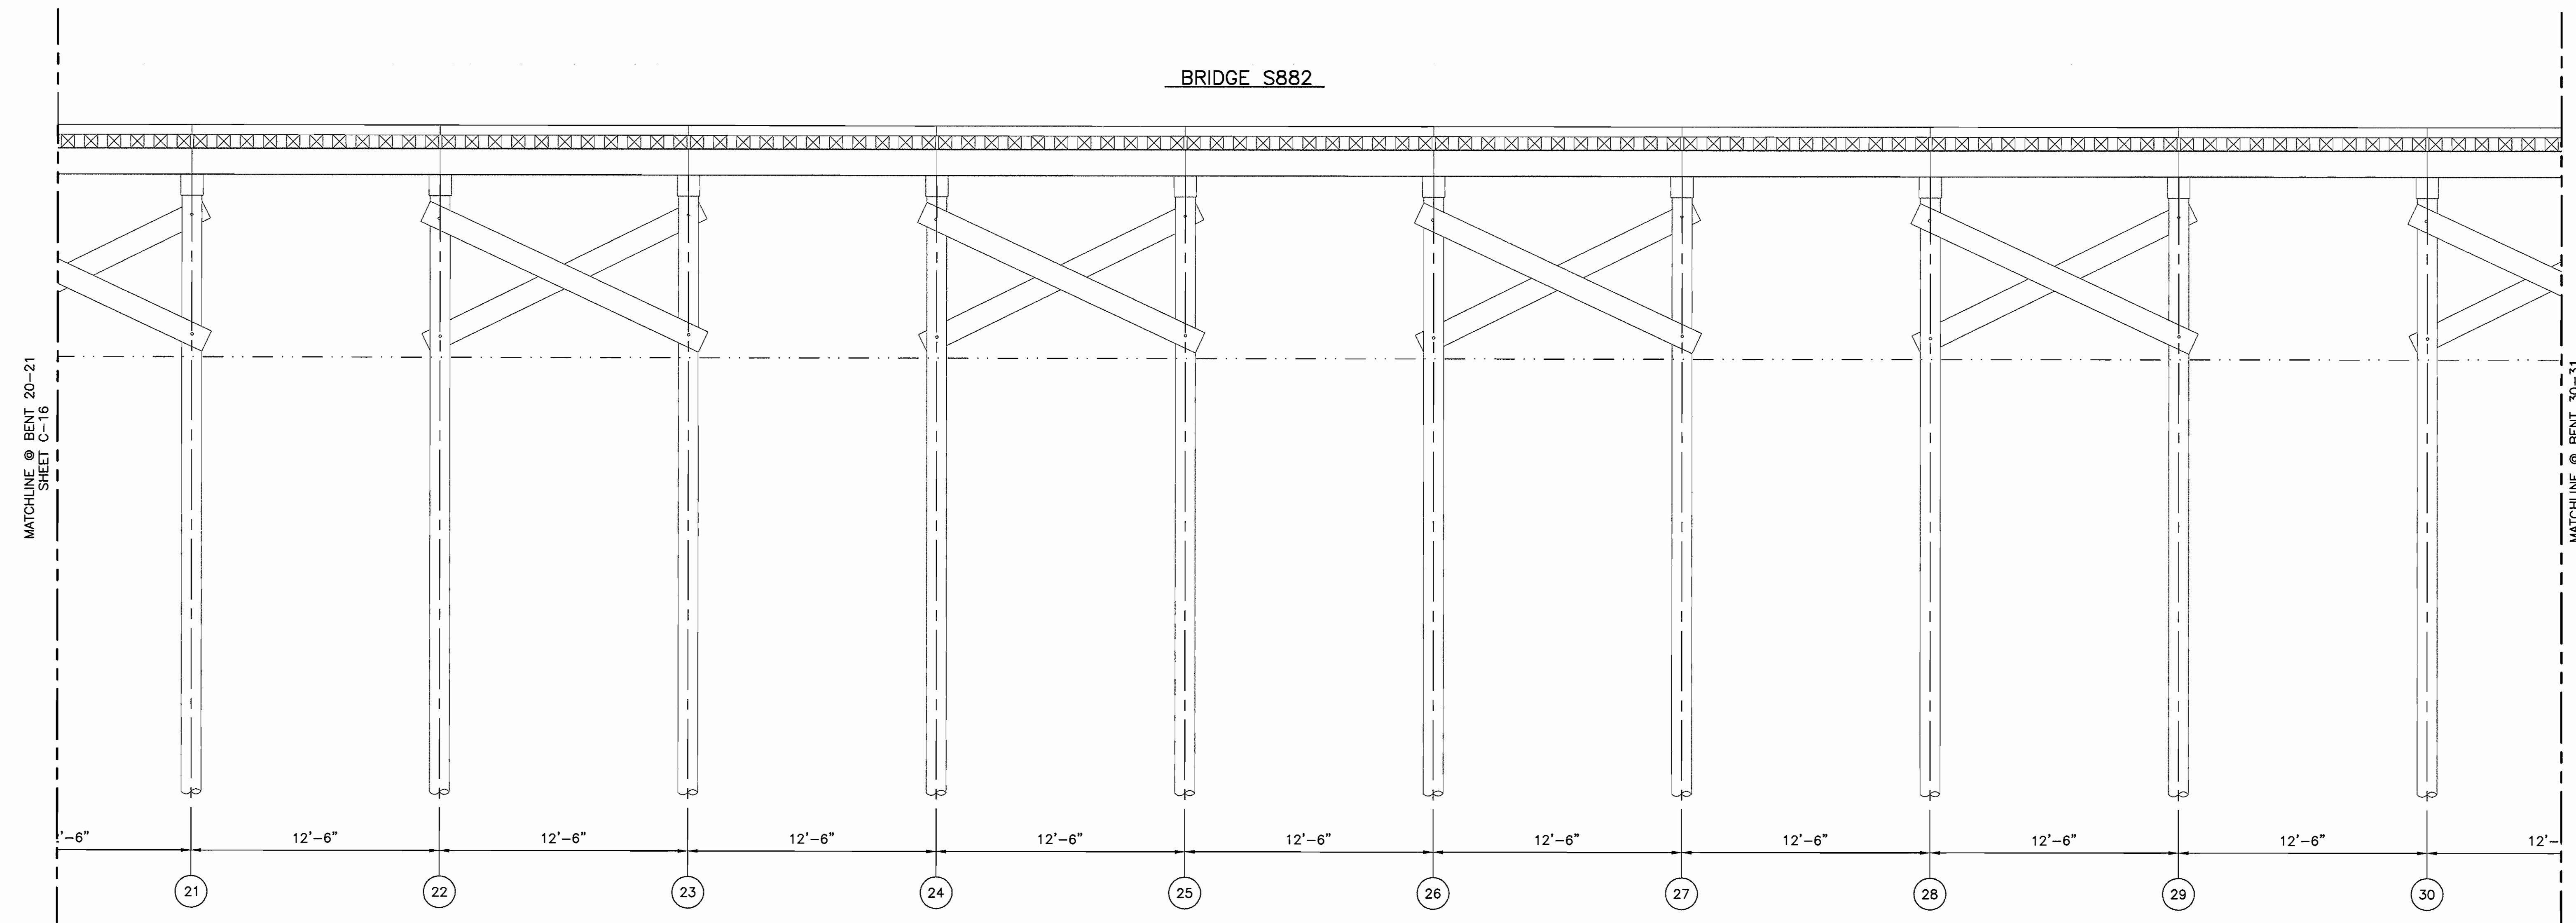
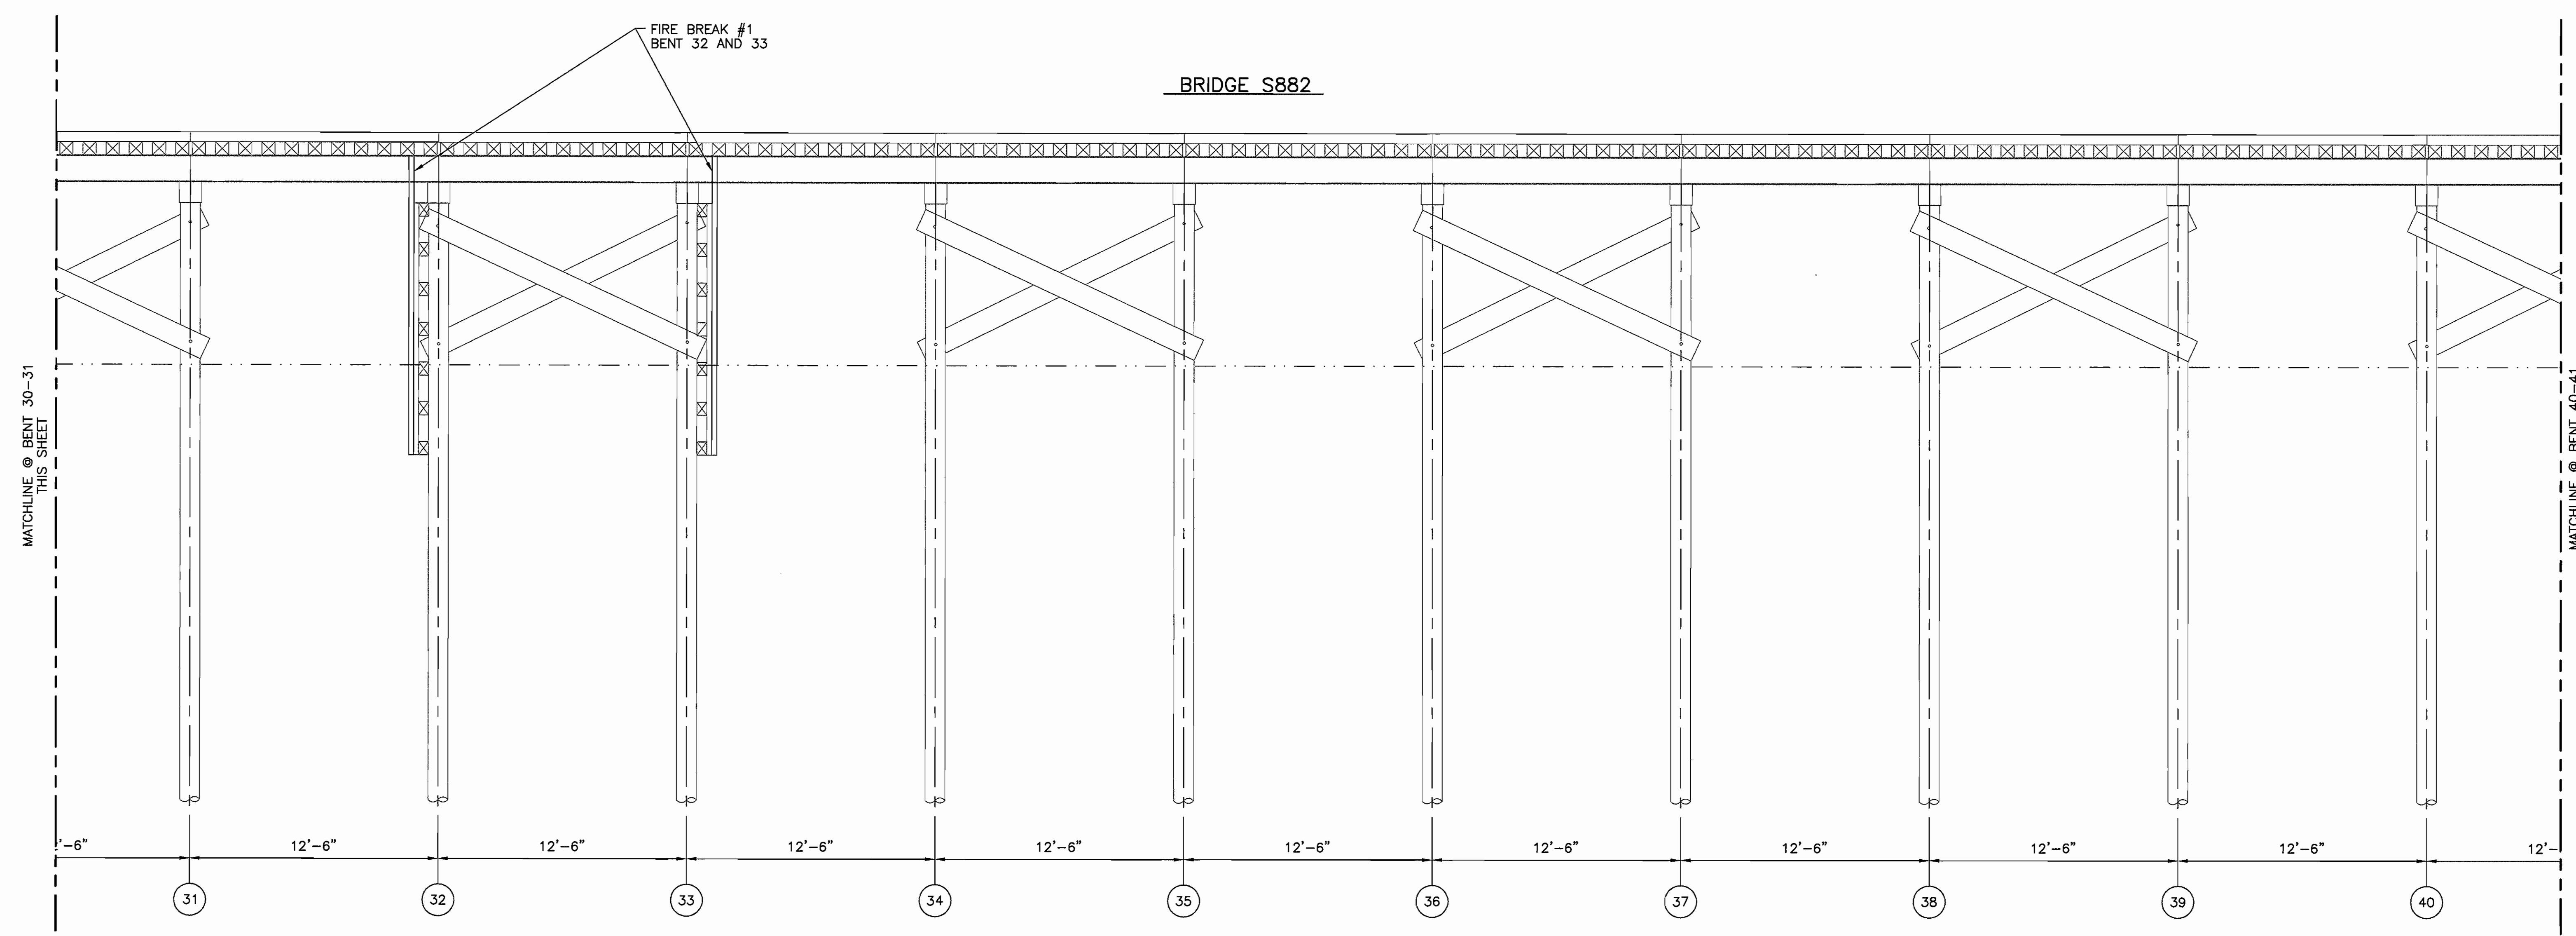
BRIDGE S882

DESCRIPTION OF RESPONSIBILITY AND REQUIREMENTS:	ACTION TO BE TAKEN:
1. REPAIR BENT 5 PILE CAP	REPAIR PILE CAP AS NEEDED.
2. REPAIR PILE D, BENT 154	REPAIR PILE PER "DECAYED PILE REPAIR DETAIL".

3. CLEAN AND INSTALL FULL HEIGHT PILE WRAPS ON ALL TIMBER PILES IDENTIFIED WITH MODERATE CHECKS, SPLINTERING, MARINE BORER ACTIVITY, FRACTURED AND/OR HEAVILY DECAYED TIMBER PILES WITH 10% OR MORE SECTION LOSS TO PREVENT FURTHER DETERIORATION AND LOSS OF SECTION.	REPAIR PILE PER "DECAYED PILE REPAIR DETAIL" TO FULL HEIGHT OF IDENTIFIED PILES AT 44 LOCATIONS IDENTIFIED IN THE REPORT.

4. REPLACE MISSING, FRACTURED, AND/OR HEAVILY DECAYED TIMBER CROSSBRACING MEMBERS, TIMBER CURBS, AND TIMBER RAIL TIES, INCLUDING REPLACEMENT OF THE MISSING, CORRODED OR BROKEN HARDWARE.	REPLACE MISSING, FRACTURED, AND/OR HEAVILY DECAYED TIMBER CROSSBRACING, CURBS, RAIL TIES, AND ANY MISSING OR CORRODED HARDWARE.

5. REPLACE THE LOWER PANELS WITH HEAVY CORROSION AND SECTION LOSS AT THE FIREBREAKS BETWEEN BENTS 1 AND 134.	REPLACE THE LOWER PANELS IN ACCORDANCE WITH THE DETAILS.

6. REPLACE THE MISSING AND BROKEN RAIL BEARING PLATES, AND RAIL SPIKES AS NEEDED.	IDENTIFY AND REPLACE THE MISSING AND BROKEN RAIL BEARING PLATES AND RAIL SPIKES AS NEEDED.

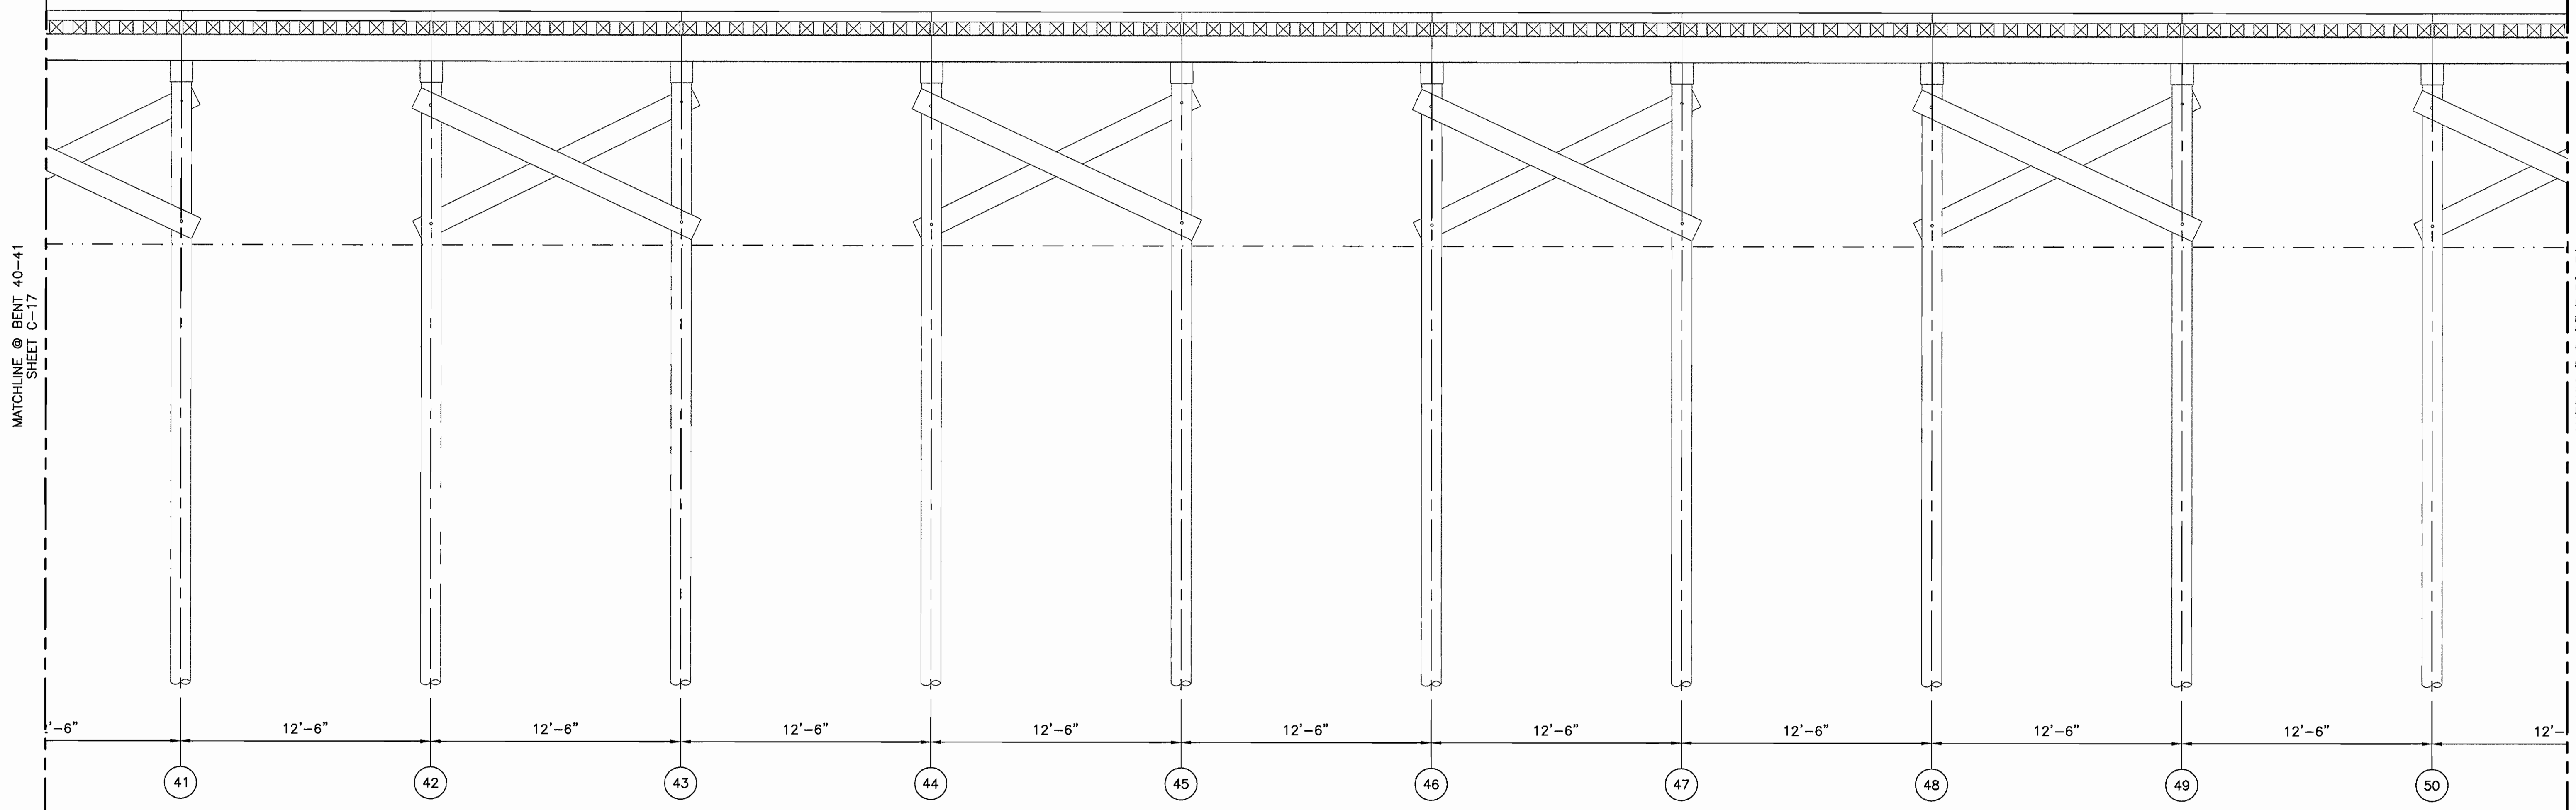
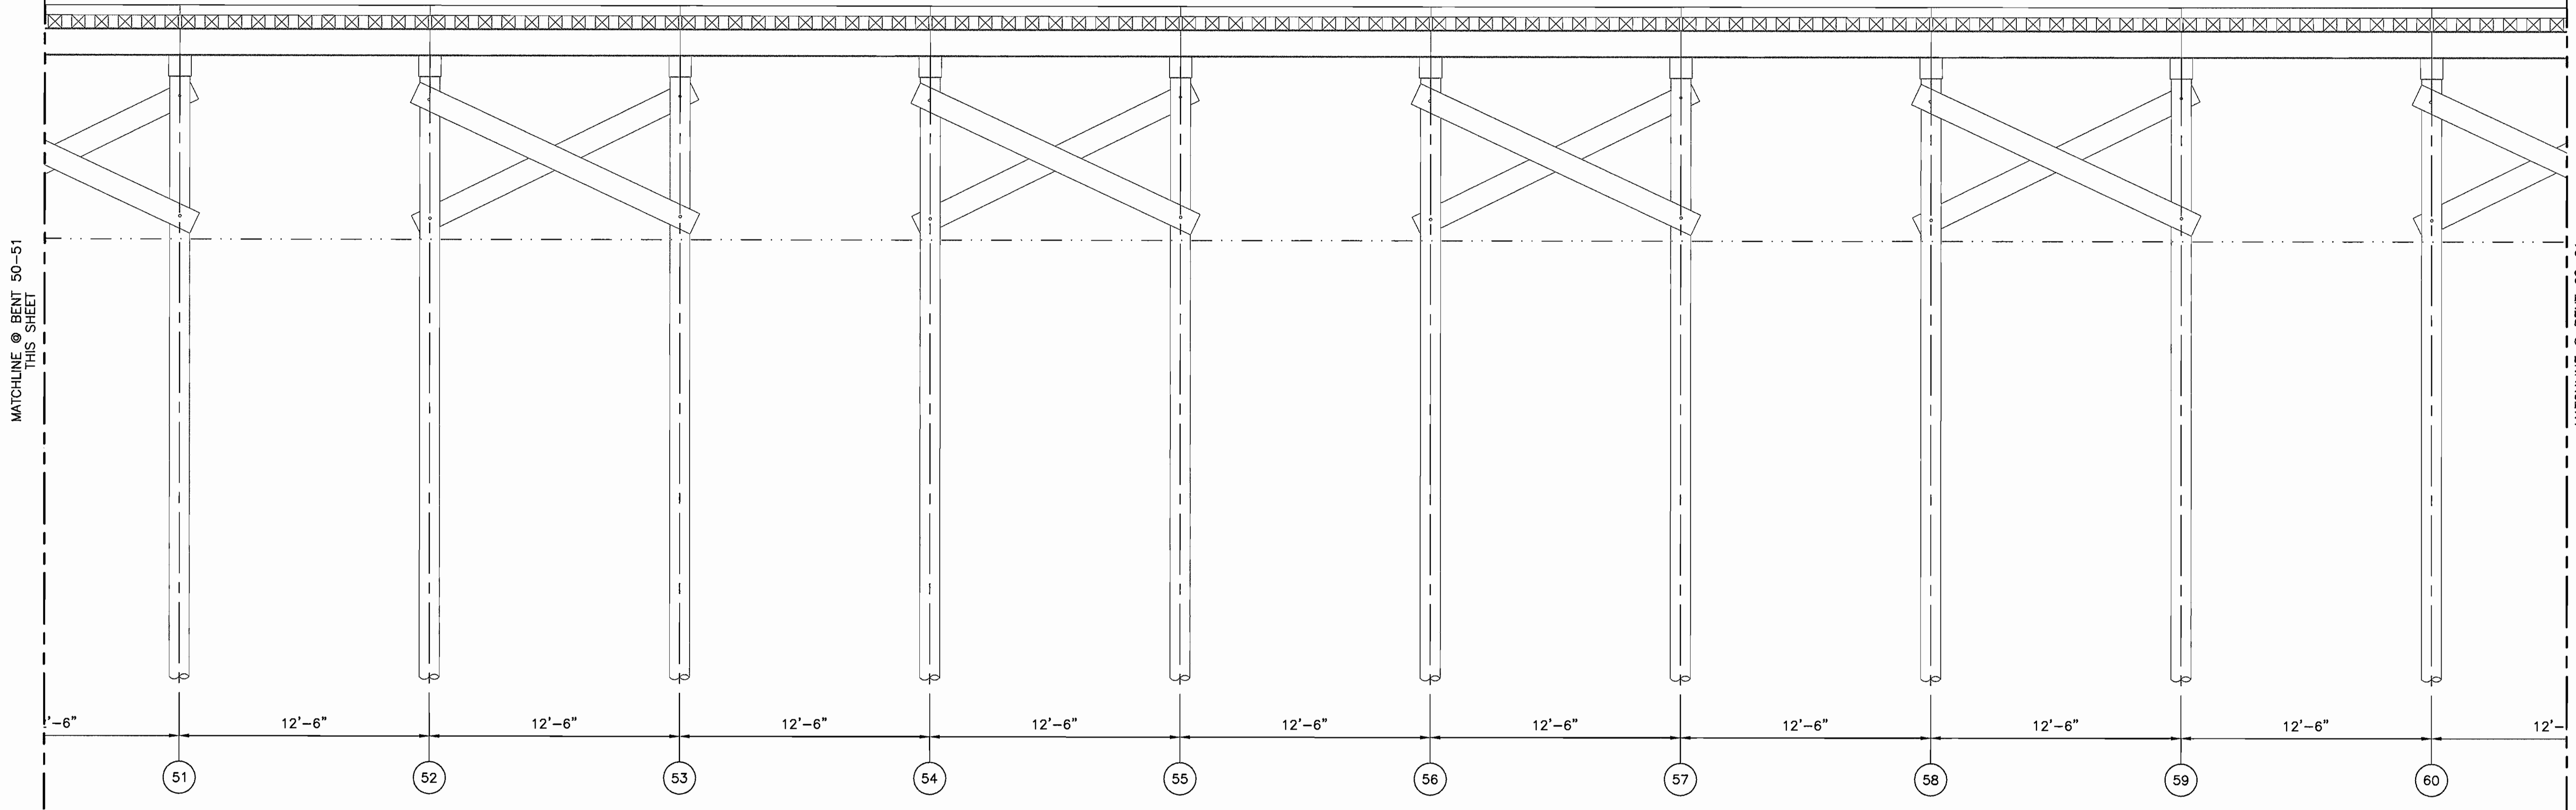
BRIDGE S882

DESCRIPTION OF RESPONSIBILITY AND REQUIREMENTS:	ACTION TO BE TAKEN:
1. REPAIR BENT 5 PILE CAP	REPAIR PILE CAP AS NEEDED.
2. REPAIR PILE D, BENT 154	REPAIR PILE PER "DECAYED PILE REPAIR DETAIL".

3. CLEAN AND INSTALL FULL HEIGHT PILE WRAPS ON ALL TIMBER PILES IDENTIFIED WITH MODERATE CHECKS, SPLINTERING, MARINE BORER ACTIVITY, FRACTURED AND/OR HEAVILY DECAYED TIMBER PILES WITH 10% OR MORE SECTION LOSS TO PREVENT FURTHER DETERIORATION AND LOSS OF SECTION.	REPAIR PILE PER "DECAYED PILE REPAIR DETAIL" TO FULL HEIGHT OF IDENTIFIED PILES AT 44 LOCATIONS IDENTIFIED IN THE REPORT.

4. REPLACE MISSING, FRACTURED, AND/OR HEAVILY DECAYED TIMBER CROSSBRACING MEMBERS, TIMBER CURBS, AND TIMBER RAIL TIES, INCLUDING REPLACEMENT OF THE MISSING, CORRODED OR BROKEN HARDWARE.	REPLACE MISSING, FRACTURED, AND/OR HEAVILY DECAYED TIMBER CROSSBRACING, CURBS, RAIL TIES, AND ANY MISSING OR CORRODED HARDWARE.

5. REPLACE THE LOWER PANELS WITH HEAVY CORROSION AND SECTION LOSS AT THE FIREBREAKS BETWEEN BENTS 1 AND 134.	REPLACE THE LOWER PANELS IN ACCORDANCE WITH THE DETAILS.

6. REPLACE THE MISSING AND BROKEN RAIL BEARING PLATES, AND RAIL SPIKES AS NEEDED.	IDENTIFY AND REPLACE THE MISSING AND BROKEN RAIL BEARING PLATES AND RAIL SPIKES AS NEEDED.
