SHEET INDEX

REPAIR BRIDGES, VARIOUS LOCATIONS MCB, CLNC

PROJECT AREA DESCRIPTIONS
 BRIDGE NO. 750 (PROP. REC. NO. 200480)
 SETH WILLIAMS BLVD. OVER WALLACE CREEK

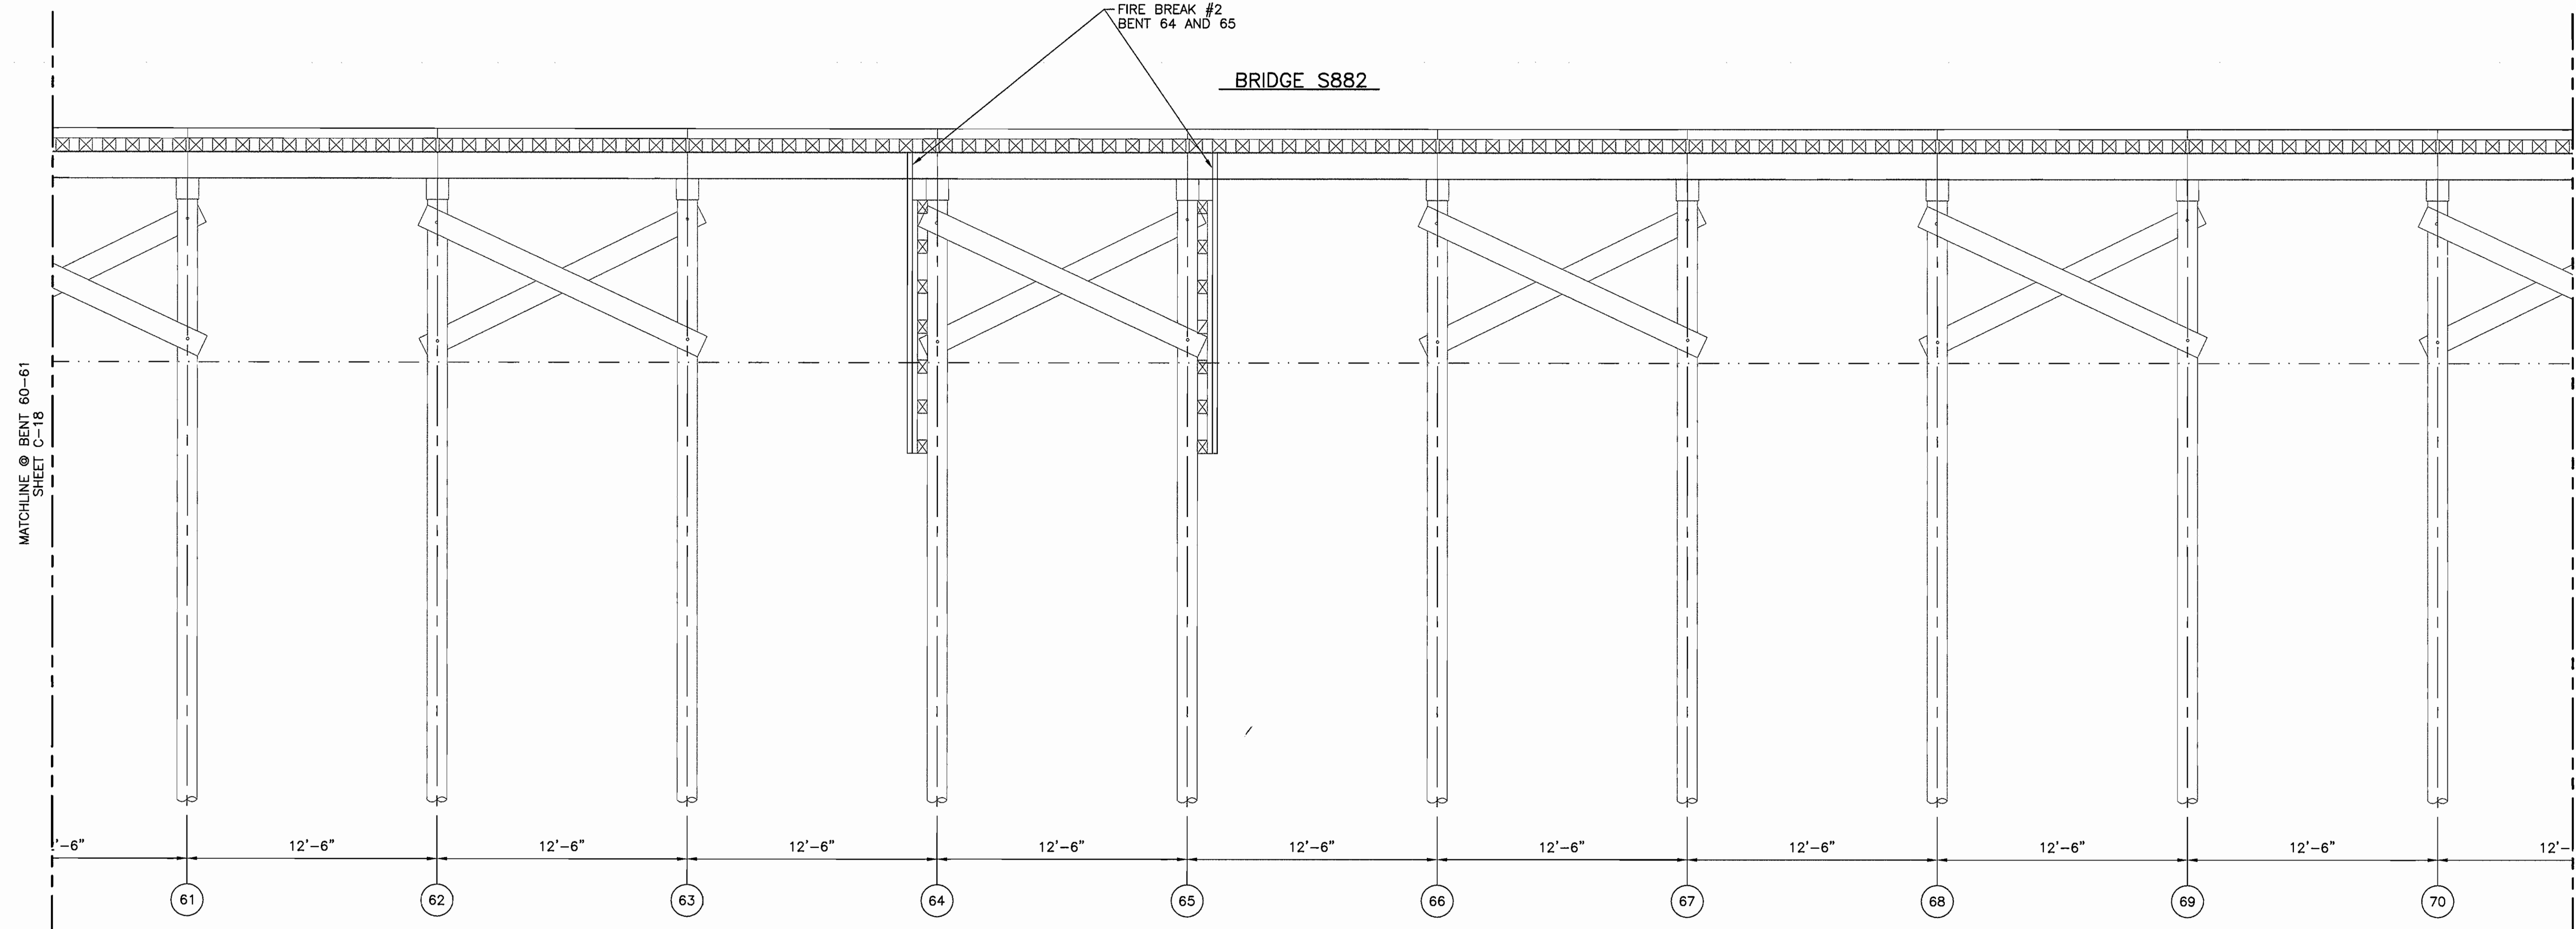
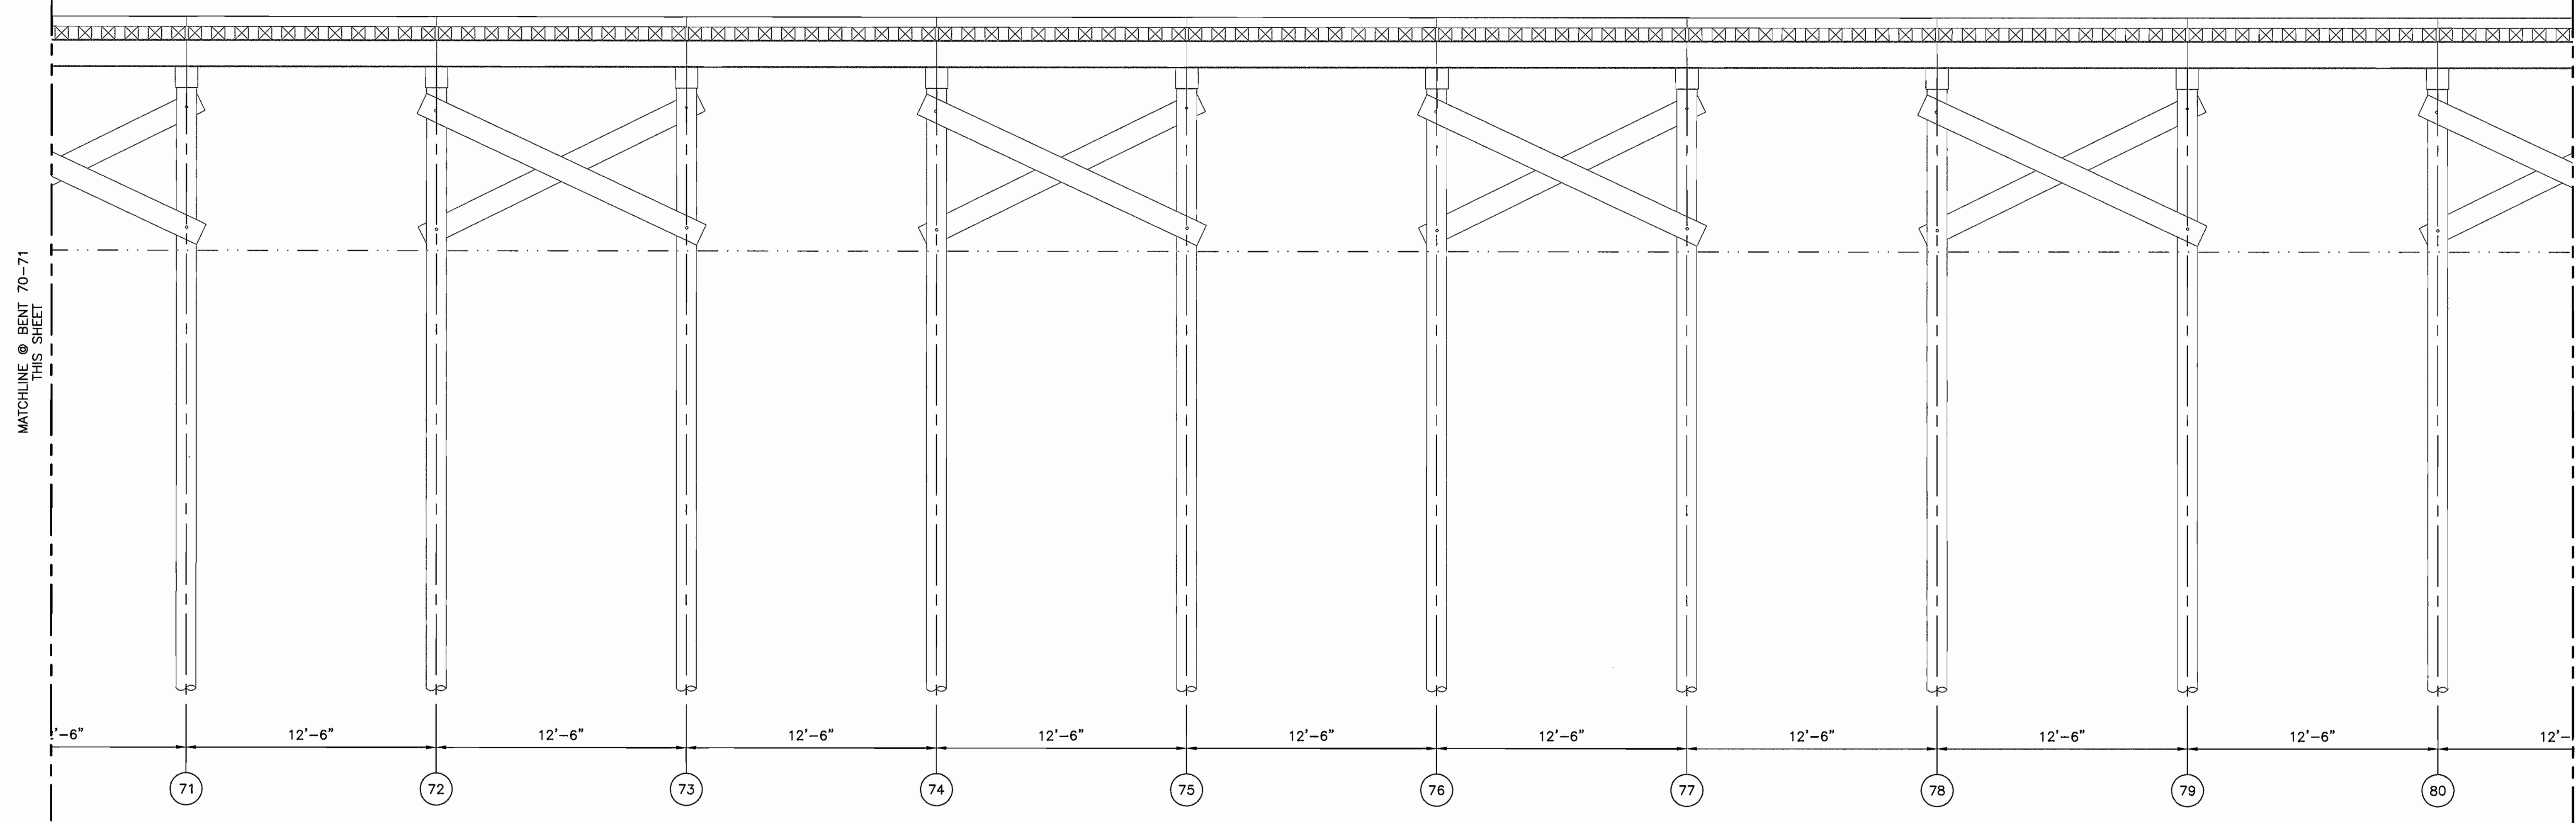
BRIDGE S882

DESCRIPTION OF RESPONSIBILITY AND REQUIREMENTS:	ACTION TO BE TAKEN:
1. REPAIR BENT 5 PILE CAP	REPAIR PILE CAP AS NEEDED.
2. REPAIR PILE D, BENT 154	REPAIR PILE PER "DECAYED PILE REPAIR DETAIL".

3. CLEAN AND INSTALL FULL HEIGHT PILE WRAPS ON ALL TIMBER PILES IDENTIFIED WITH MODERATE CHECKS, SPLINTERING, MARINE BORER ACTIVITY, FRACTURED AND/OR HEAVILY DECAYED TIMBER PILES WITH 10% OR MORE SECTION LOSS TO PREVENT FURTHER DETERIORATION AND LOSS OF SECTION.	REPAIR PILE PER "DECAYED PILE REPAIR DETAIL" TO FULL HEIGHT OF IDENTIFIED PILES AT 44 LOCATIONS IDENTIFIED IN THE REPORT.

4. REPLACE MISSING, FRACTURED, AND/OR HEAVILY DECAYED TIMBER CROSSBRACING MEMBERS, TIMBER CURBS, AND TIMBER RAIL TIES, INCLUDING REPLACEMENT OF THE MISSING, CORRODED OR BROKEN HARDWARE.	REPLACE MISSING, FRACTURED, AND/OR HEAVILY DECAYED TIMBER CROSSBRACING, CURBS, RAIL TIES, AND ANY MISSING OR CORRODED HARDWARE.

5. REPLACE THE LOWER PANELS WITH HEAVY CORROSION AND SECTION LOSS AT THE FIREBREAKS BETWEEN BENTS 1 AND 134.	REPLACE THE LOWER PANELS IN ACCORDANCE WITH THE DETAILS.

6. REPLACE THE MISSING AND BROKEN RAIL BEARING PLATES, AND RAIL SPIKES AS NEEDED.	IDENTIFY AND REPLACE THE MISSING AND BROKEN RAIL BEARING PLATES AND RAIL SPIKES AS NEEDED.

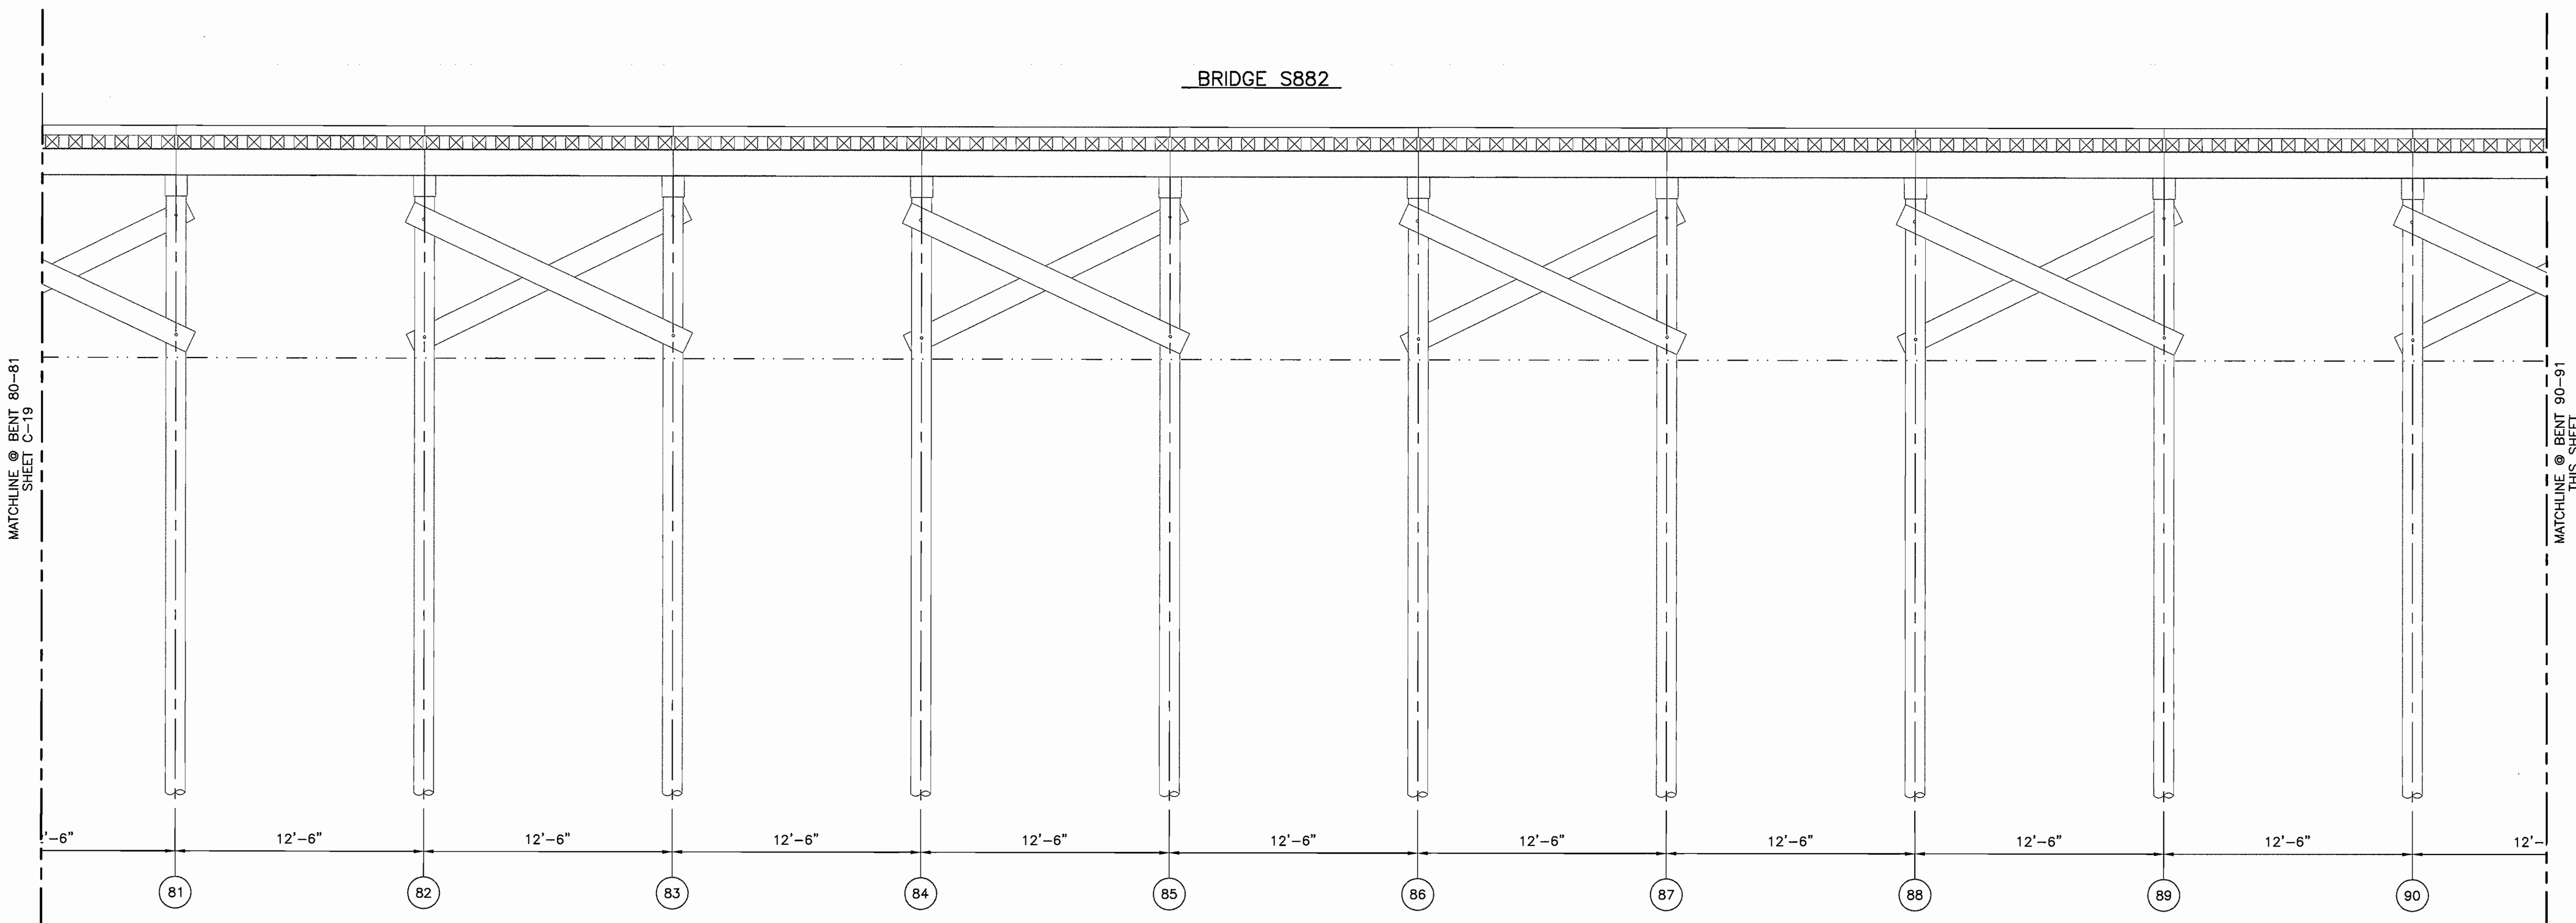
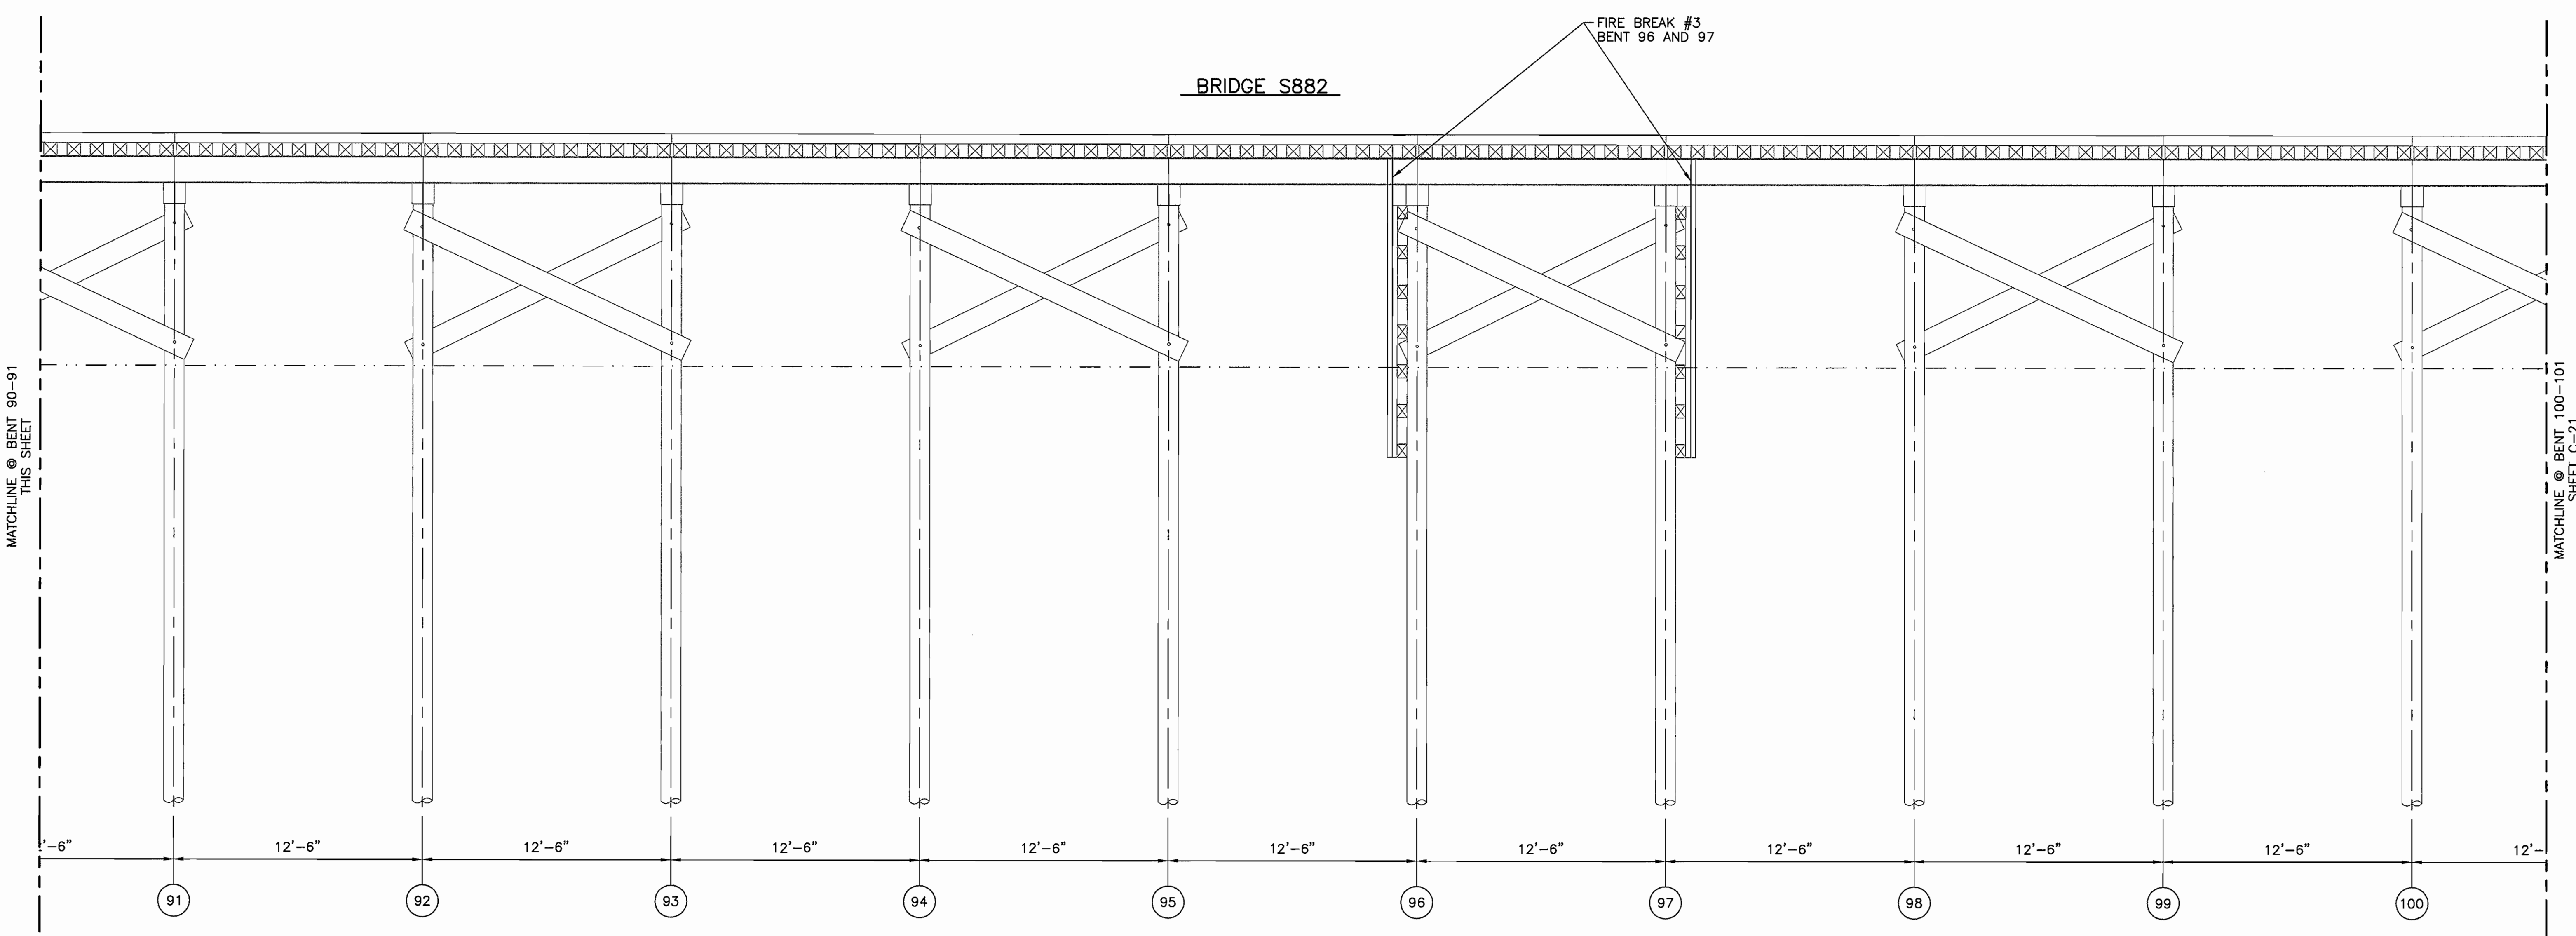
BRIDGE S882

DESCRIPTION OF RESPONSIBILITY AND REQUIREMENTS:	ACTION TO BE TAKEN:
1. REPAIR BENT 5 PILE CAP	REPAIR PILE CAP AS NEEDED.
2. REPAIR PILE D, BENT 154	REPAIR PILE PER "DECAYED PILE REPAIR DETAIL".

3. CLEAN AND INSTALL FULL HEIGHT PILE WRAPS ON ALL TIMBER PILES IDENTIFIED WITH MODERATE CHECKS, SPLINTERING, MARINE BORER ACTIVITY, FRACTURED AND/OR HEAVILY DECAYED TIMBER PILES WITH 10% OR MORE SECTION LOSS TO PREVENT FURTHER DETERIORATION AND LOSS OF SECTION.	REPAIR PILE PER "DECAYED PILE REPAIR DETAIL" TO FULL HEIGHT OF IDENTIFIED PILES AT 44 LOCATIONS IDENTIFIED IN THE REPORT.

4. REPLACE MISSING, FRACTURED, AND/OR HEAVILY DECAYED TIMBER CROSSBRACING MEMBERS, TIMBER CURBS, AND TIMBER RAIL TIES, INCLUDING REPLACEMENT OF THE MISSING, CORRODED OR BROKEN HARDWARE.	REPLACE MISSING, FRACTURED, AND/OR HEAVILY DECAYED TIMBER CROSSBRACING, CURBS, RAIL TIES, AND ANY MISSING OR CORRODED HARDWARE.

5. REPLACE THE LOWER PANELS WITH HEAVY CORROSION AND SECTION LOSS AT THE FIREBREAKS BETWEEN BENTS 1 AND 134.	REPLACE THE LOWER PANELS IN ACCORDANCE WITH THE DETAILS.

6. REPLACE THE MISSING AND BROKEN RAIL BEARING PLATES, AND RAIL SPIKES AS NEEDED.	IDENTIFY AND REPLACE THE MISSING AND BROKEN RAIL BEARING PLATES AND RAIL SPIKES AS NEEDED.
