FACILITIES ENGINEERING DEPARTMENT  
FACILITIES DIRECTORATE  
Marine Corps Air Station  
Cherry Point, North Carolina 28533-0006

PHOTO #1, Building 4310

**Sketch No. B4310-01**

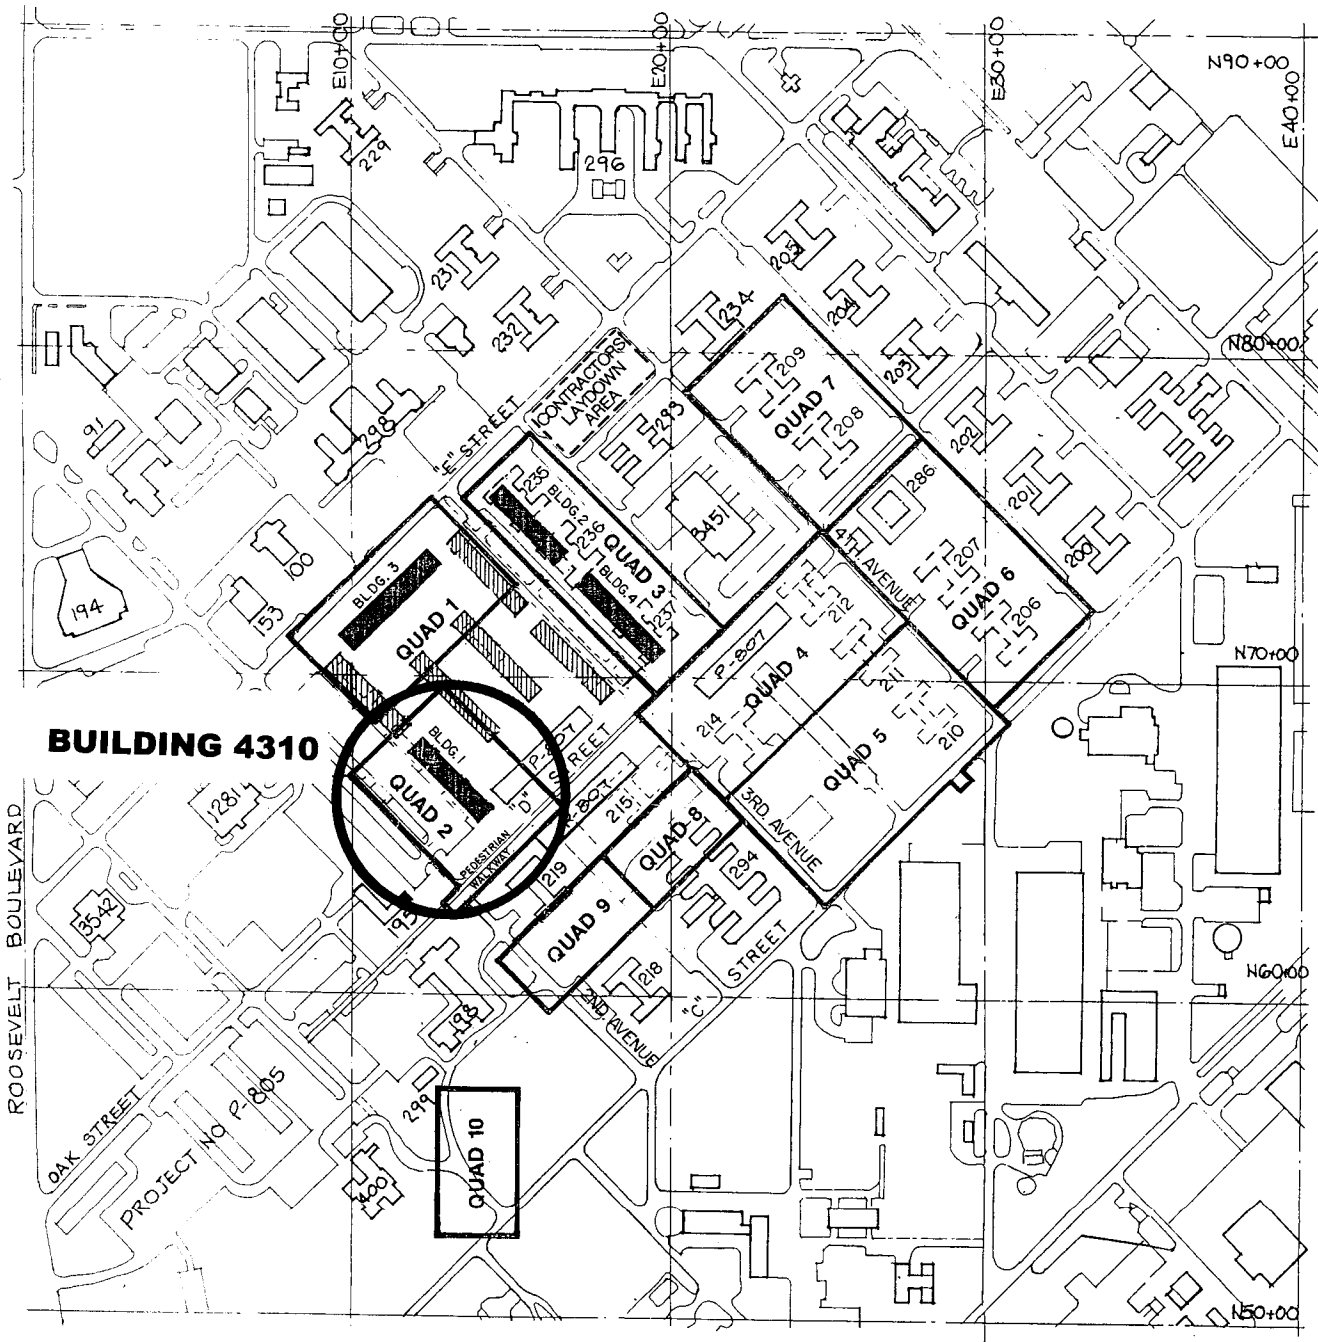
**Sketch No. B4310-02**

FB9

REPLACE BEAM # FB9

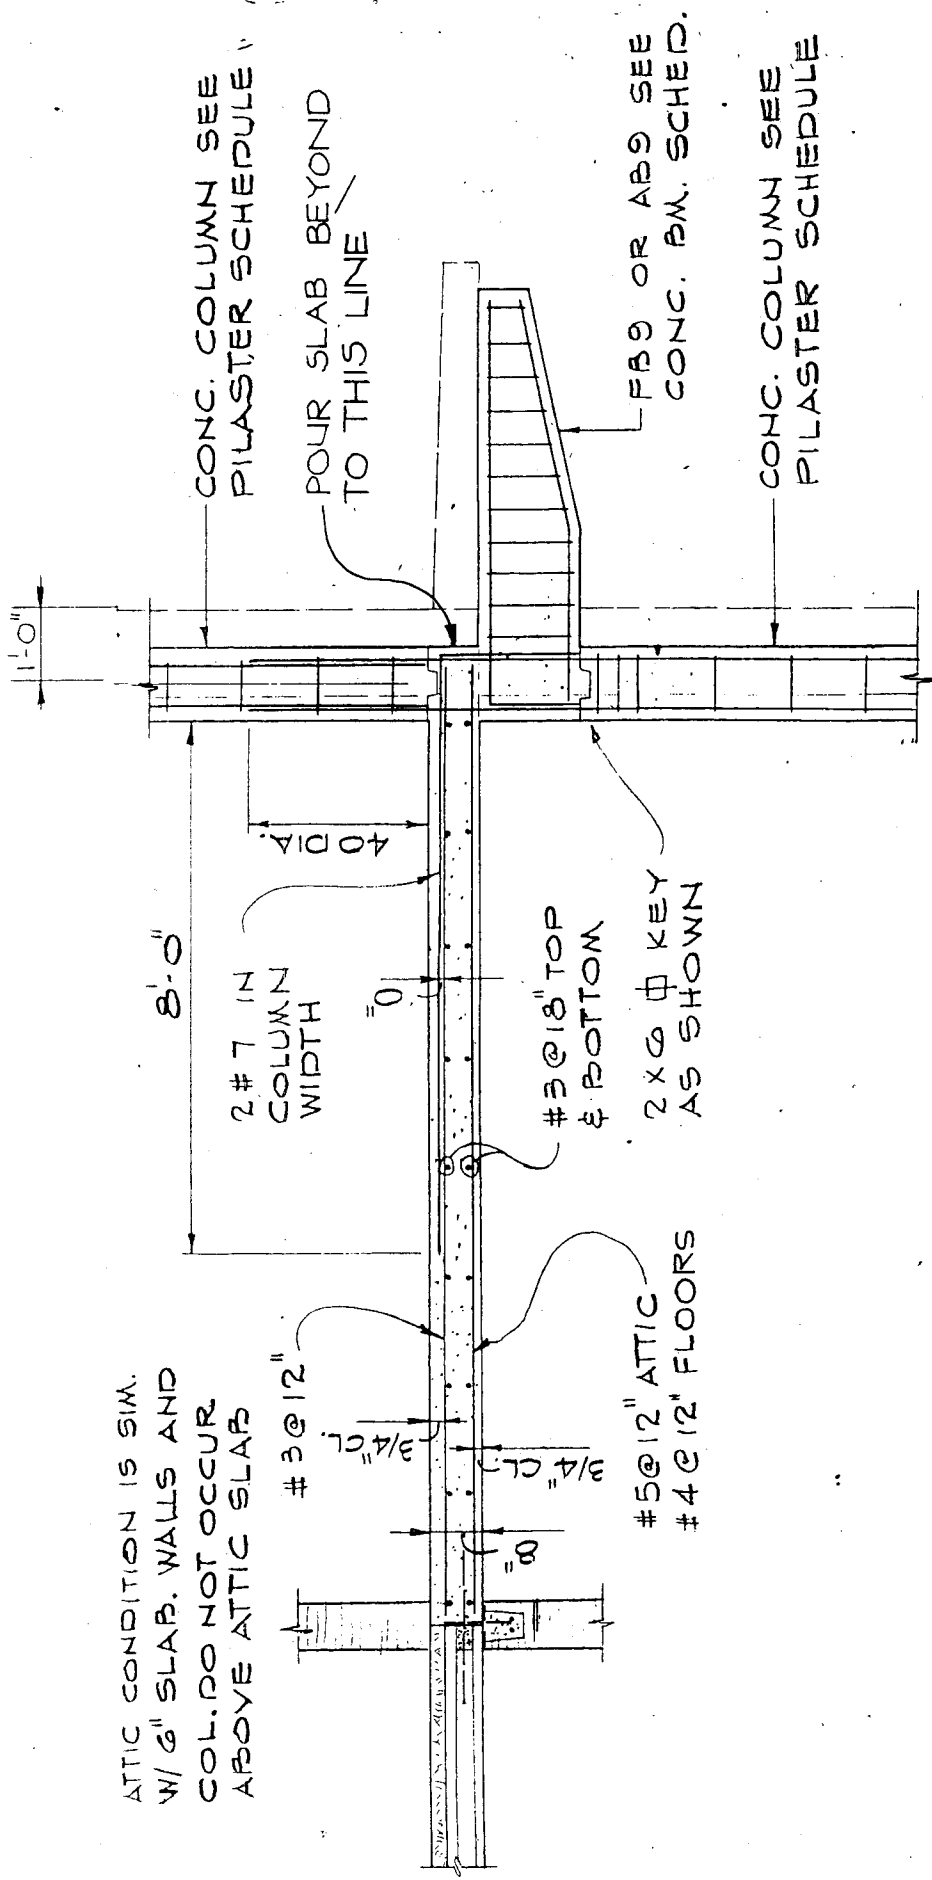
7 5158  
DETAIL AT CONC. BM. FB9  
N.T.S.  
52

**Note: This detail is taken from as-built record drawings. The Contracting Officer does not know if the detail reflects the actual construction of the beam.**

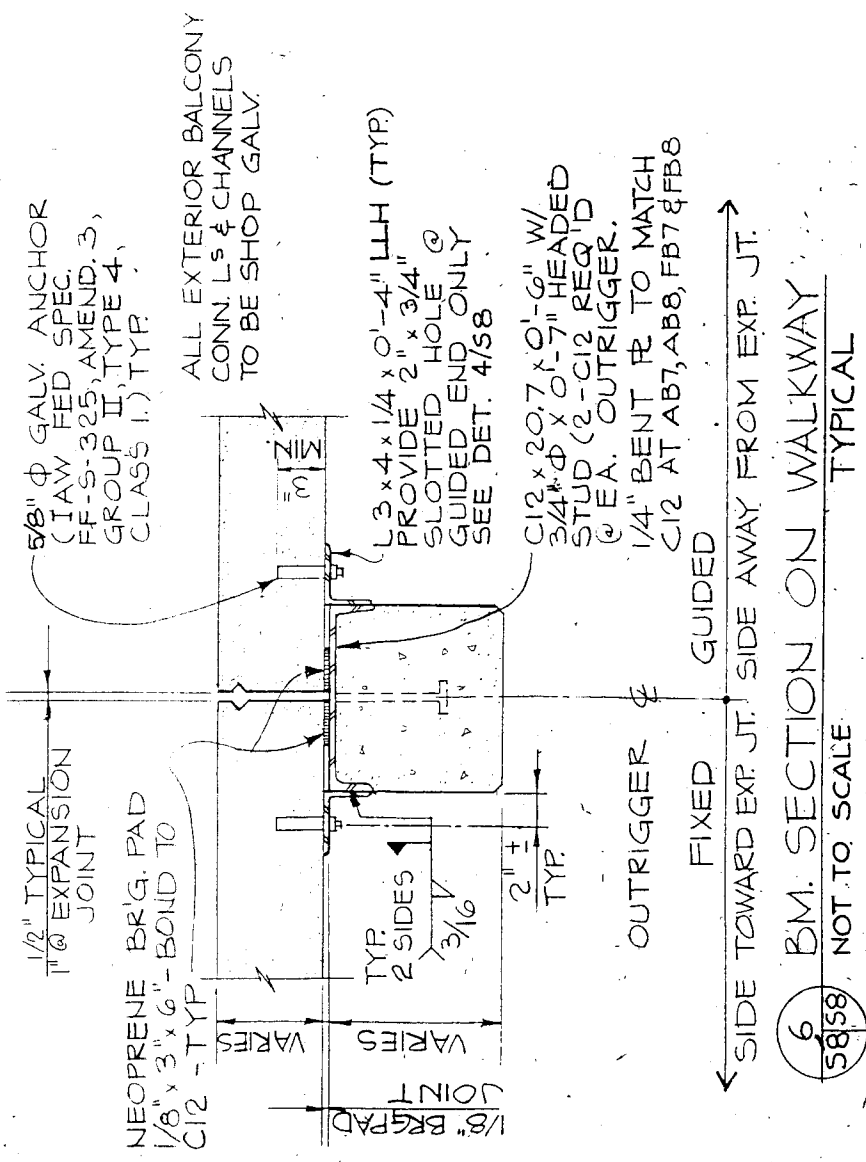
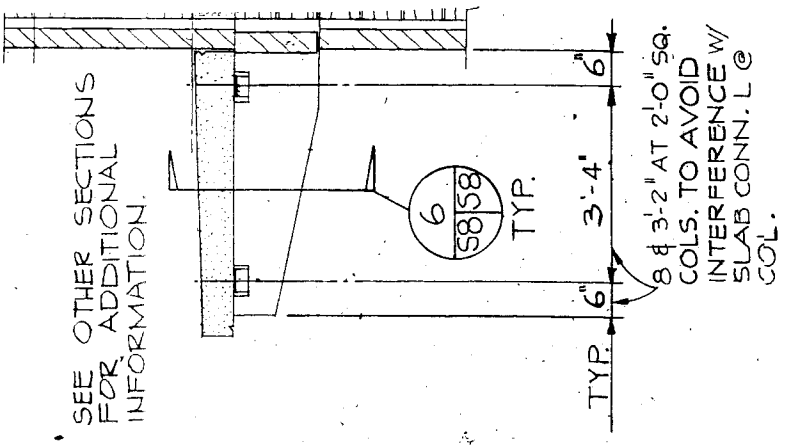
- 1. This detail is taken from as-built record drawings. The Contracting Officer does not know if the detail reflects the actual construction of the beam.**
- 2. Steel reinforcing in the beam section and in the walkway section is not shown.**
- 3. Walkways do not always have angles anchoring them to the beam as is shown on the detail.**
